PROJECT NAME: 412 6th Street
Roseville, CA 95678

ASSIGNMENT: Evaluation of design and its impact on existing trees

REPORT DATE: April 7, 2025

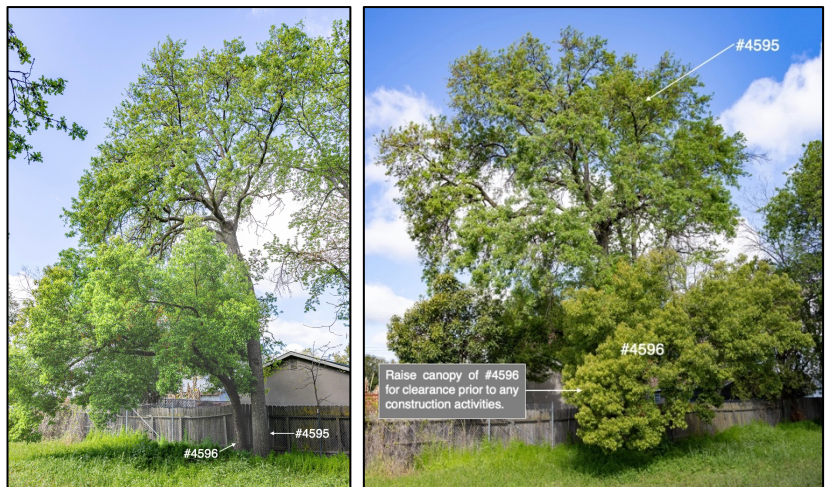
There are 2 trees next to the western property line, #4596, a camphor and #4595, a valley oak (photos at right) that are codominant where the valley oak depends on the camphor. Retaining the camphor will require specific pruning treatments for clearance. Camphor trees have a low tolerance for root damage so specialized excavation and root

pruning will be required. Root pruning requirements will not be known until they are excavated. In the event the camphor will not tolerate the required root pruning removal would be the option.

The canopy of the camphor has been shading the trunk of the valley oak which is now dependent on that shade. Removal of the camphor tree will expose the trunk of the valley oak to sunscald. Sunscald occurs when bark that is usually shaded by foliage becomes fully exposed to sunlight. The excessive sunlight causes the tissue in the bark to become so hot that the cells in the cambium start to die. This results in dried out bark that flakes off creating lesions in the bark that over time open up into large wounds. The damaged area then becomes a decay pocket that is sometimes not recognized. These types of wounds can go undetected but will eventually weaken the stem of the valley oak which could lead to its failure or ultimate decline.

Removing the camphor would also leave the remaining valley oak with a low live crown ratio. The live crown ratio (LCR) is the ratio of crown length to total tree height. The LCR is affected by species, growing conditions, pruning history, previous branch failures, and natural branch shedding. A low LCR is created when the crowns are over-pruned. In this case a low LCR would be created with the removal of the camphor. A low LCR is a condition of concern, especially when the tree is exposed to higher wind conditions that follow soil saturating rainfall. A general rule for urban trees is when the LCR is less than 30% there is an increased likelihood of whole tree failure when taking in to account site-specific factors such as construction and excavation that could contribute to tree instability.

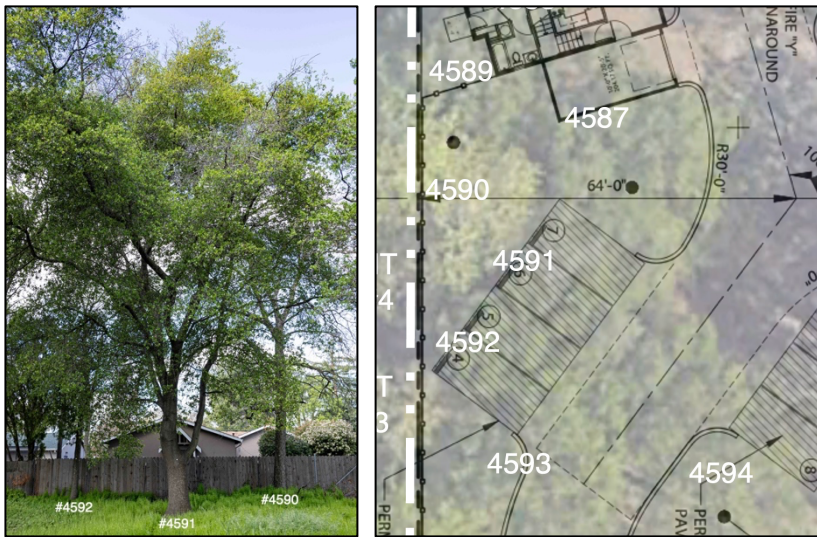
Tree #4591 (photo below left) is located in the northwest section of the site and will likely be

impacted by grading for a parking area. Retaining this tree will require careful excavation, specific root pruning and regular care during the construction phase. Retaining the tree also depends on the amount of roots that are cut at the time of grading. In the event the tree could become destabilized as a result of excessive root loss the tree will need to be removed.
