## Kurt Stegen Consulting Arborist

Date: September 11, 2019

Location: 450 Diamond Oaks Road  
Roseville, CA. 95678  
APN 015-360-022

Customer: Tangent Design & Engineering Corp  
660 Auburn Folsom Road St 204  
Auburn, CA. 95603  
916-572-5955  
[www.tangentde.com](http://www.tangentde.com)

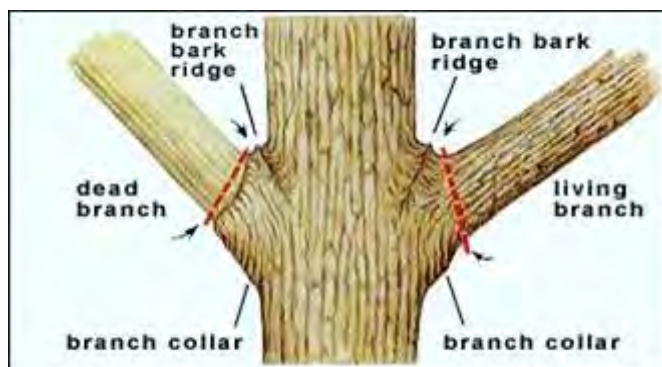
Trimming limbs that will be interfering with the project should be kept to a minimum. Flush cutting and removing the branch collar will prevent healing and cavities can form. When removing limbs, leave a small stub, part of the limb being removed and retain the branch collar. (See diagram below)
