This report has been prepared for Wesley Cambron and Allstate Renovations Inc., at the property 114 & 114A, Roseville Street, Roseville, CA. There is only one tree on the property and it will be designated as Tree # 1, as indicated on the attached aerial image of the property titled "Tree # 1 Location". This image also shows the two properties previously mentioned. This permit has been written to assess current conditions of Tree # 1 and future health impacts if said tree is retained, and proposed structures are built. This report has been written to conform with the guidelines established by Roseville Municipal Code 19.66.050

Minimum Information for Tree # 1

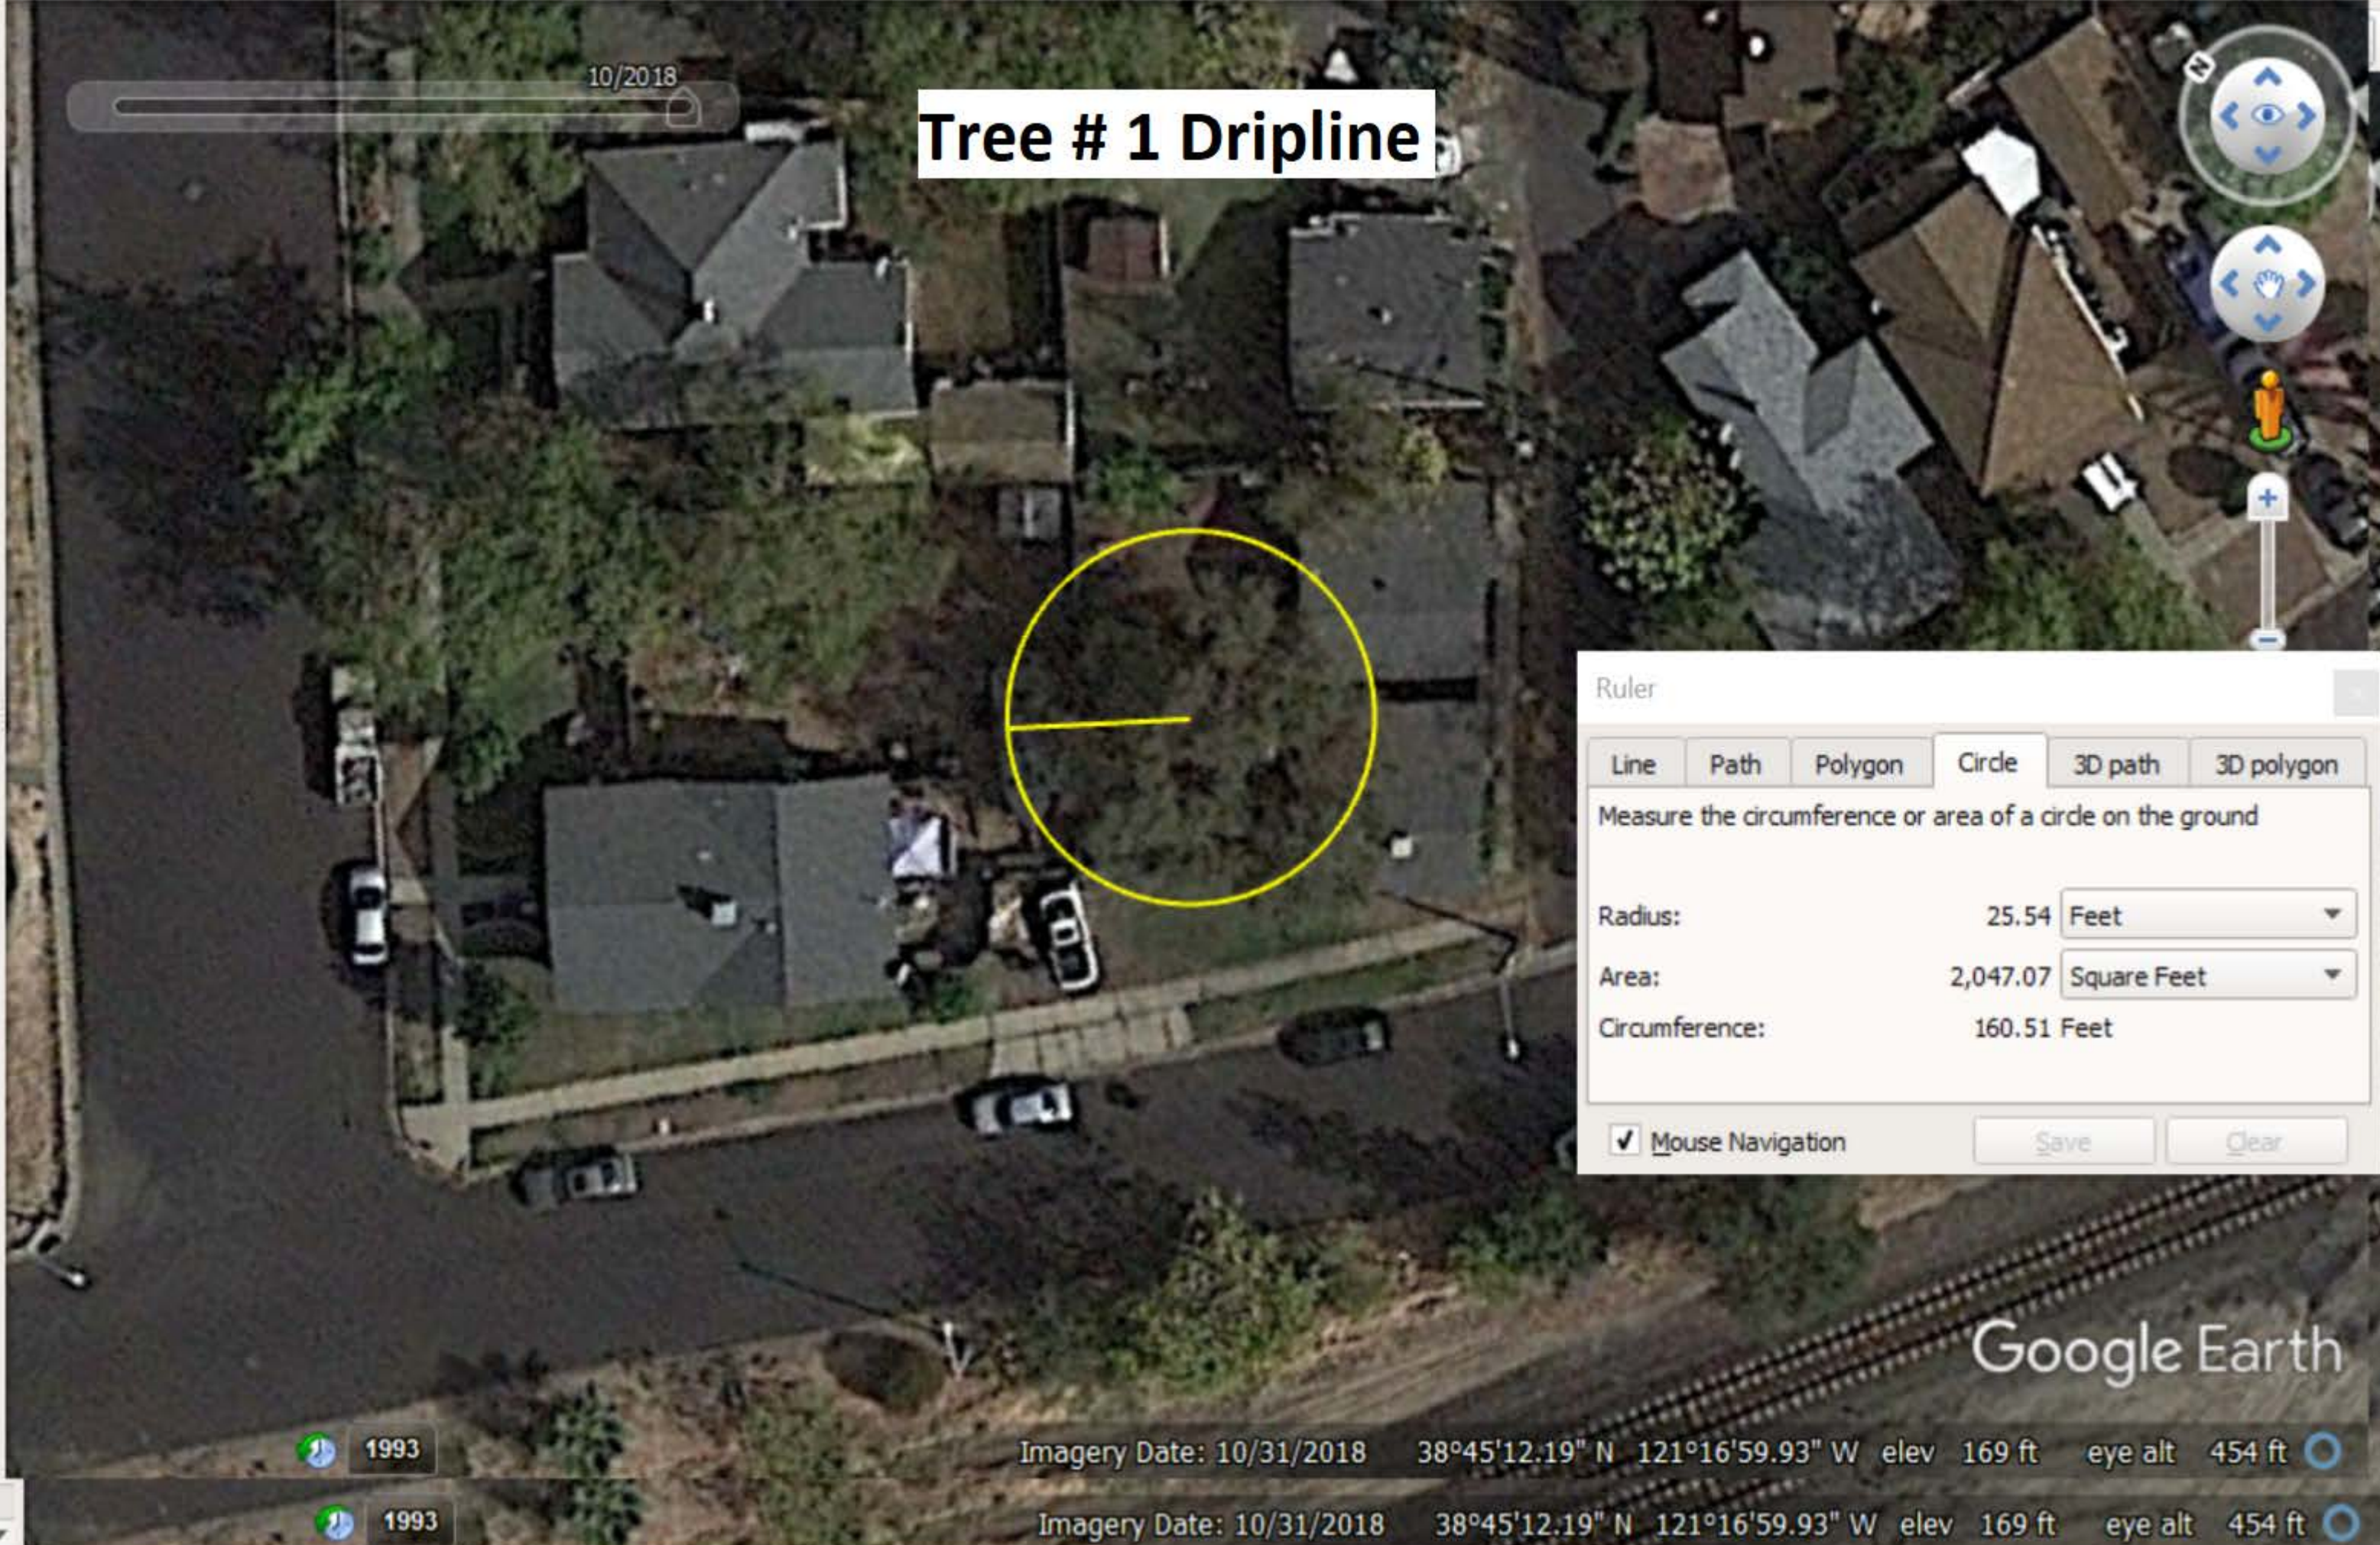
Tree # 1 Dripline

measuring tape walked out from the base of the tree to its furthest spread, as well as using GoogleEarth to gauge an accurate spread of the canopy, as seen in attached image titled, "Tree # 1 Dripline".

Radius: 25.54 Feet
