# Exhibit B

RE: Large Oak tree located at Campus Oaks 3

RE: Large Blue Oak, located on the lot under construction at the S/E corner of Blue Oaks Blvd and Woodcreek Blvd

**TREE # 3 – Blue Oak (*Quercus douglasii*)**

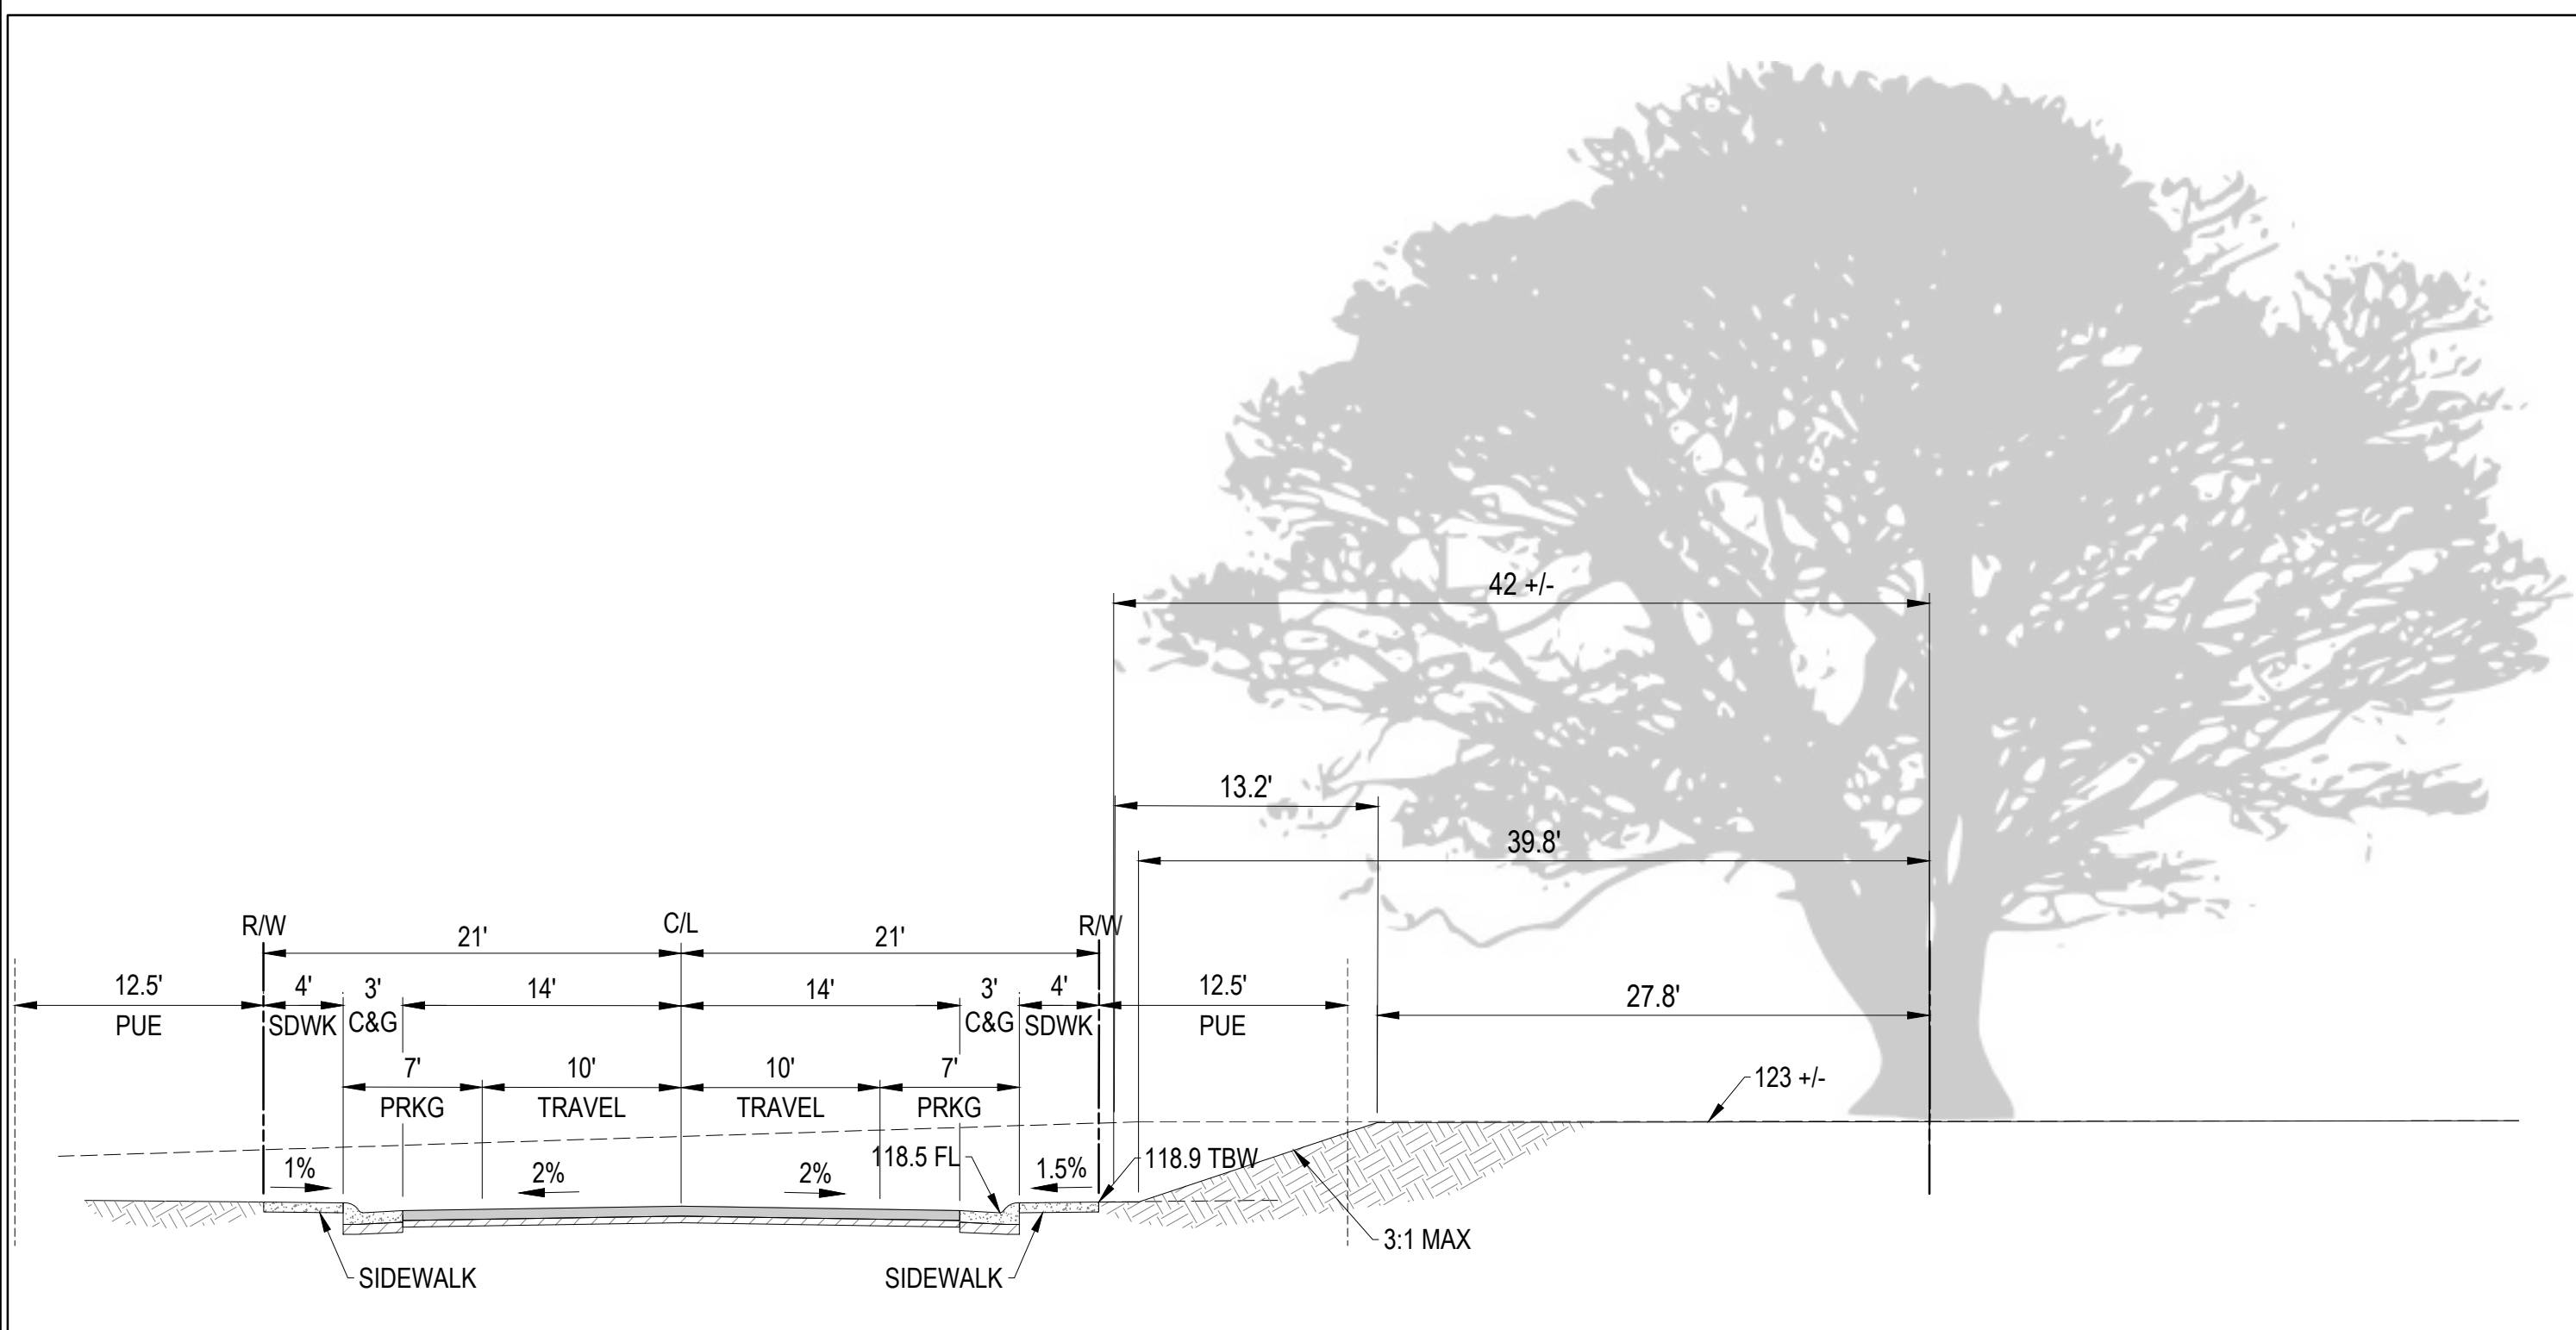
### TREE ENCROACHMENT SECTION (1 of 2)

42' ROAD SECTION (KNIGHTSBRIDGE LANE)

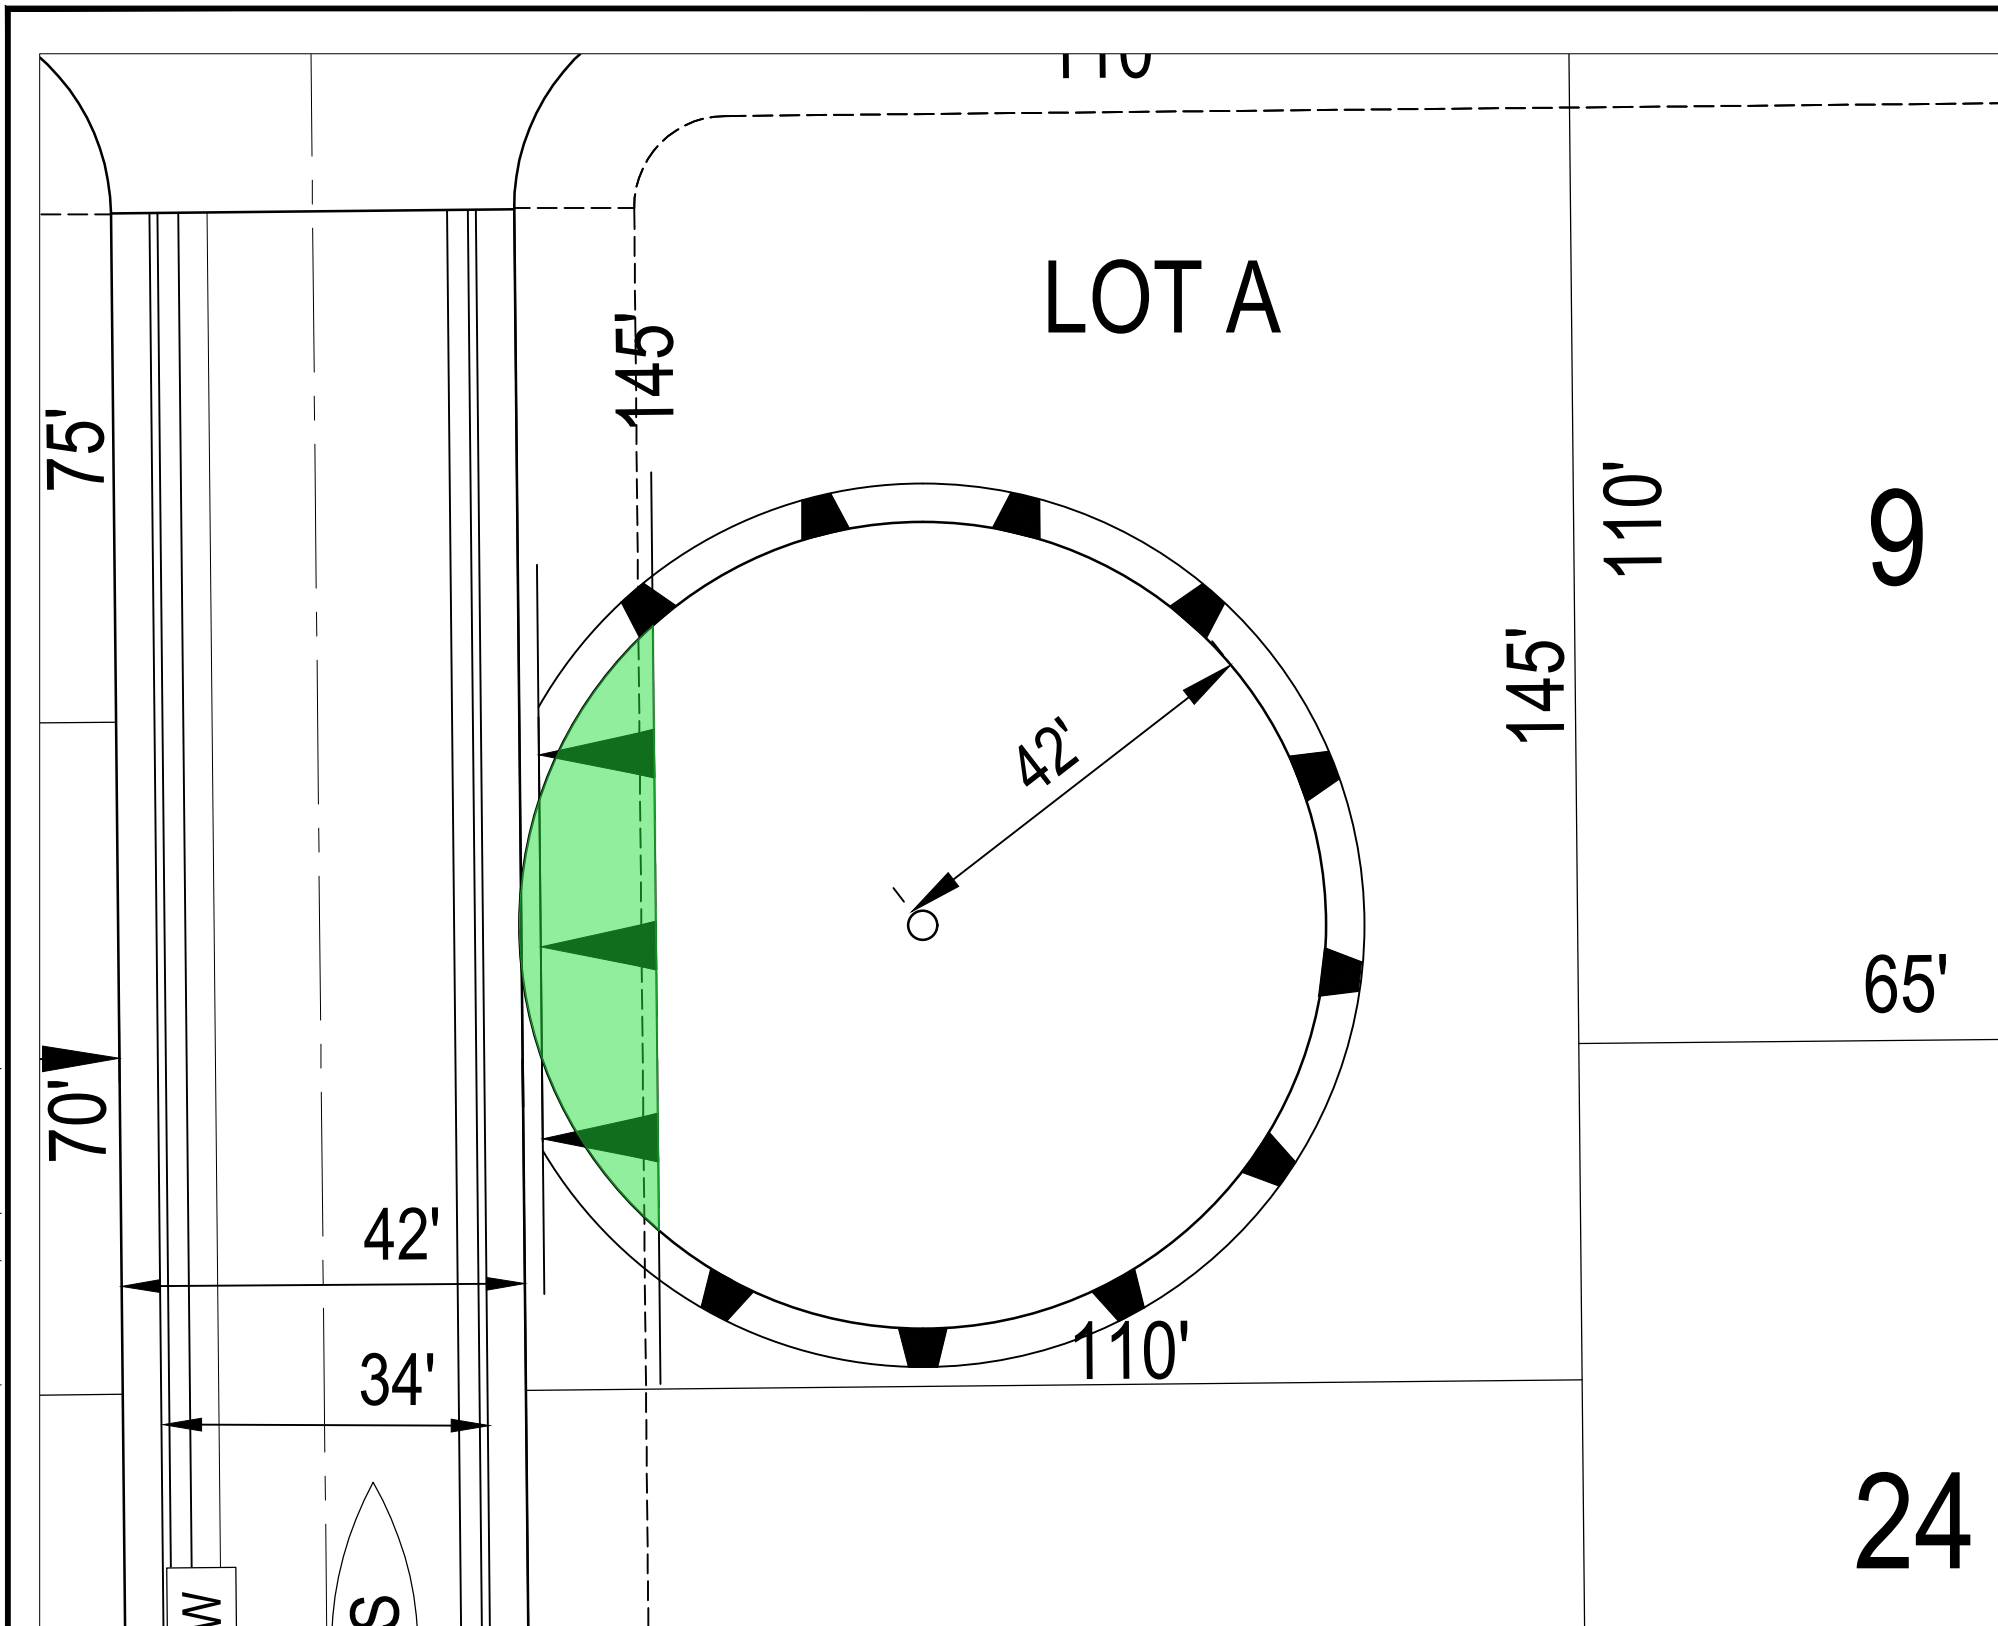
**TREE ENCROACHMENT (2 of 2)**

Tree Canopy Area  
 (@ 42' D.L.R)  
 5,542 sf  
 Full Impact =  
 622 sf (11.2%)
