RE: Tree Evaluation, Impact Assessment and Preservation Specifications:  
2130 Douglas Boulevard, Roseville

**TREE EVALUATION, IMPACT ASSESSMENT  
AND PRESERVATION SPECIFICATIONS  
2130 DOUGLAS BOULEVARD, ROSEVILLE**

**Prepared for  
HOK  
San Francisco, California**

**March 3, 2021**

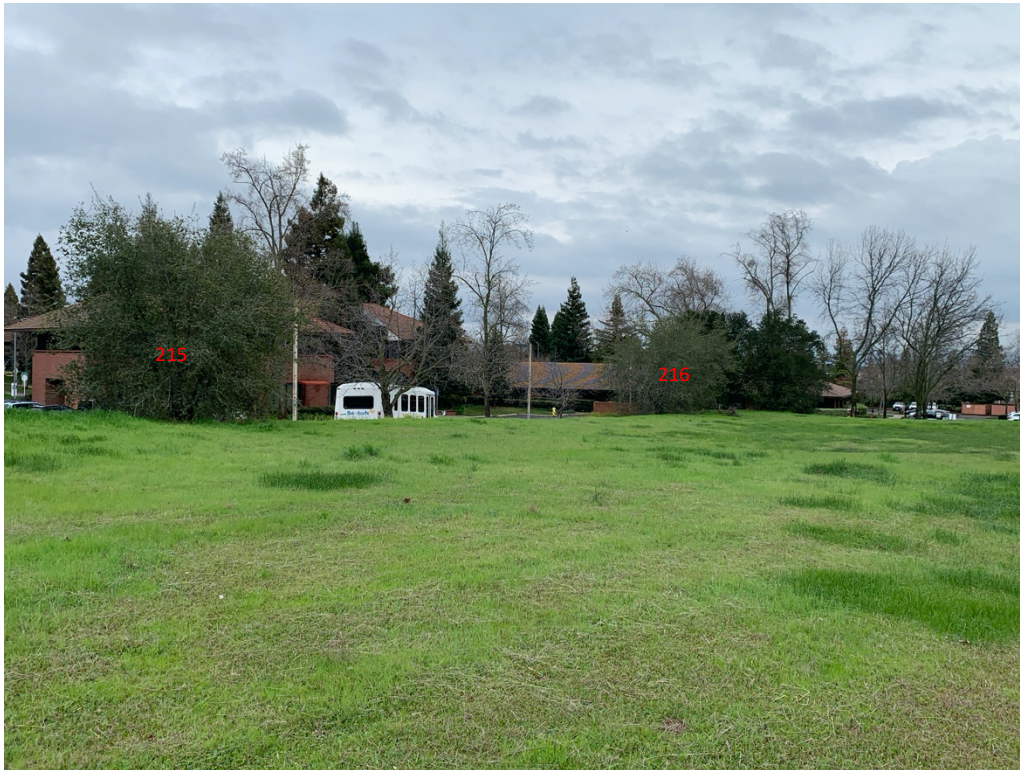
Interior live oak tree #215 had trunks with diameters equal to 9,5,6,3 and 4 inches. While the health of tree #215 was fair/good, I rated its structure as poor/fair. The multiple trunks originated from near ground level and bark was included (embedded) between them. There is no feasible means to improve this tree's structure and the likelihood of one or more of its trunks falling will increase with time. For these reasons, *I recommend that tree 215 be removed.*

*Figure 1. Looking southeastward at interior live oak trees 215 and 216 (labeled).*

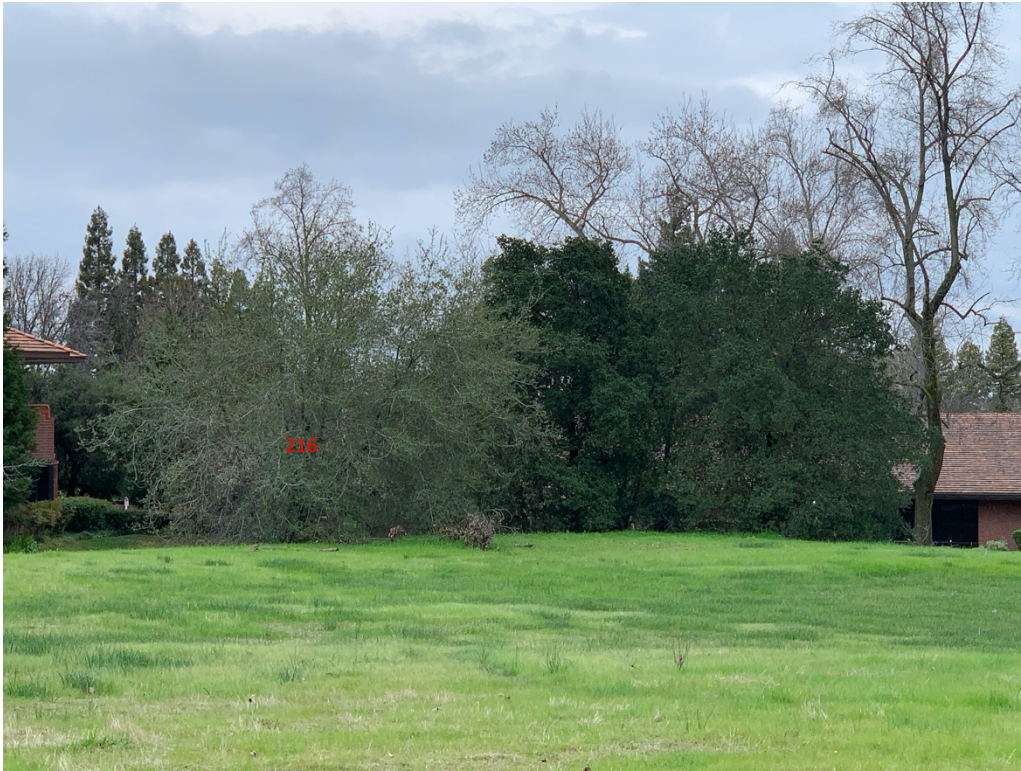
Tree #217 was a six-inch diameter interior live oak with fair health and fair structure. It had codominant trunks and low vigor. Irrigating this tree (infrequently) and training (pruning) it should improve its condition.

*Figure 2. Looking southeast at interior live oak trees 216 (left) and 217 (obscured and behind 216).*

The proposed grading and infrastructure are located 5 feet west southwest and 8 feet north northwest of the trunk of tree #216. Considering the proximity of the proposed grading to the trunk of this tree which has a protection zone of 17 feet, I rated the impact of the proposed construction as severe. *For this reason, I recommend this tree be removed.*

The proposed grading and infrastructure are located 6 feet west southwest of the trunk of tree #217. This tree has a protection zone of 6 feet so there will be no encroachment into this tree's protection zone. Considering this, I rated the impact of the proposed construction as low/moderate for this tree.
