ARBORIST REPORT

121 E Street
Roseville, Ca 95747

March 15, 2022

TREE REPORT

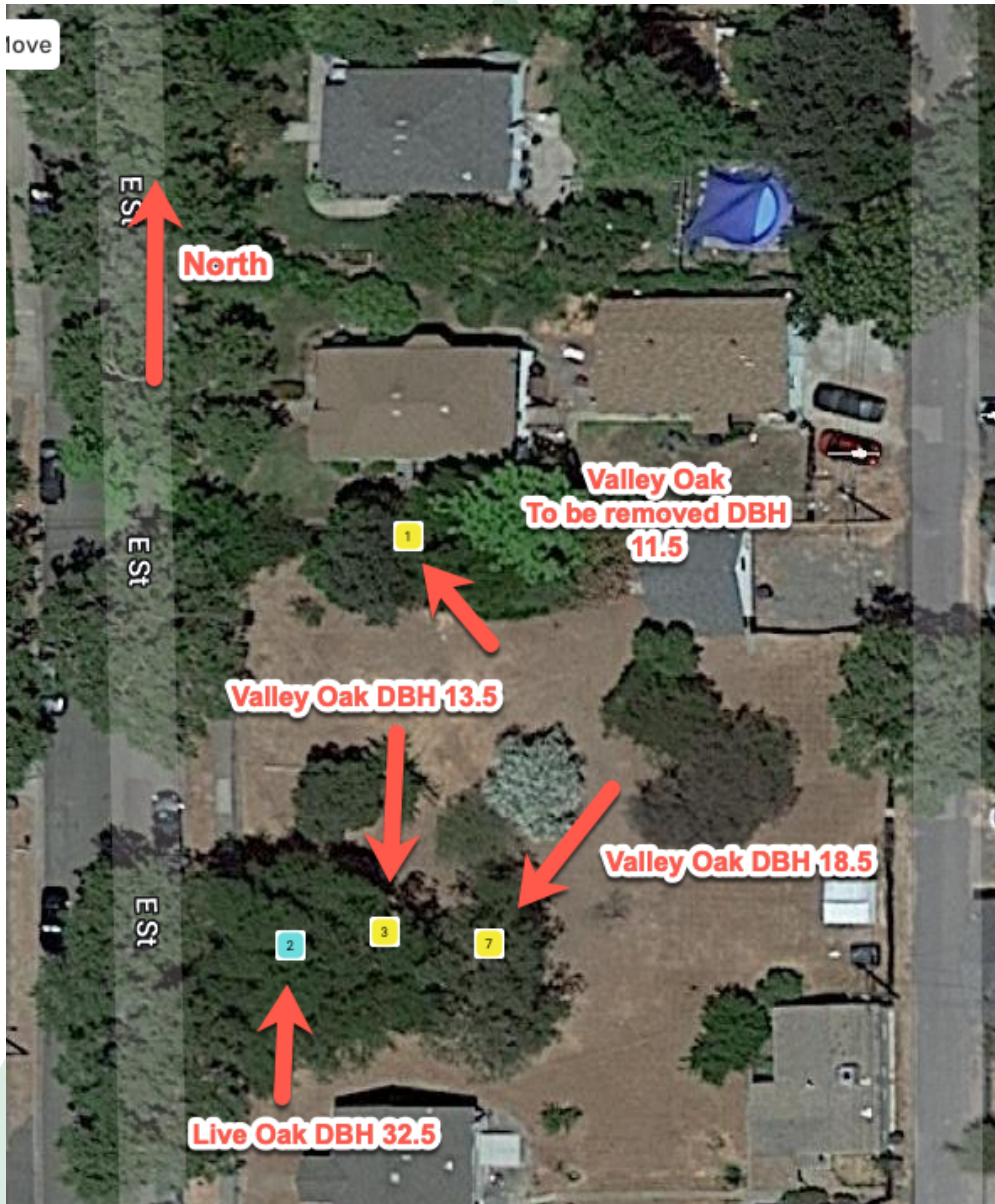
Two (2) Valley Oaks (*Quercus lobar*) and one (1) Canyon Live Oak (*Quercus chrysolepis*) are located on or near the Southern property line. Less than 20% of the trees' canopies and root zones have the potential to be impacted by the proposed construction. All three (3) of these trees are in good health.

Any necessary pruning to the canopies, in my opinion, if performed properly and to industry standards, required for the proposed construction will not be detrimental to the long term health of the trees.

Prior to the start of construction and at the completion of construction, an application of ArborFusion or similar, is recommended to reduce stress to the trees during the construction process.

A tree protection system should be installed prior to the start of construction to protect the trunk from equipment, storing of construction materials etc. The protection zone should be as large as conditions allow and have 6-8" layer of mulch/ wood chips to help protect the root zone. If conditions allow, extending the mulch/ wood chips out to the trees' drip line would be beneficial.

If pruning of scaffolding roots is necessary; It is recommended to have a certified Arborist onsite to ensure proper root pruning and to advise on any potential risks to their overall health and structural stability. The non-invasive walkway that is proposed will not cause any additional stress to the trees or its root zone.

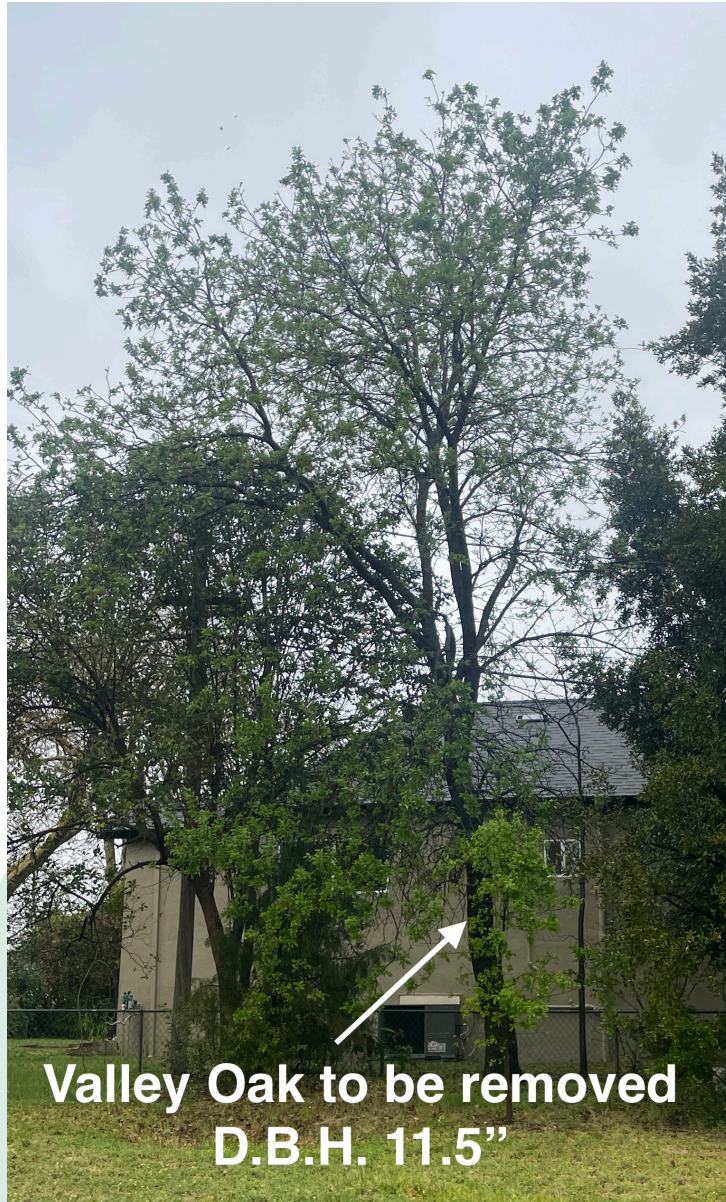
One (1) Valley Oaks (*Quercus lobar*) with a D.B.H. of 11.5". The tree is in good health. There are power and data lines above the tree. The trees' proximity to the power and data lines, existing (neighboring structure) and proposed new construction is not ideal and lacks the appropriate space for the tree to reach its mature size.

I was informed by Wes Cambron, representing Allstate Renovations Inc., that during a recent site visit with their local utility (Roseville Electric) they were told the tree could be a potential hazard. They would like to have this tree removed as soon as possible.

Valley Oak to be removed
D.B.H. 11.5"

Considering the trees' location, construction needs and the property as a hole; It is my opinion that removing this tree and is acceptable.
