REVISED¹ PRE-DEVELOPMENT ARBORIST REPORT & TREE INVENTORY

RE: 1995 Rocky Ridge Drive, APN #469-100-013; City of Roseville Jurisdiction

APPENDIX 4 – SITE PHOTOGRAPHS by Tyler Thomson, November 13, 2023

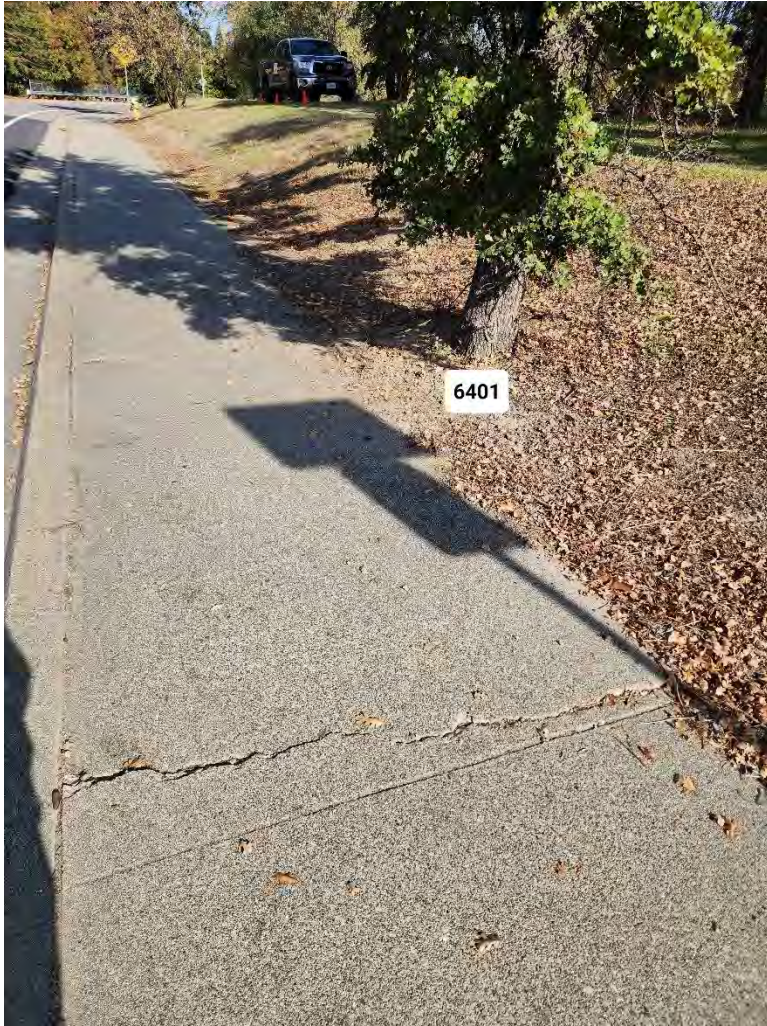
6401		Yes		Valley oak	<i>Quercus lobata</i>	10		54	16	3-Minor Problems	Fair	partially buried flare, 1.5 feet from sidewalk. signs of sidewalk beginning to lift. codominant at 5 feet, fair connection. fair crown balance and density.	Proposed for removal
6402		Yes		Valley oak	<i>Quercus lobata</i>	15		15	17	3-Minor Problems	Fair	partially buried flare, 6 feet from sidewalk. signs of sidewalk beginning to lift. codominant at 2 feet, crowded connection with included bark. fair crown balance and density. low small lateral branches.	Proposed for removal
6403		Yes	Yes	Valley oak	<i>Quercus lobata</i>	21.5		12	26	3-Minor Problems	Fair	fair base on top of slope leading to drainage. fair crown balance and density. south canopy branches overlap property line by approximately 6 feet.

Photo #1, Shows Tree #6401, 1.5 feet from sidewalk

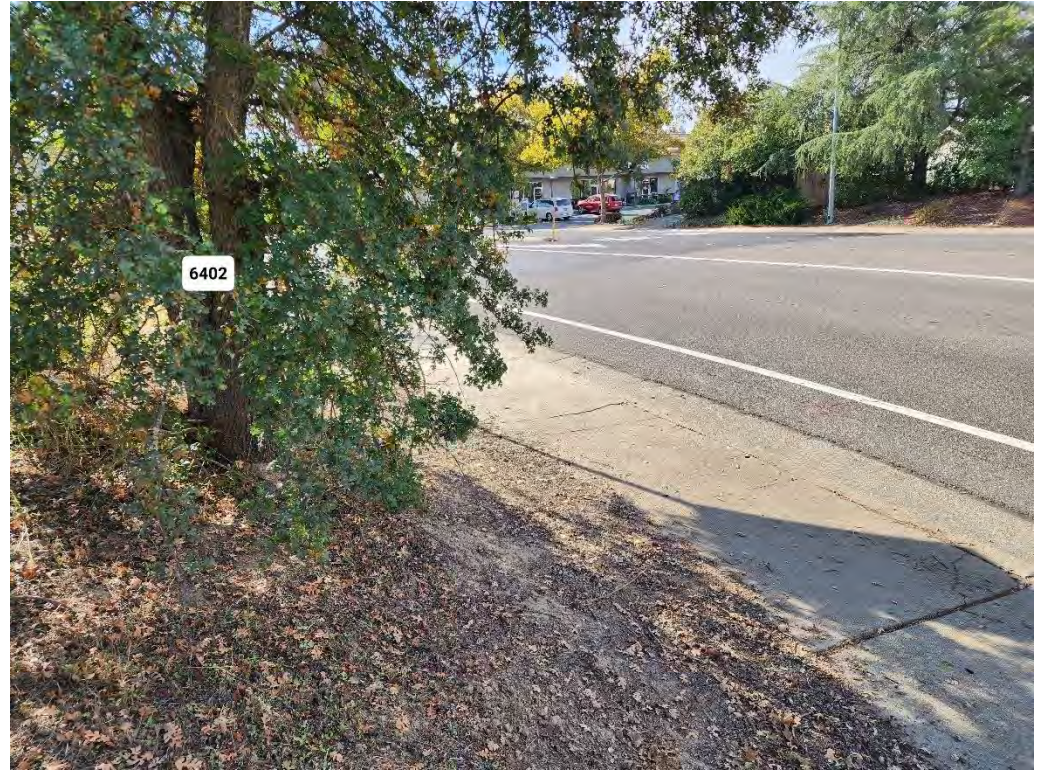
Photo #2, Shows Tree #6402, 6 feet from sidewalk

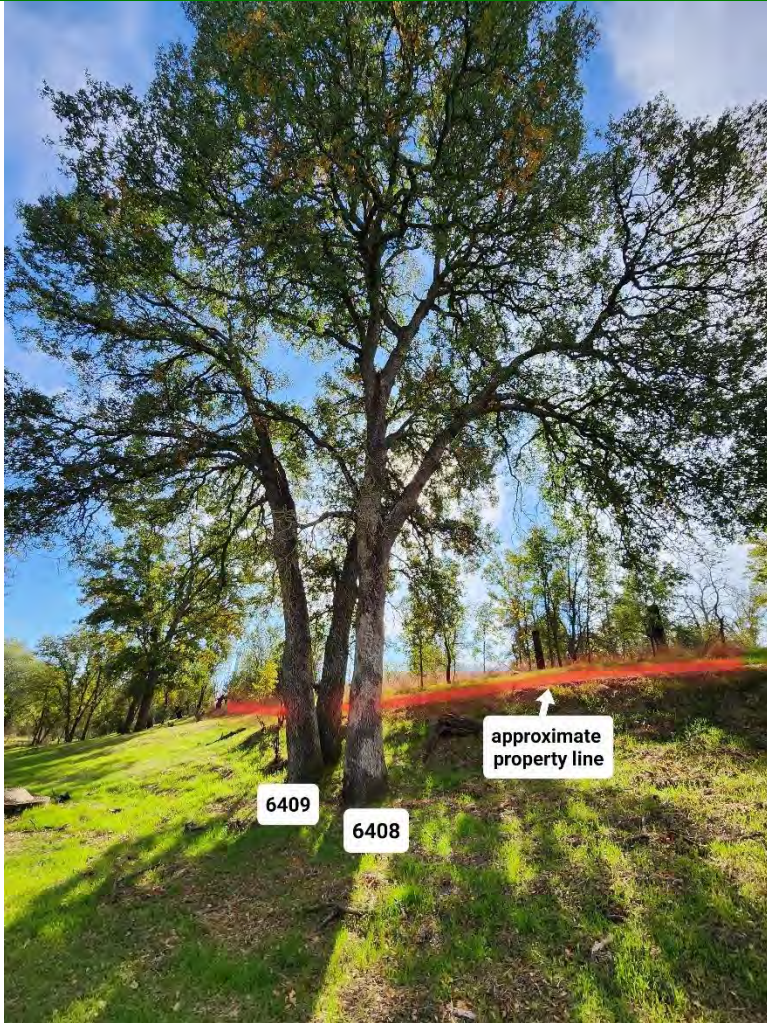
Photo #3, Shows offsite Trees #6409 & #6408, from left to right, and approximate property line

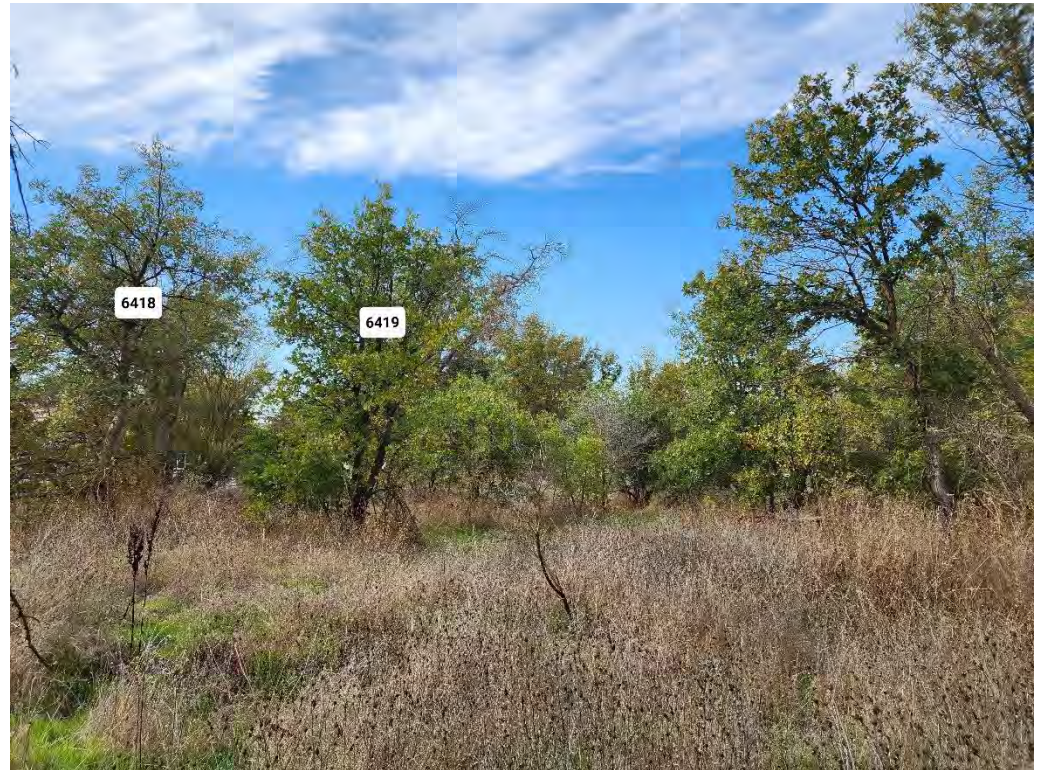
Photo #4, Shows Trees #6418 & #6419, from left to right

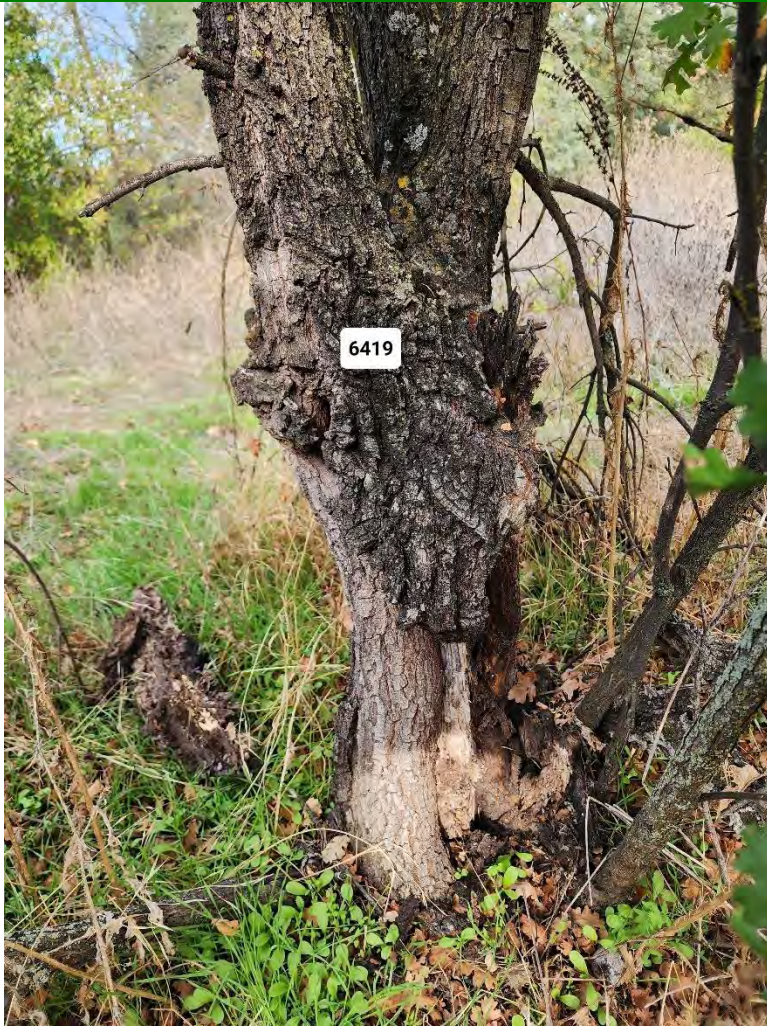
Tag #	Old Tag #	Protected by Code	Offsite	Species Common Name	Species Botanical Name	DBH (in.)	DBH Multi-Stem (in.)	Measured At (in.)	Canopy Radius (ft.)	Arborist Rating	City of Roseville Rating	Notes	Development Status
6419		Yes		Valley oak	<i>Quercus lobata</i>	7.5		10	10	1-Extreme Structure or Health Problems	Poor	60% dead bark on base and lower trunk. severe/extensive internal decay south. multi-stem at 2 feet, weak attachments. miniaturized foliage. low vigor.	Proposed for removal
6420		Yes		Valley oak	<i>Quercus lobata</i>	11		12	10	1-Extreme Structure or Health Problems	Poor	buried flare. swollen codominant union at 2 feet. west codominant stem completely dead, still standing. east codominant stem has severe bark and internal decay. sparse foliage, severe branch die-back. low vigor.	Proposed for removal
6421		Yes		Valley oak	<i>Quercus lobata</i>	6		54	9	1-Extreme Structure or Health Problems	Poor	dead 4 inch lower stem northwest. 50% dead bark around base and trunk. severe branch die-back throughout. low vigor.	Proposed for removal

Photo #5, Shows Tree #6419, with dead bark and severe/ extensive internal decay

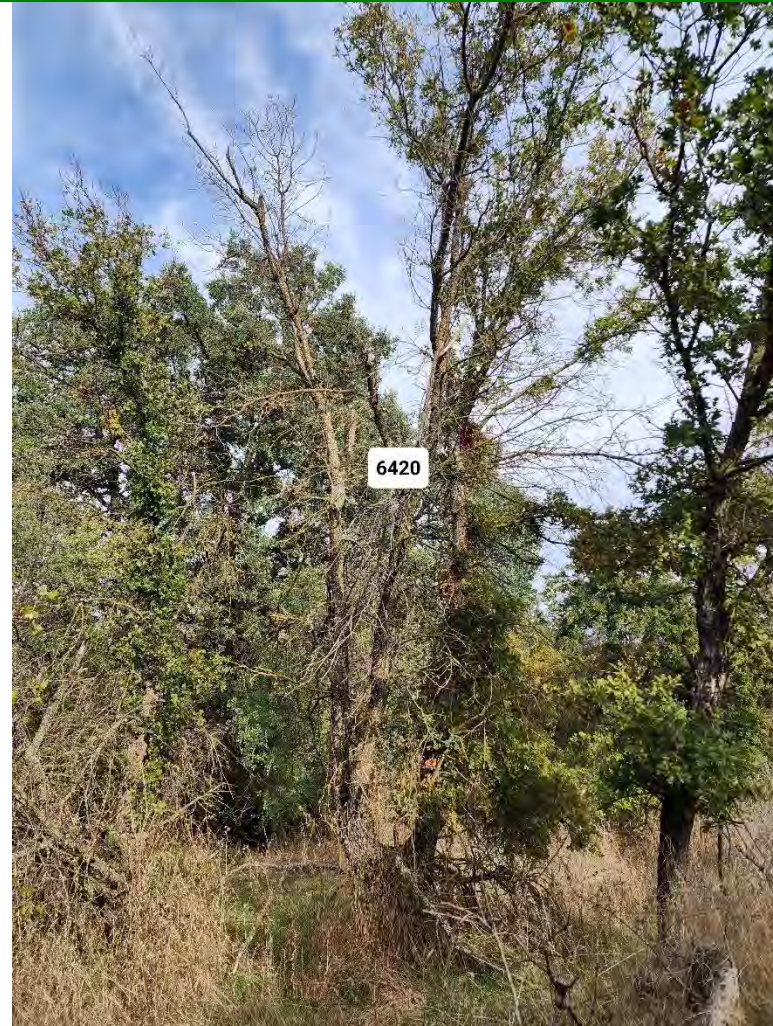
Photo #6, Shows Tree #6420, with dead codominant stem and sparse foliage

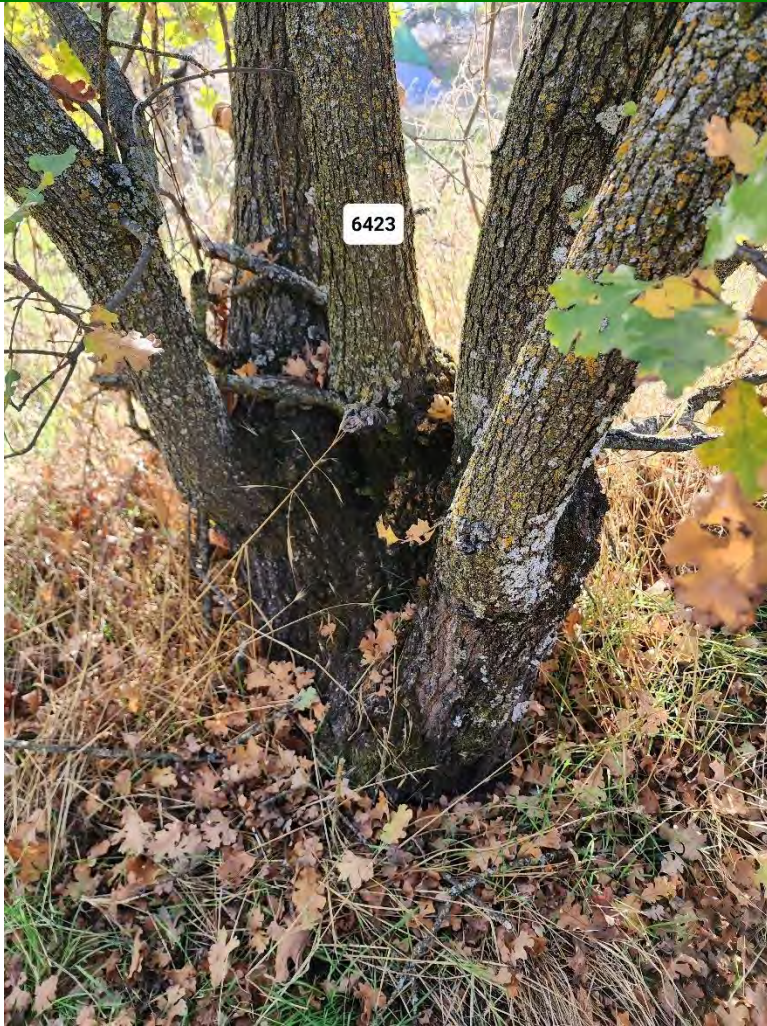
6422		Yes		Valley oak	<i>Quercus lobata</i>	10		3	5	1-Extreme Structure or Health Problems	Poor	85% dead. severe/extensive decay throughout. low vigor.	Proposed for removal
6423		Yes		Valley oak	<i>Quercus lobata</i>	13		3	13	2-Major Structure or health problems	Fair to Poor	buried flare. severely crowded multi-stem union at 1.5 feet. short intranodal growth, miniaturized foliage. low vigor.	Proposed for removal
6424		Yes		Valley oak	<i>Quercus lobata</i>	12	4.5, 4, 3.5	54	11	1-Extreme Structure or Health Problems	Poor	multi-stem at grade, possible weak connections. moderate bark decay in middle stem. top half dead north stem. severe branch die-back throughout. low vigor.	Proposed for removal
6425		Yes		Valley oak	<i>Quercus lobata</i>	26	6, 6, 6, 4, 4	54	14	2-Major Structure or health problems	Fair to Poor	crowded multi-stem union at grade, weak attachments. crowded unbalanced primary stems. epicormic sprouts. small branch die-back throughout. fair/low vigor.	Proposed for removal

Photo #7, Shows Tree #6423, with severely crowded multi-stem union at 1.5 feet

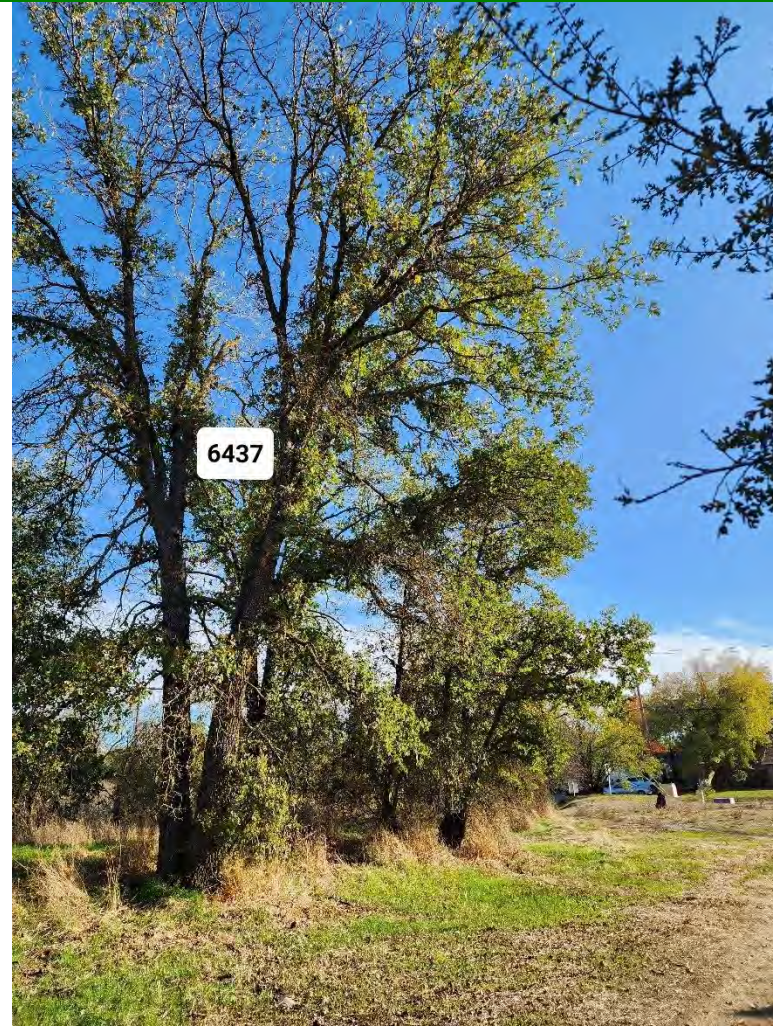
6437		Yes		Valley oak	<i>Quercus lobata</i>	26.5	13.5, 13	54	24	2-Major Structure or health problems	Fair to Poor	codominant at 1 foot, fair attachment. fair branching and crown balance. low crown density with severe small branch die-back. low vigor.	Proposed for removal
6438		Yes		Valley oak	<i>Quercus lobata</i>	10		10	15	2-Major Structure or health problems	Fair to Poor	dead 6 inch stem at grade north. swollen lower trunk south at 1 foot. weak stem attachments with included bark. small branch die-back throughout.	Proposed for removal
6439		Yes		Blue oak	<i>Quercus douglasii</i>	8		12	11	2-Major Structure or health problems	Fair to Poor	swollen base, multiple small dead branches. codominant at 3 feet, crowded stems. sparse miniaturized foliage. low vigor.	Proposed for removal
6440		Yes		Valley oak	<i>Quercus lobata</i>	12		54	18	2-Major Structure or health problems	Fair to Poor	fair base. codominant at 8 feet. severe branch die-back throughout. low vigor.	Proposed for removal

Photo #8, Shows Tree #6437

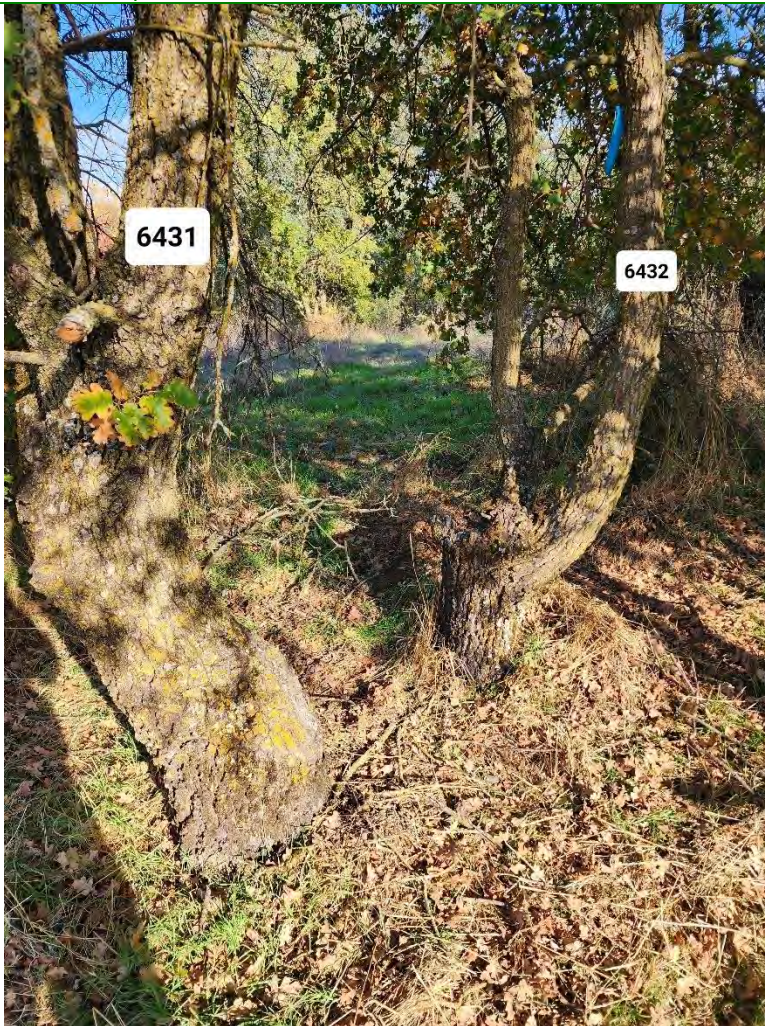
Photo #9, Shows Trees #6431 & #6432, from left to right

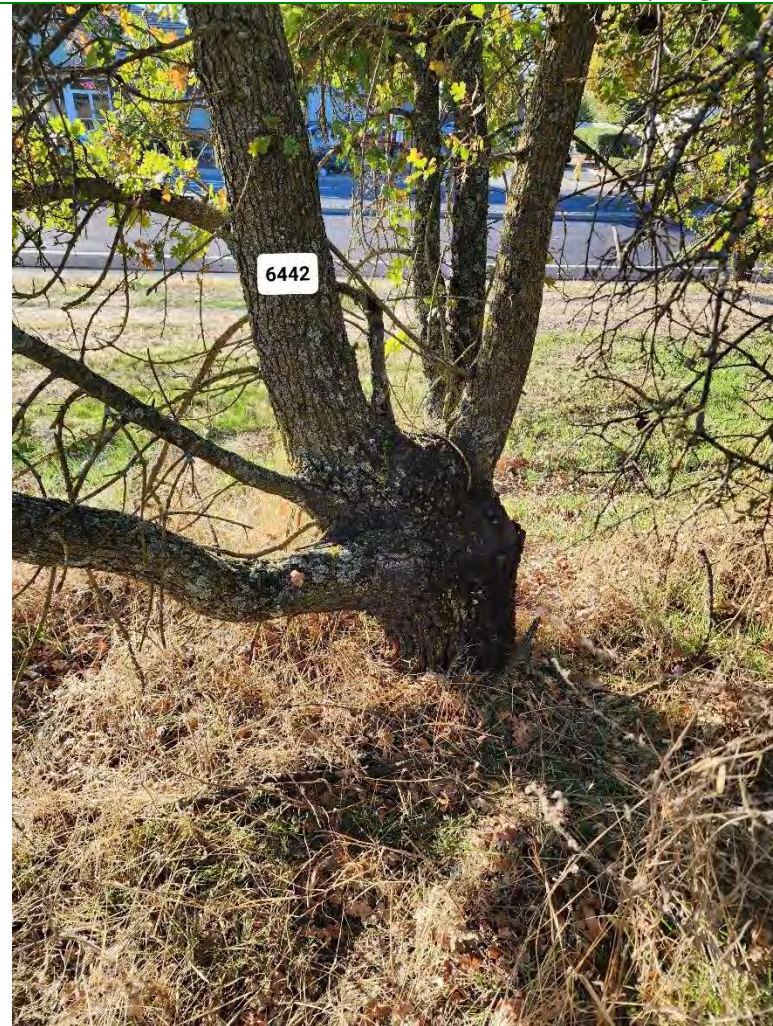
Photo #10, Shows Tree #6442, with crowded unbalanced stem attachments and bark decay

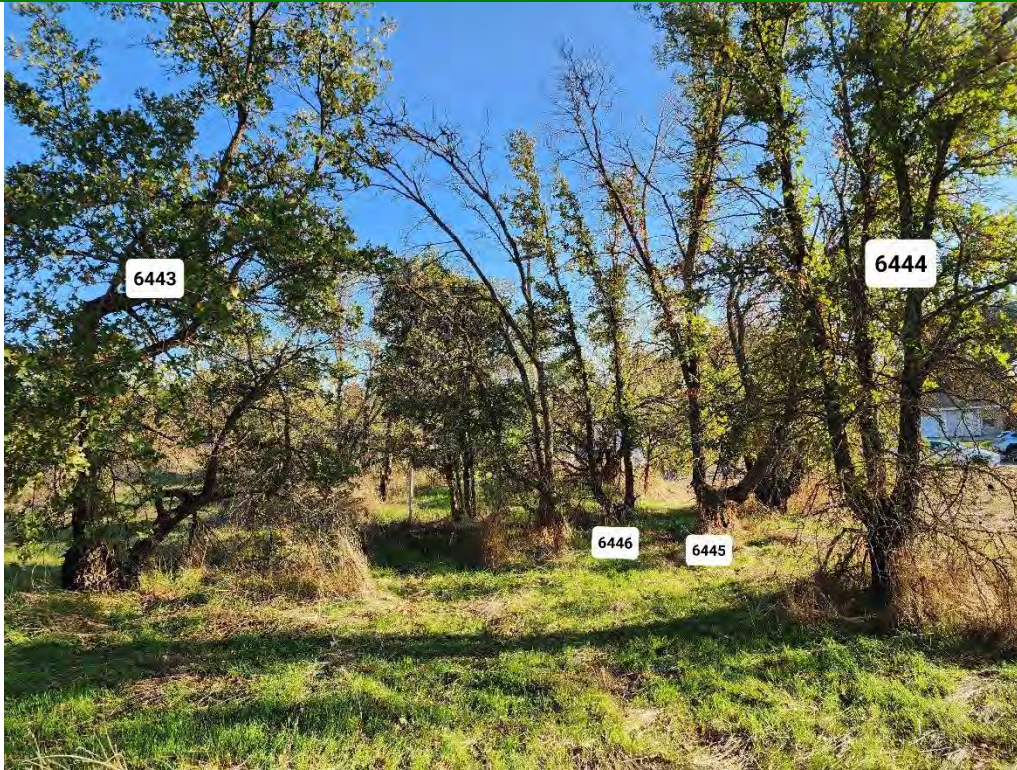
6446		No		Valley oak	<i>Quercus lobata</i>	8.5	4.5, 4	10	9	1-Extreme Structure or Health Problems	Poor	codominant at grade, severe bark decay. high amount of epicormic sprouts on stems. moderate/severe branch die-back throughout. low vigor.	Proposed for removal
6447		Yes		Valley oak	<i>Quercus lobata</i>	18	11, 7	6	5	1-Extreme Structure or Health Problems	Poor	codominant at grade, severe bark decay throughout. 11 dbh codominant stem completely dead. tree 95% dead.	Proposed for removal
6448		Yes		Valley oak	<i>Quercus lobata</i>	13.5		12	12	3-Minor Problems	Fair	fair base. crowded multi-stem union at 2 feet. fair crown balance and density. short intranodal growth, stunted short tree. small low branches all directions.	Proposed for removal

Photo #11, Shows Trees #6443, #6446, #6445 & #6444, from left to right
