Dry Creek Greenway Trail Fluvial Audit

Prepared for:
City of Roseville
and Psomas

Prepared by:
cbec, inc.

December 2014
Project Number: 13-1041

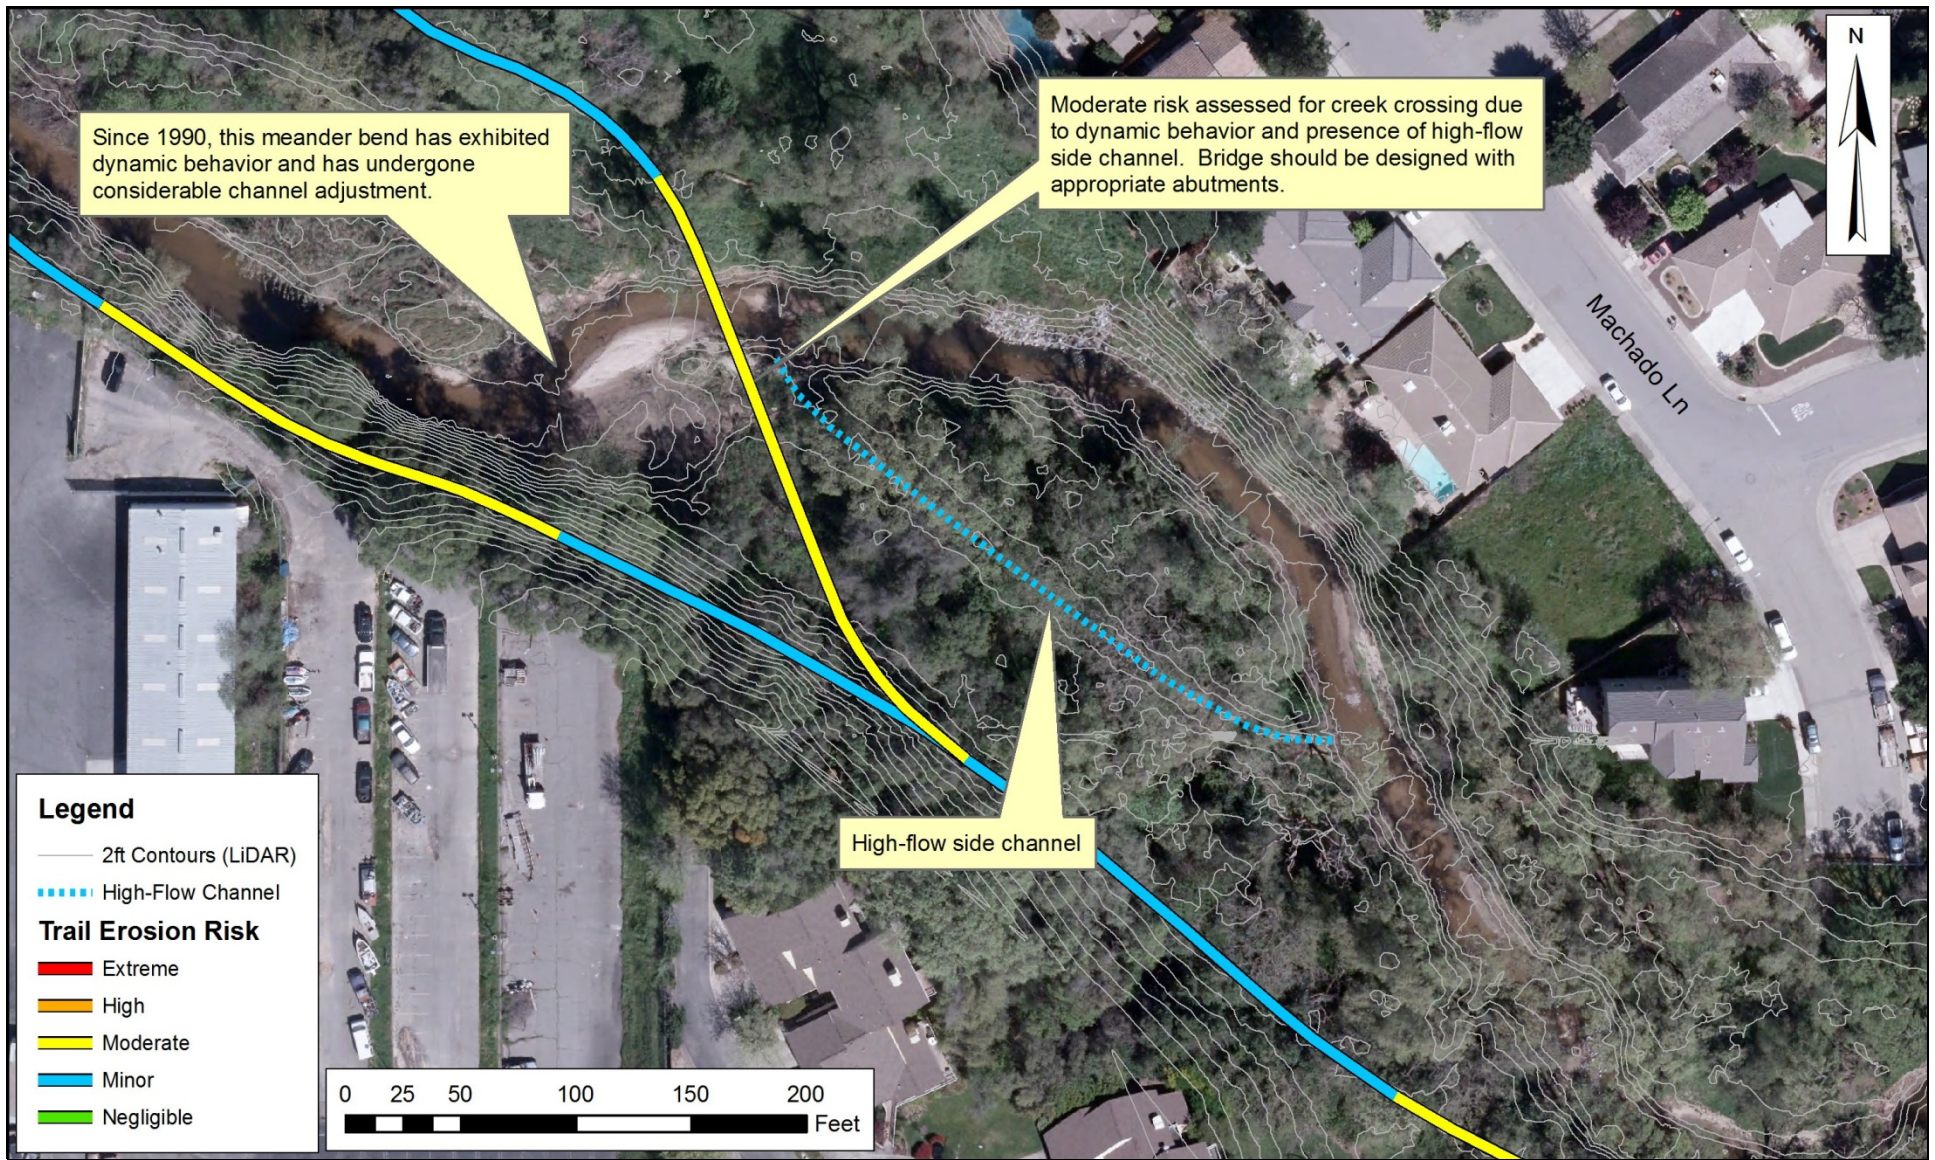
Figure 1

1. Roughly 400 feet upstream of the confluence of Cirby and Dry Creeks is a high-flow side channel on the southern side of Cirby Creek's main channel (see Figure 1). At the downstream end of the side channel, the main channel has exhibited considerable dynamic behavior and bank retreat since 1990. This dynamic behavior and the presence of the side channel should be considered in assessing trail location and the design of a stream crossing and any associated bridge abutments.

Since 1990, this meander bend has exhibited dynamic behavior and has undergone considerable channel adjustment.

Moderate risk assessed for creek crossing due to dynamic behavior and presence of high-flow side channel. Bridge should be designed with appropriate abutments.

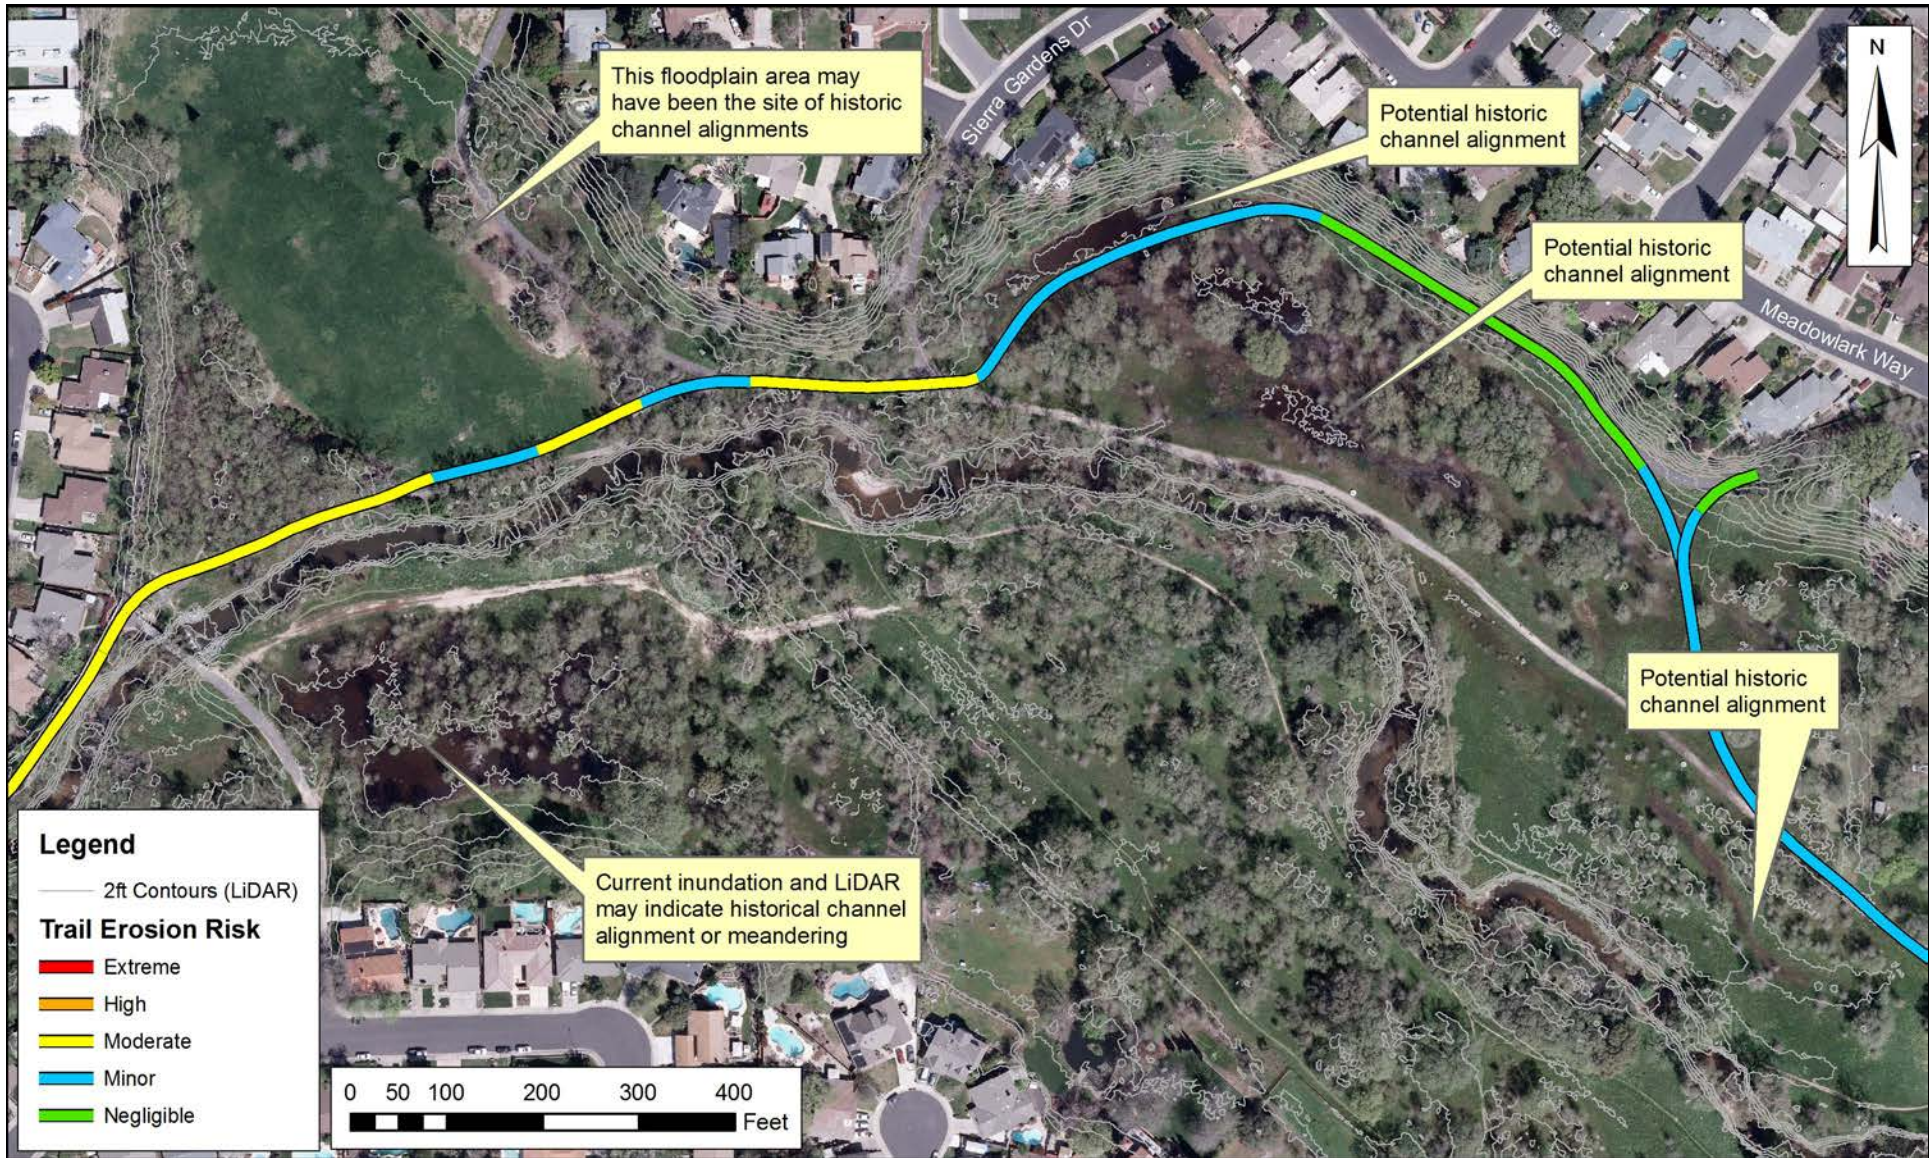
Dry Creek Greenway Trail Fluvial Audit
LiDAR Assessment - Linda Creek 1
 Project No. 13-1041 Created By: JDS **Figure 2**

2. In the open space south of Sierra Gardens Drive and Meadowlark Way, the relatively wide floodplain area shows evidence of numerous historical channel alignments (see Figure 2). While historical aerials do not indicate dramatic shifts in channel alignment since 1990, it is important to note that this section of Linda Creek and its floodplain have demonstrated significant dynamic behavior over longer historical time frames.

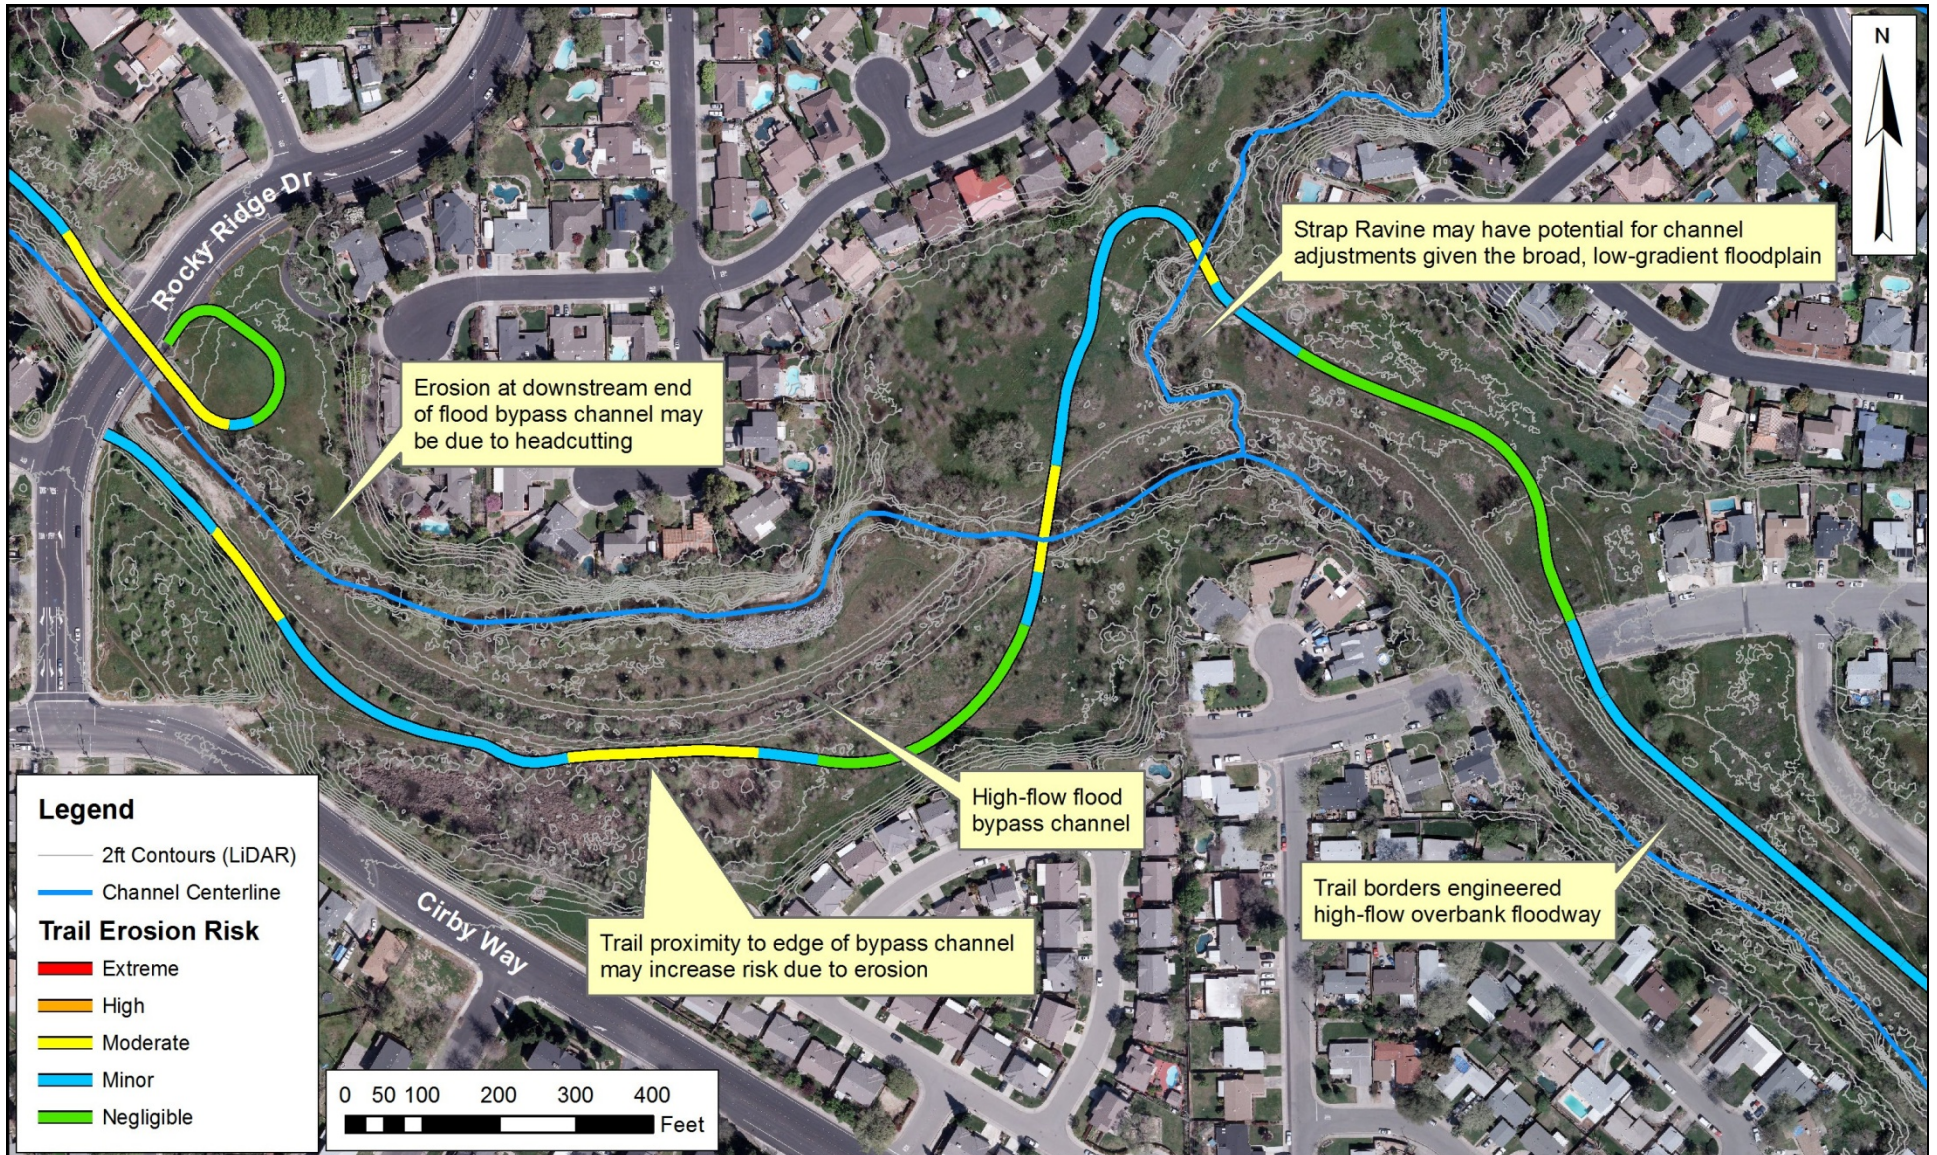
Figure 3

3. Between Rocky Ridge Drive and Champion Oaks Drive, a high-flow flood bypass channel is present in the Linda Creek floodplain (see Figure 3). This flood bypass channel interacts with the main channel in a number of locations and likely influences in-channel hydraulics and bank erosion. The proposed trail's proximity to the flood bypass channel may increase erosion risk to the path at several locations.

The proximity of the proposed trail to the flood bypass channel (or excavated terrace), particularly between Rocky Ridge Dr and Old Auburn Rd, poses an increased erosion risk to the trail in several locations as demonstrated in Figures 3 and 18.

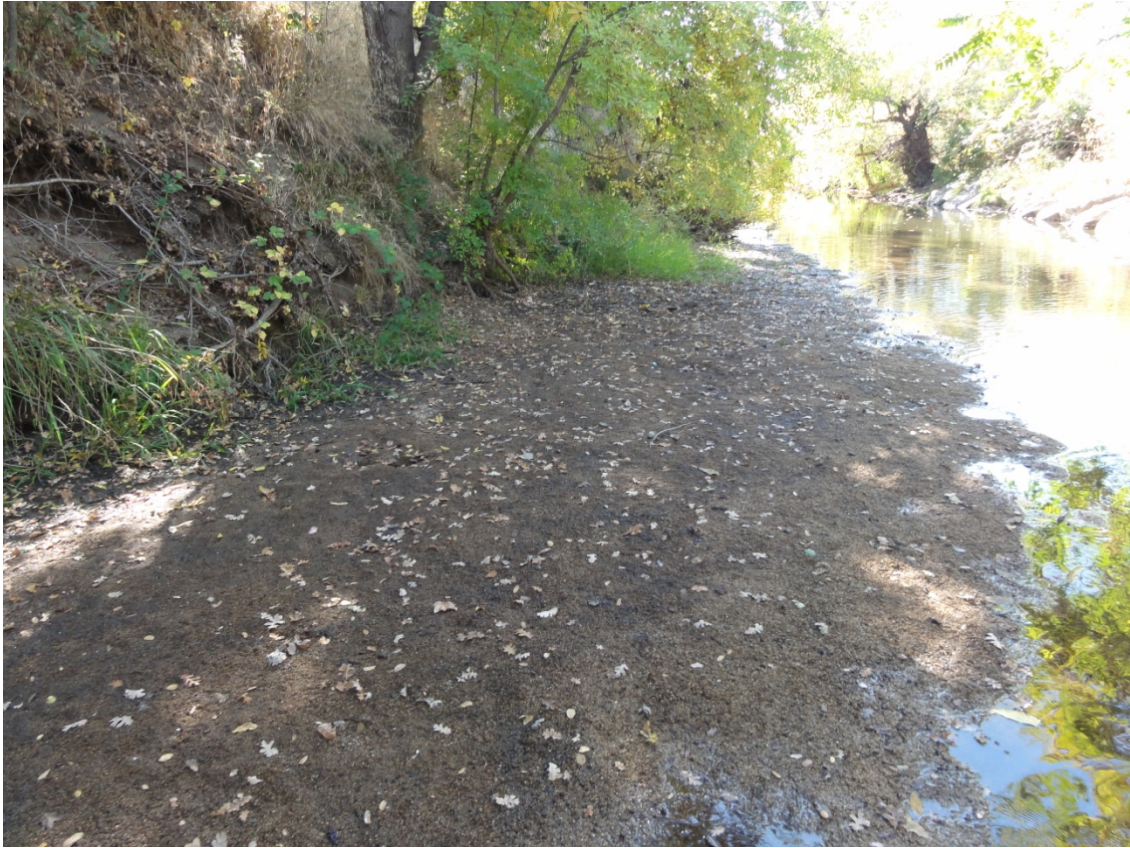
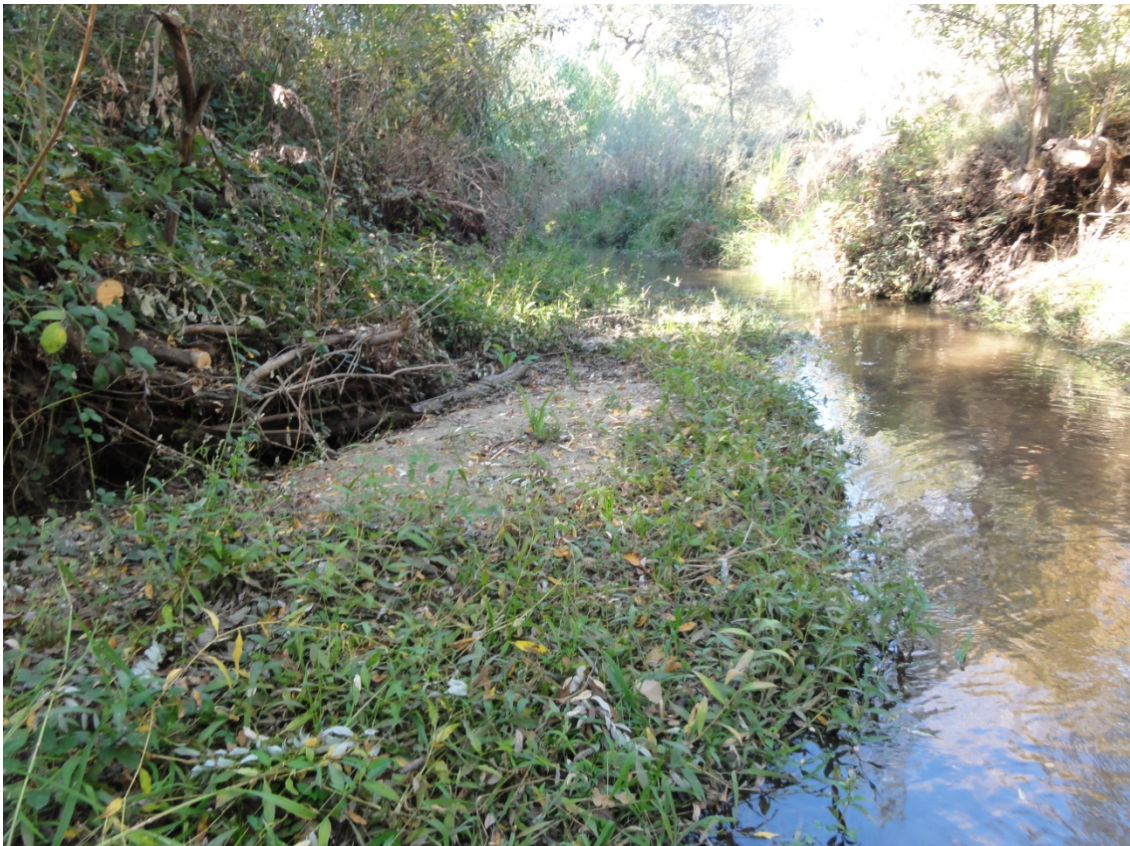
Figure 9

Notes: Un-vegetated bar (top) suggests recent deposition; lightly vegetated bar (bottom)

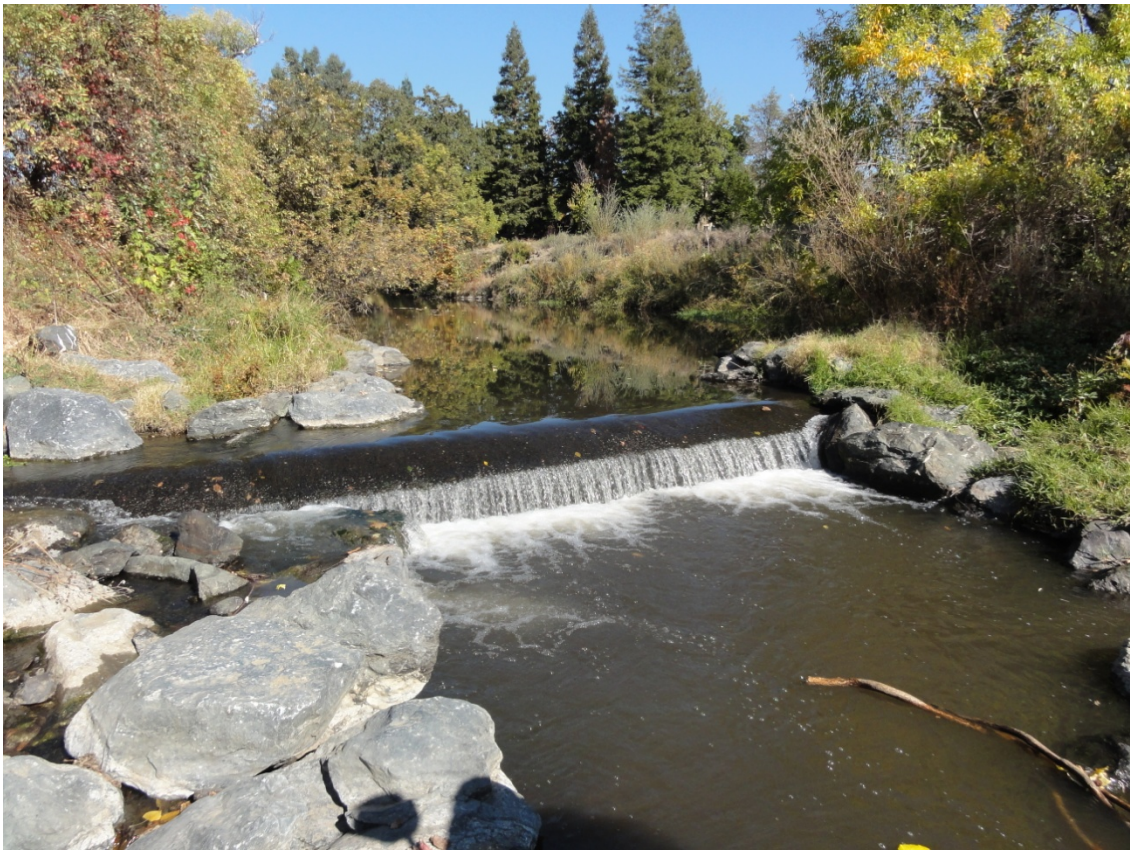
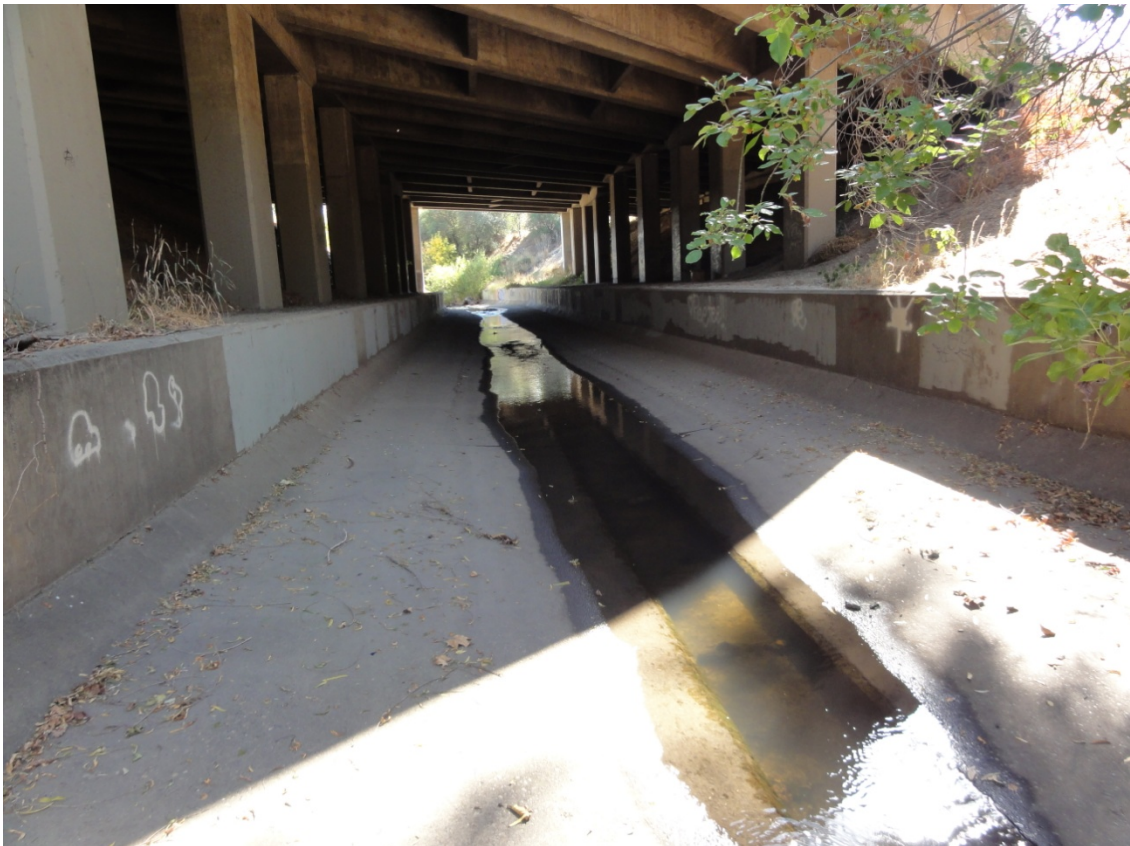
Figure 10

Notes: Concrete-encased sewer line functions as a weir on Dry Creek at confluence with Cirby (top); I-80 culvert on Cirby Creek (bottom)

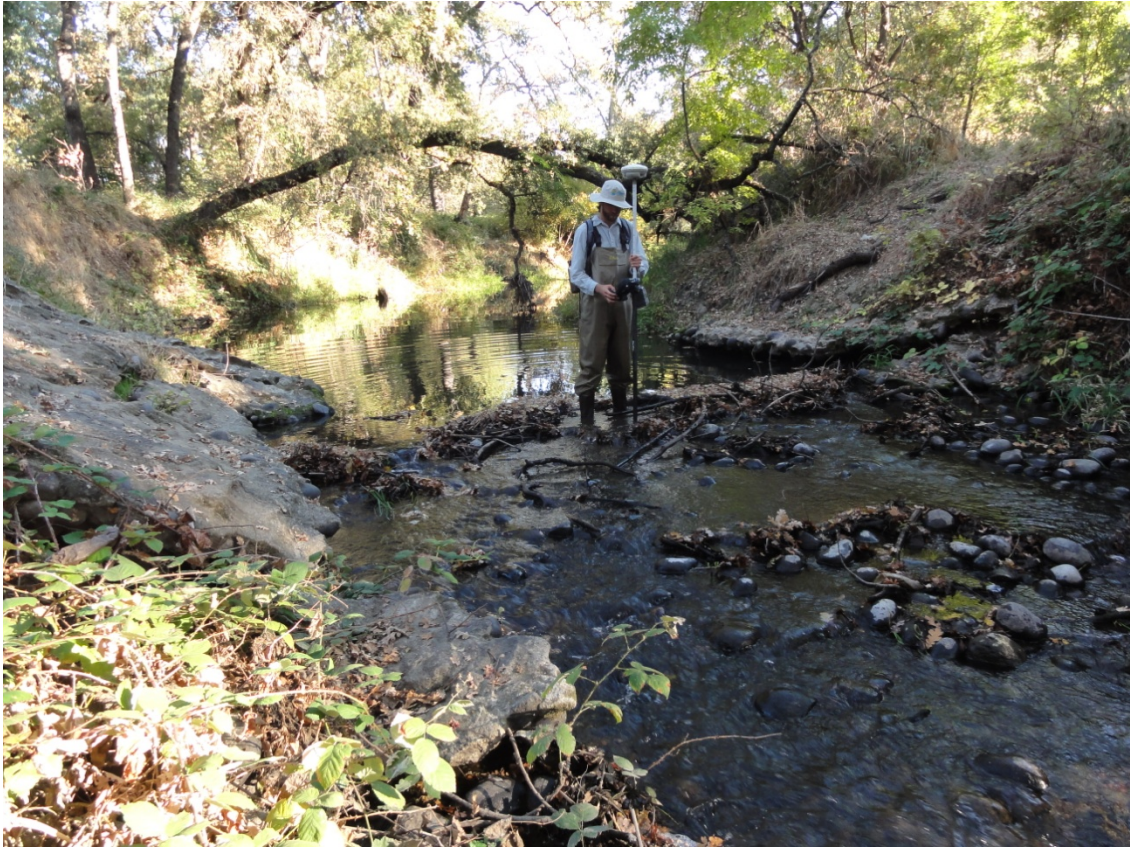
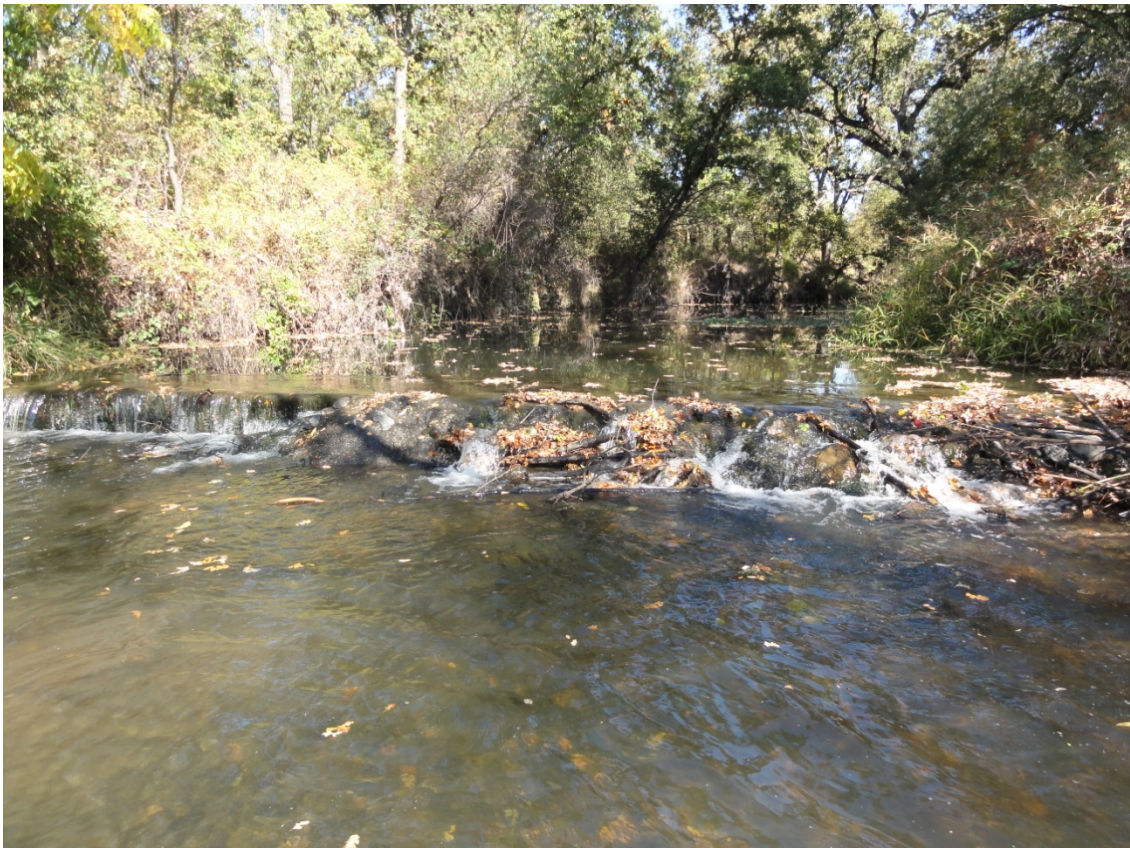
Figure 11

Notes: Cobble weir on Linda (top); concrete weir (potential sewer line crossing) south of Sierra Gardens Dr (bottom)

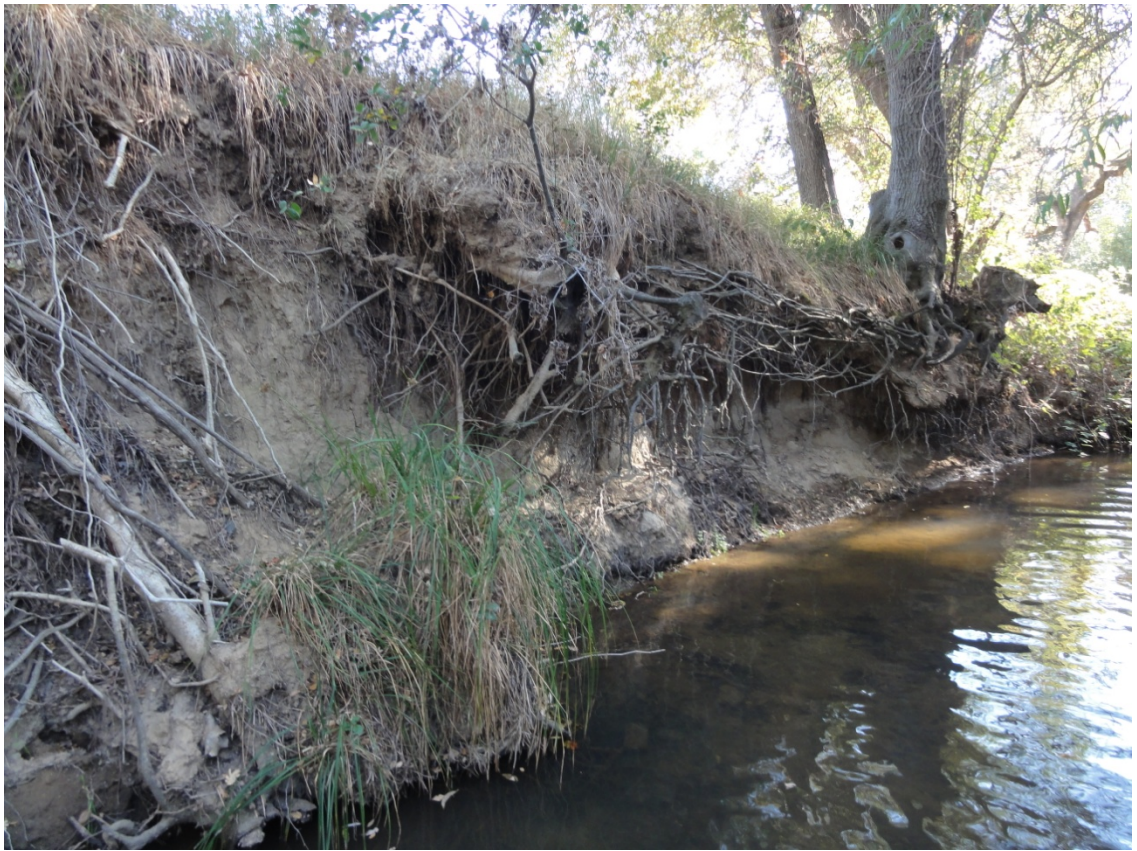
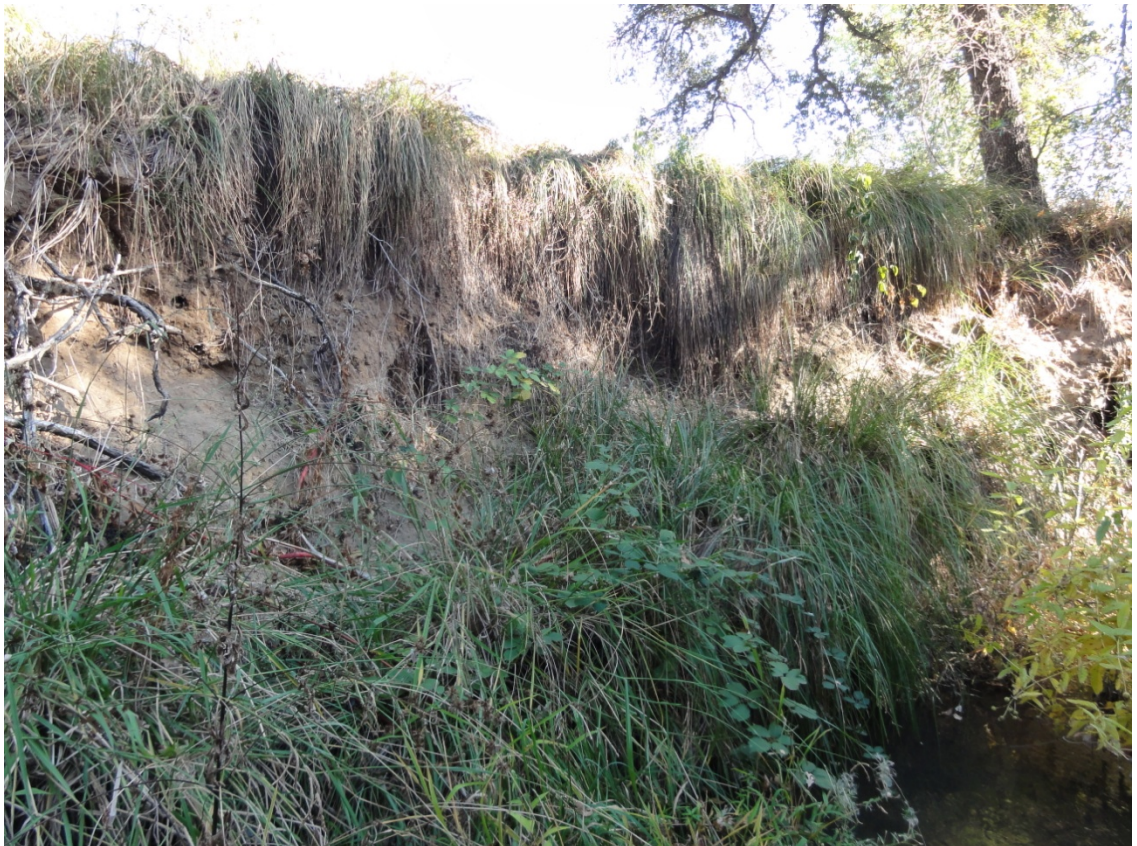
Figure 25

LINDA-H3 was given a high risk assessment due to the trail's proximity to the top of bank and ongoing severe erosion (see Figures 25 and 31). The suggested actions are the same as those specified in LINDA-H2 but the bank protection and channel modification measures would need to be somewhat tailored to the site-specific conditions at LINDA-H3.

Notes: Bank erosion at
downstream end (top)
and upstream end
(bottom) of LINDA-H3

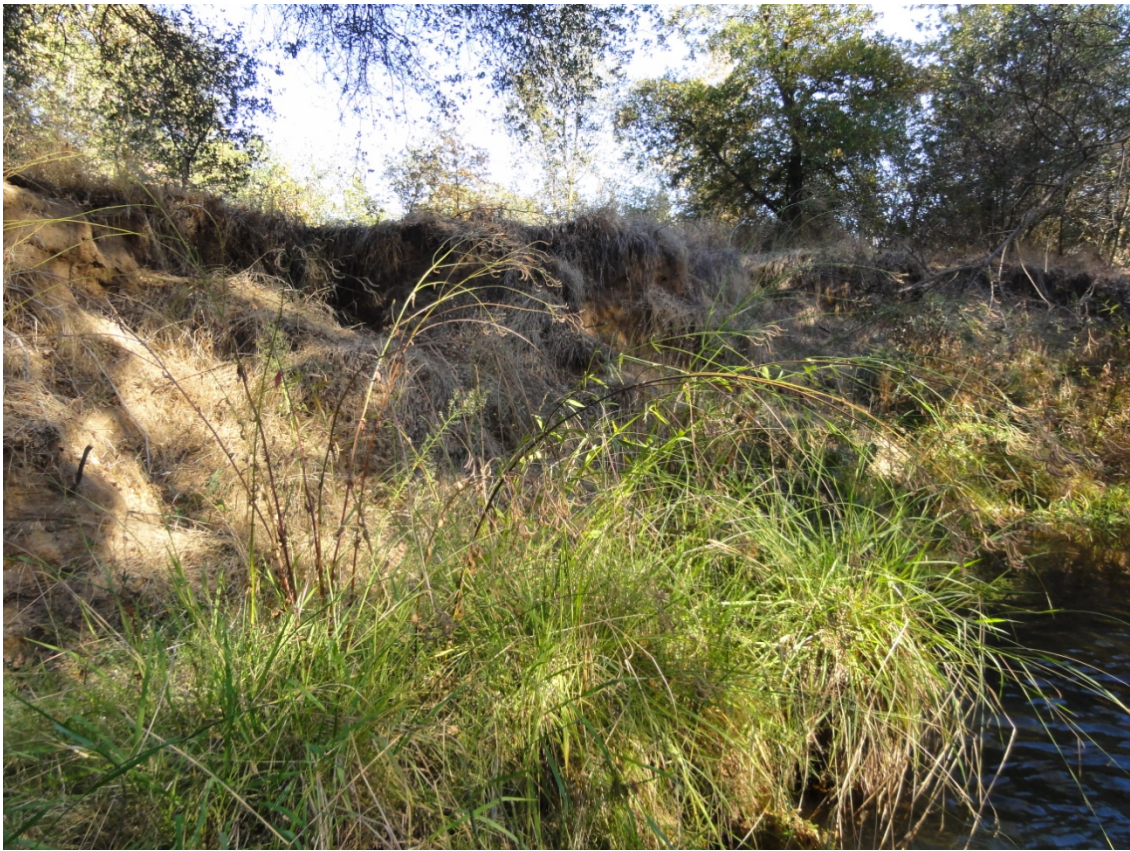
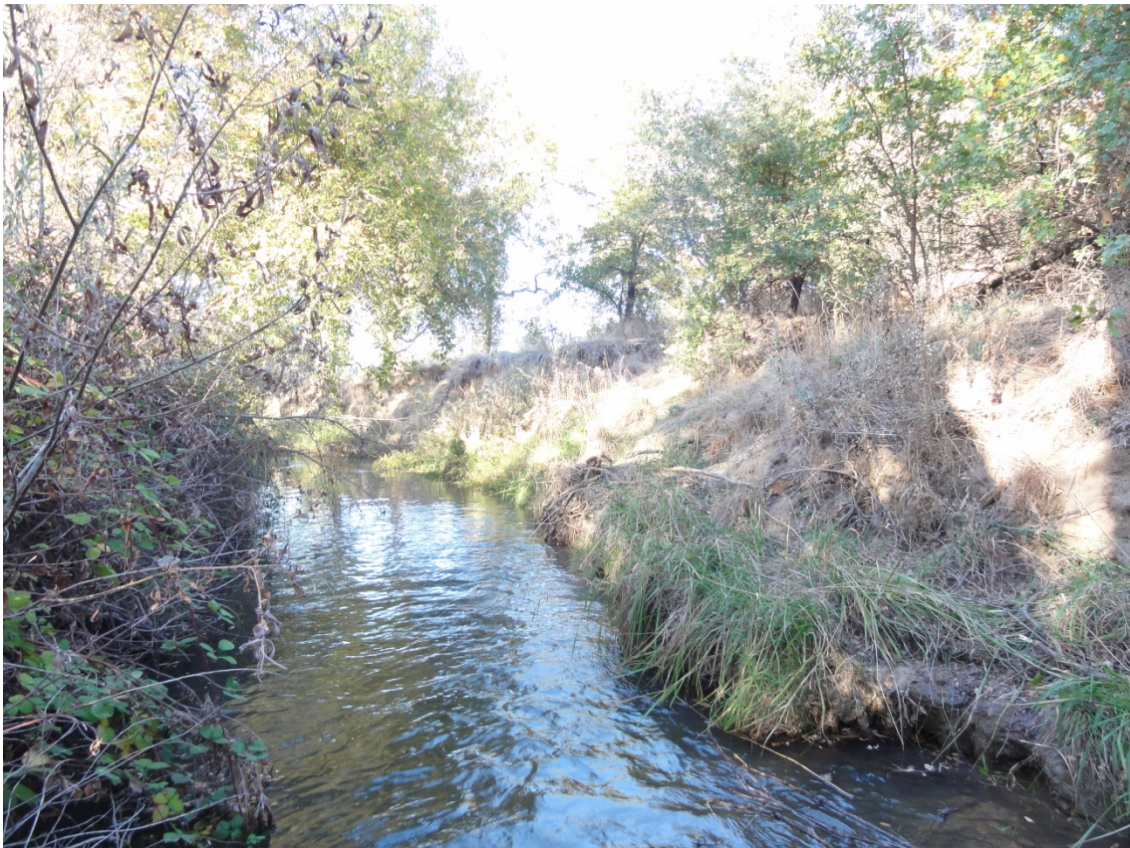
Figure 26

Notes: Bank erosion at
downstream end (top)
and continuing upstream
(bottom) along LINDA-H3

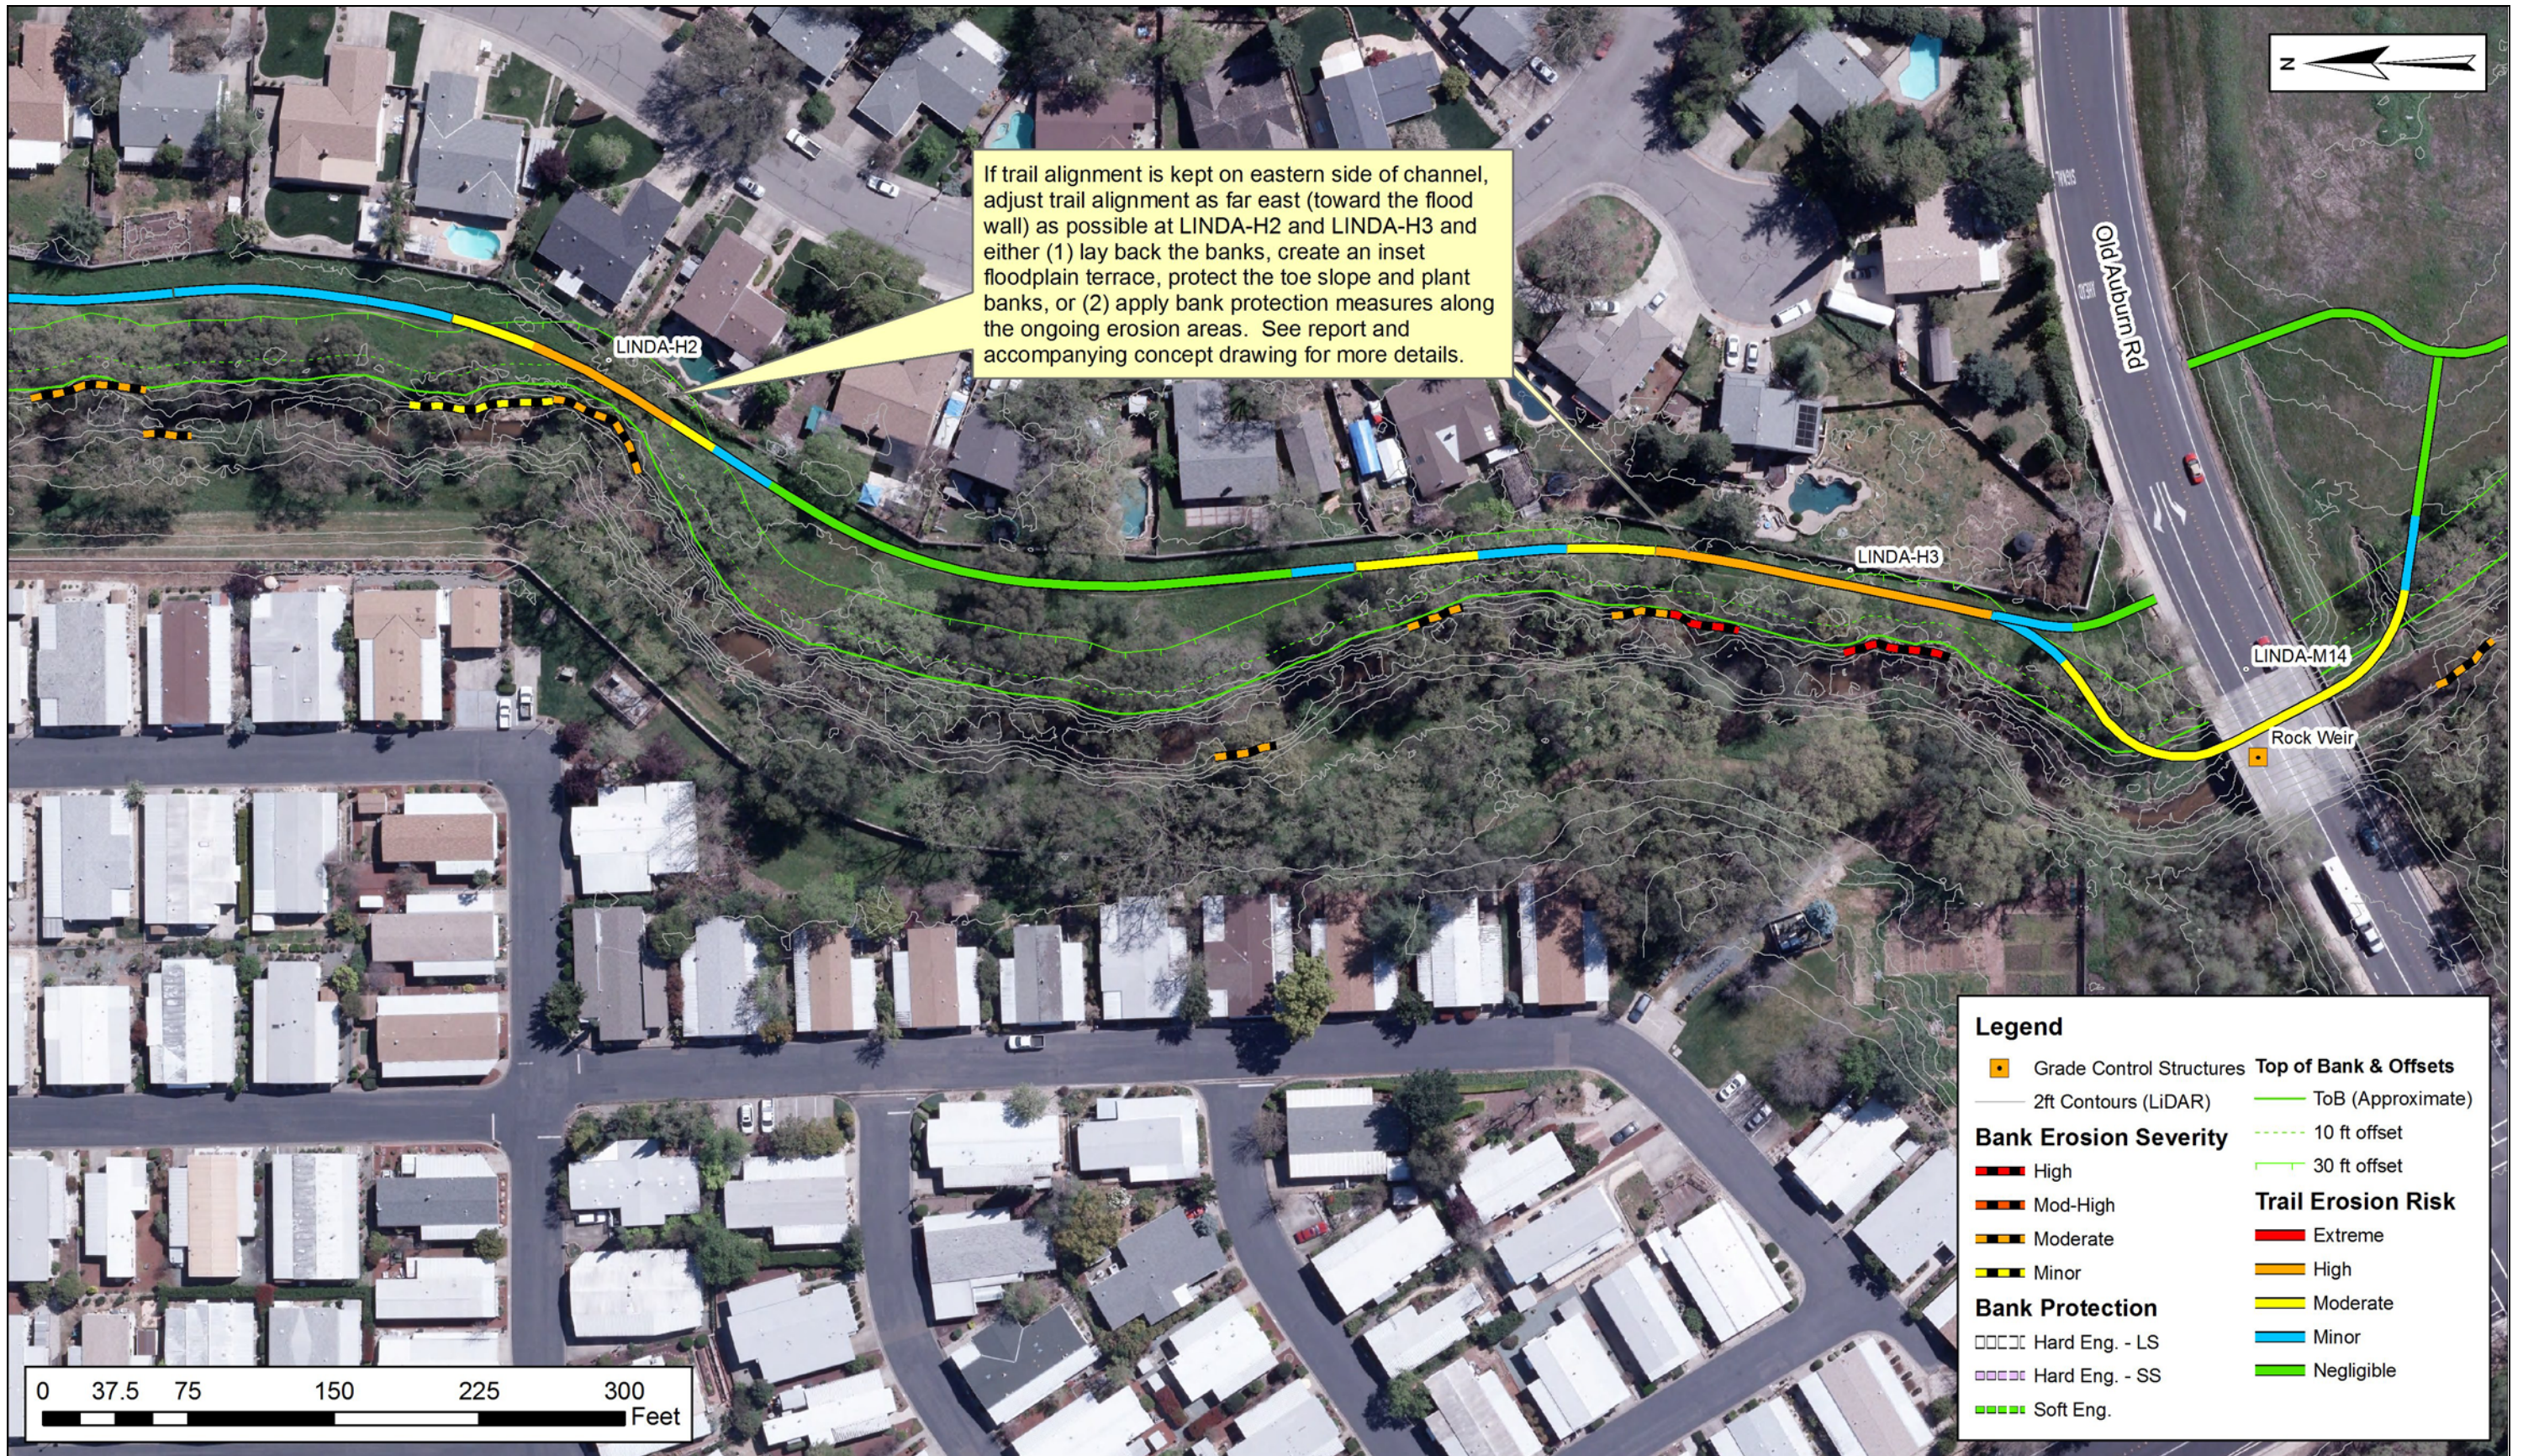
Figure 31

Notes: Trail width not to scale. The bank lay-back option may not be feasible due to existing storm drain infrastructure.

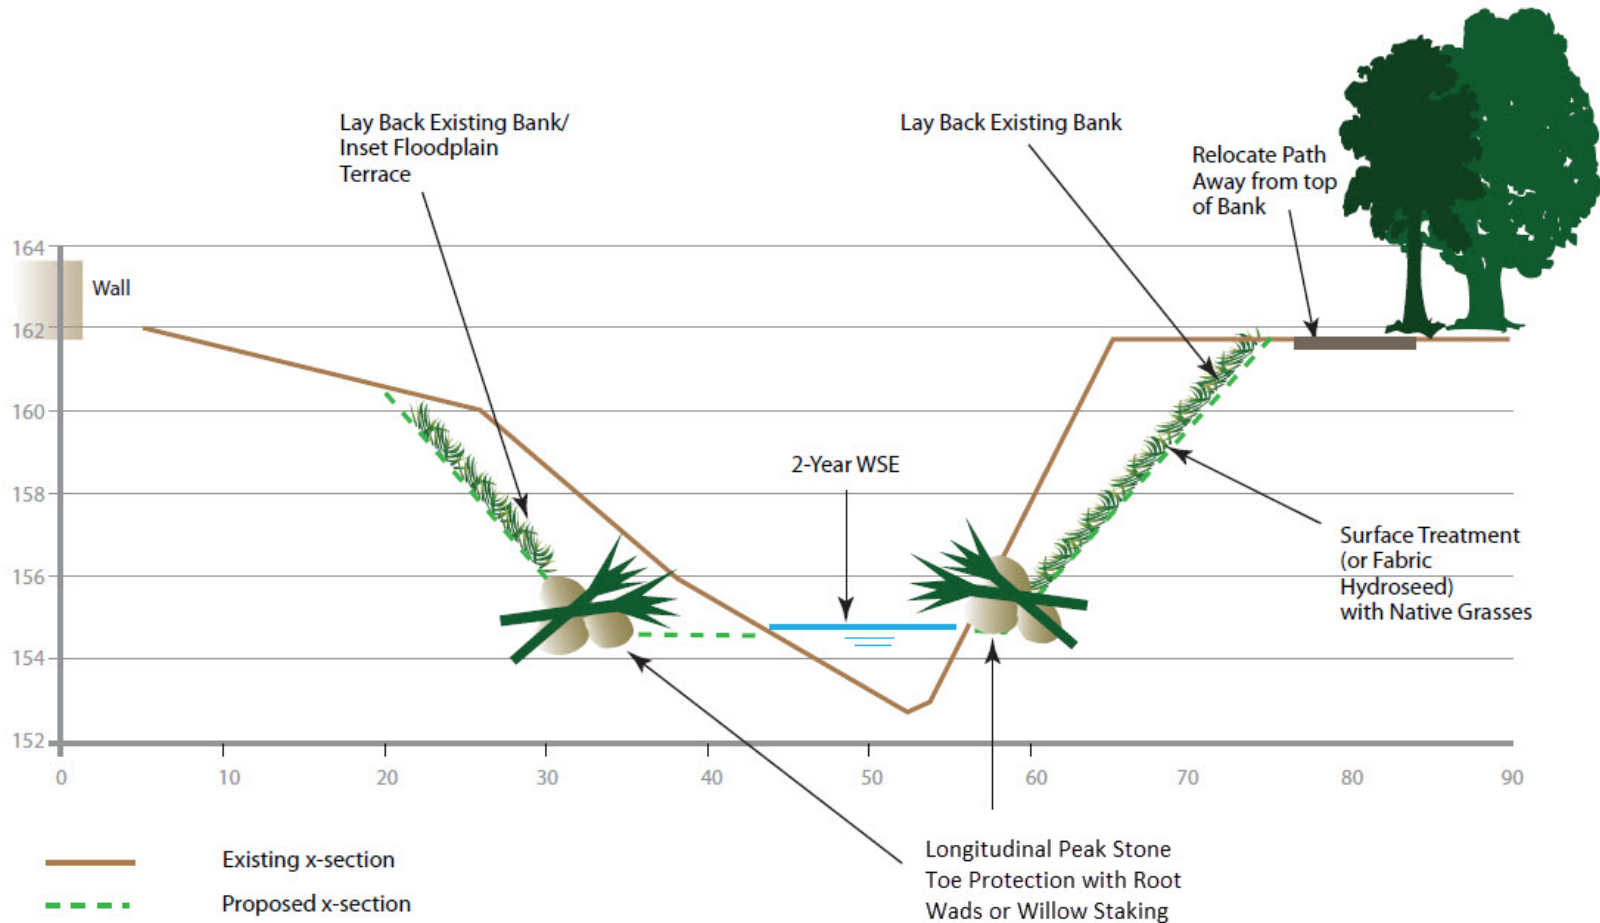
Figure 32

Notes: The bank lay-back option may not be feasible due to existing storm drain infrastructure. A determination of the minimum trail setback distance from the top of the new bank would require a more detailed site analysis including additional field assessment (e.g., soil types, vegetation characteristics), potentially hydraulic modeling, trail design details, risk tolerance assessment and project longevity.
