**MOURIER M31 APARTMENTS**  
80 UNIT APARTMENT PROJECT

WOODCREEK OAKS BLVD.  
ROSEVILLE, CALIFORNIA

# PRELIMINARY GRADING AND DRAINAGE PLAN MOURIER M31 APARTMENTS

# SECTIONS AND DETAILS MOURIER M31 APARTMENTS

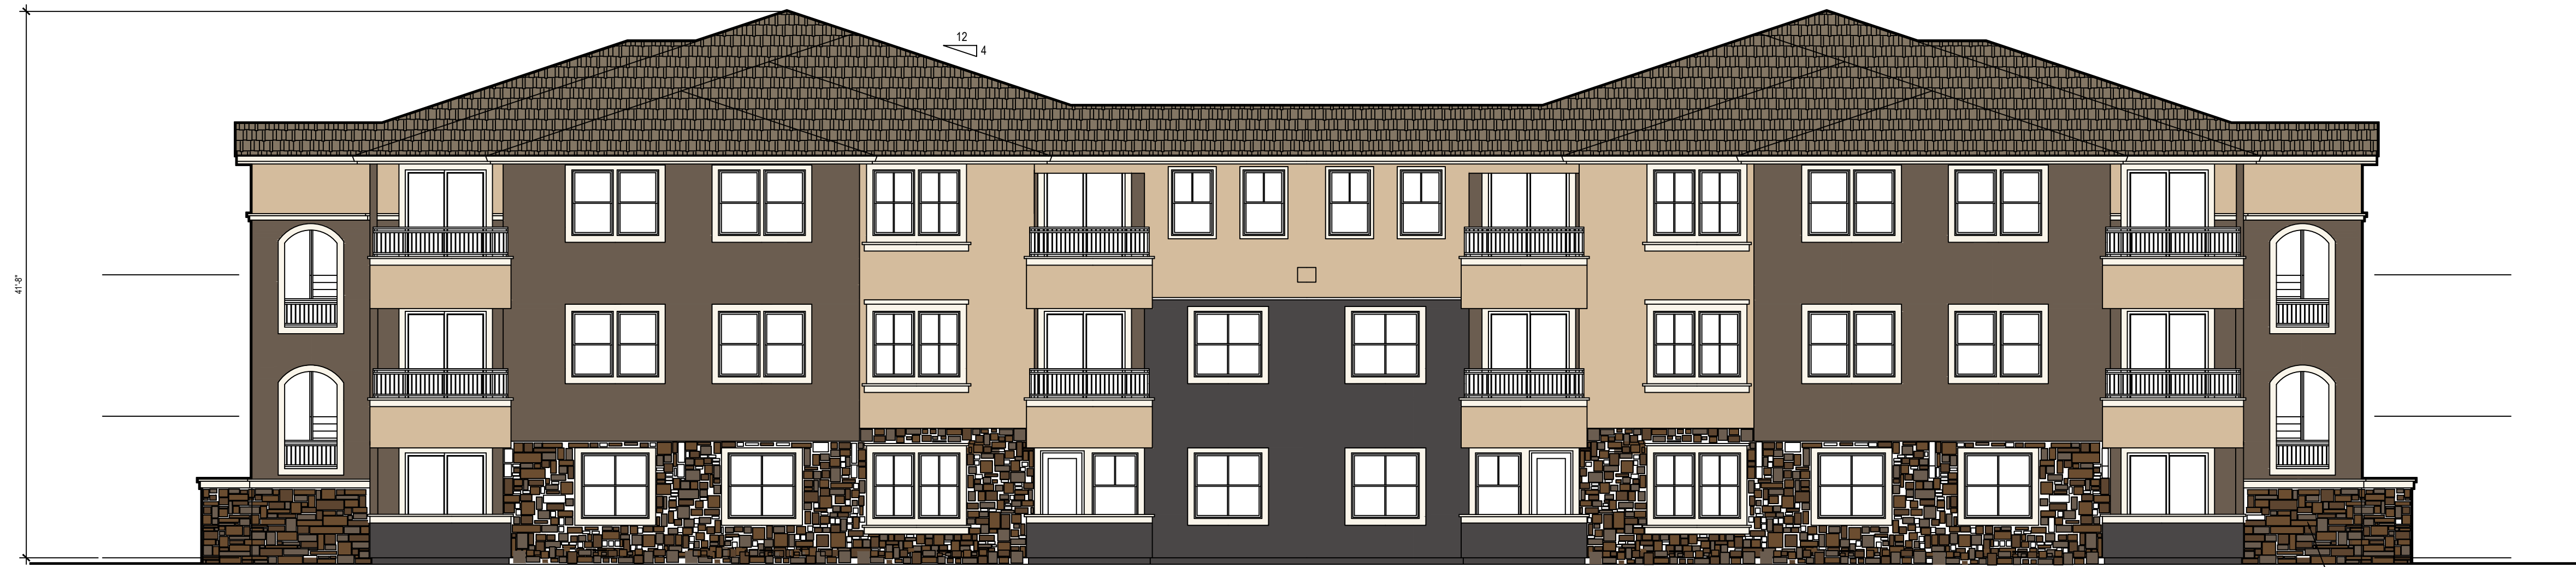
**FRONT ELEVATION** A **COLOR SCHEME 1**  
1/8" = 1'-0"

ADHERED MASONRY VENEER

CONCRETE ROOF TILES

VINYL WINDOWS & S.G.D.'S  
W/ INSUL. GLASS, TYP.

5' GALV MET FACIA GUTTER WITH  
RECTANGULAR DOWNSPOUTS  
(PAINT), TYP.

KWIK KOTE STUCCO

METAL OVERHEAD GARAGE DOOR

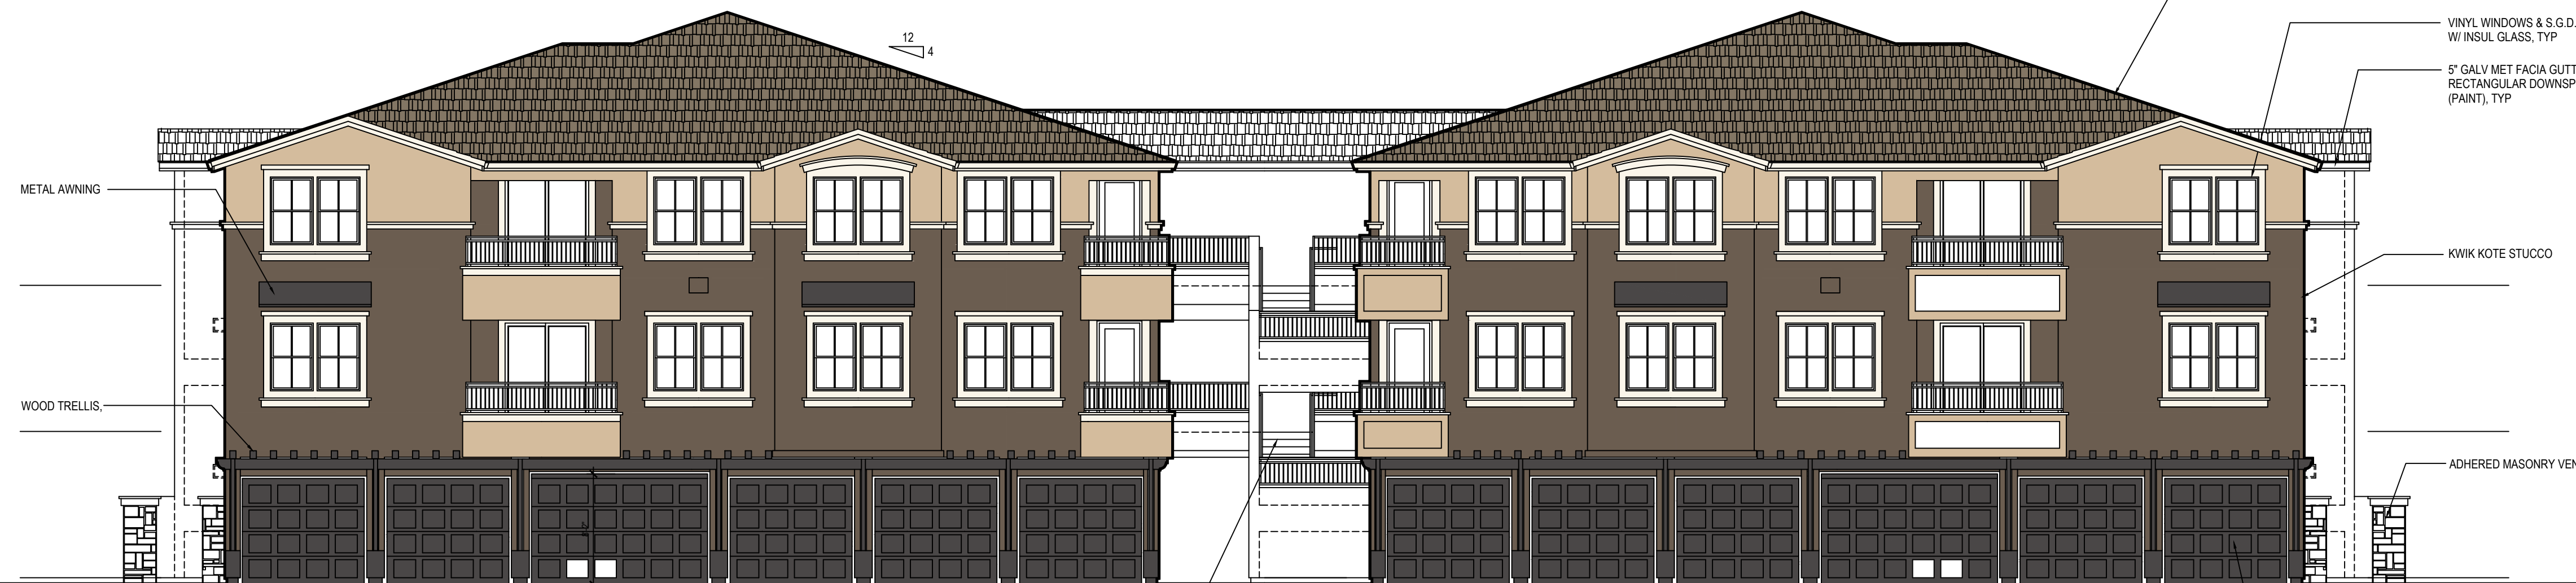
**REAR ELEVATION** A  
1/8" = 1'-0"

PREFABRICATED STAIR SYSTEM

CONCRETE ROOF TILES

5' GALV MET FACIA GUTTER WITH  
RECTANGULAR DOWNSPOUTS  
(PAINT), TYP.

PROFILE OF STAIR WALL IN  
FOREGROUND

VINYL WINDOWS & S.G.D.'S  
W/ INSUL. GLASS, TYP.

1-COAT STUCCO

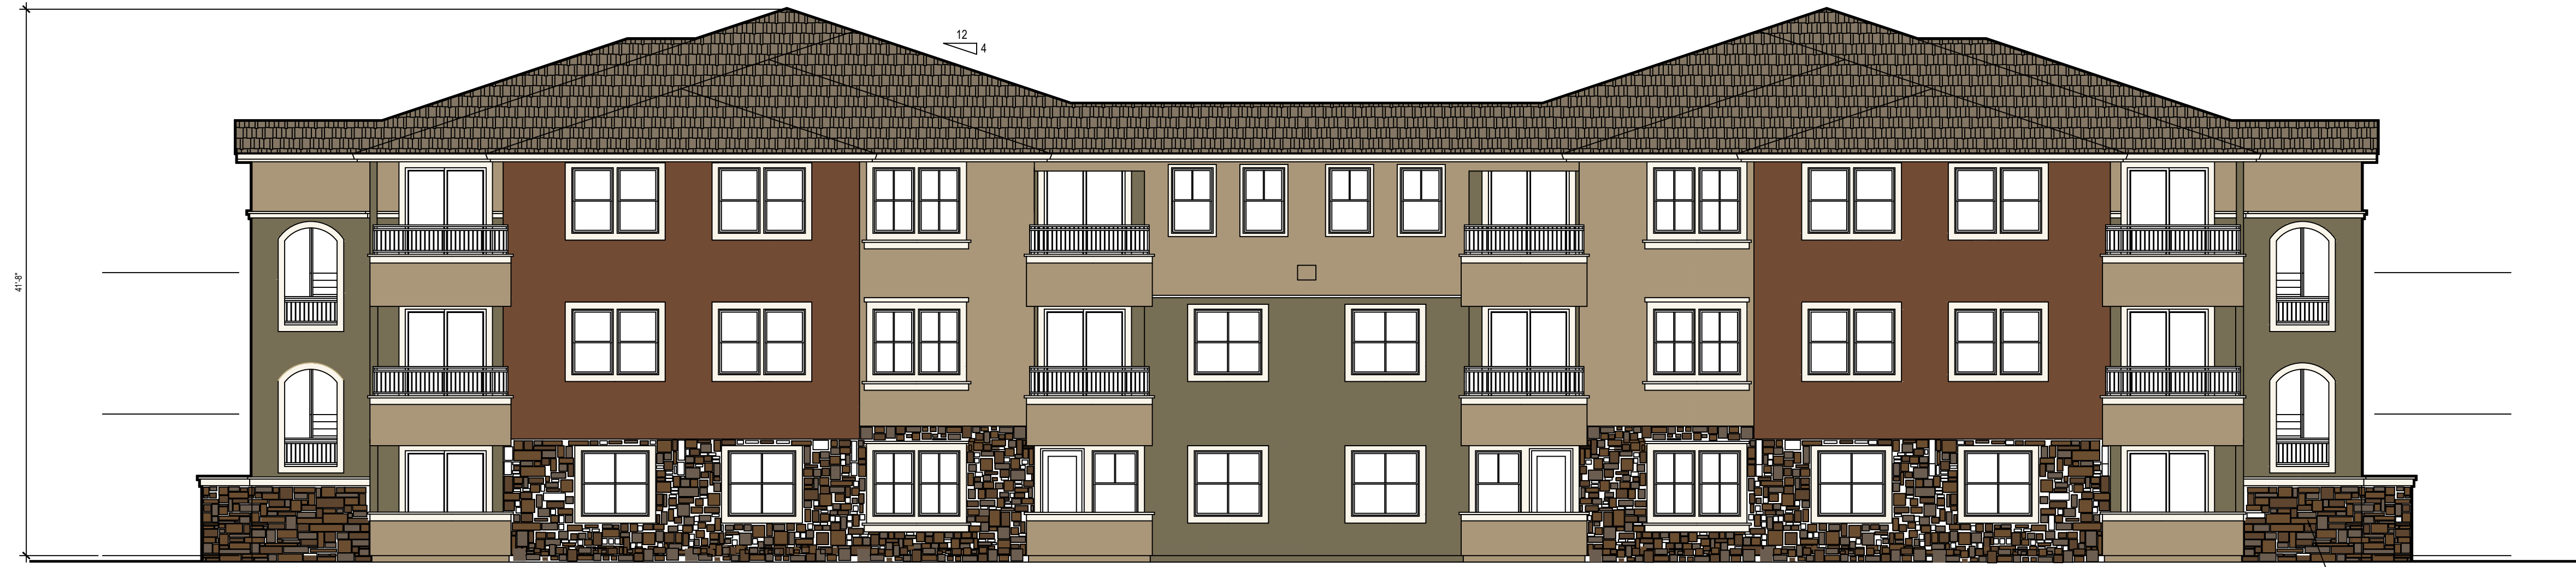
**FRONT ELEVATION** A **COLOR SCHEME 2**  
1/8" = 1'-0"

ADHERED MASONRY VENEER

CONCRETE ROOF TILES

VINYL WINDOWS & S.G.D.'S  
W/ INSUL. GLASS, TYP.

5' GALV MET FACIA GUTTER WITH  
RECTANGULAR DOWNSPOUTS  
(PAINT), TYP.

KWIK KOTE STUCCO

METAL OVERHEAD GARAGE DOOR

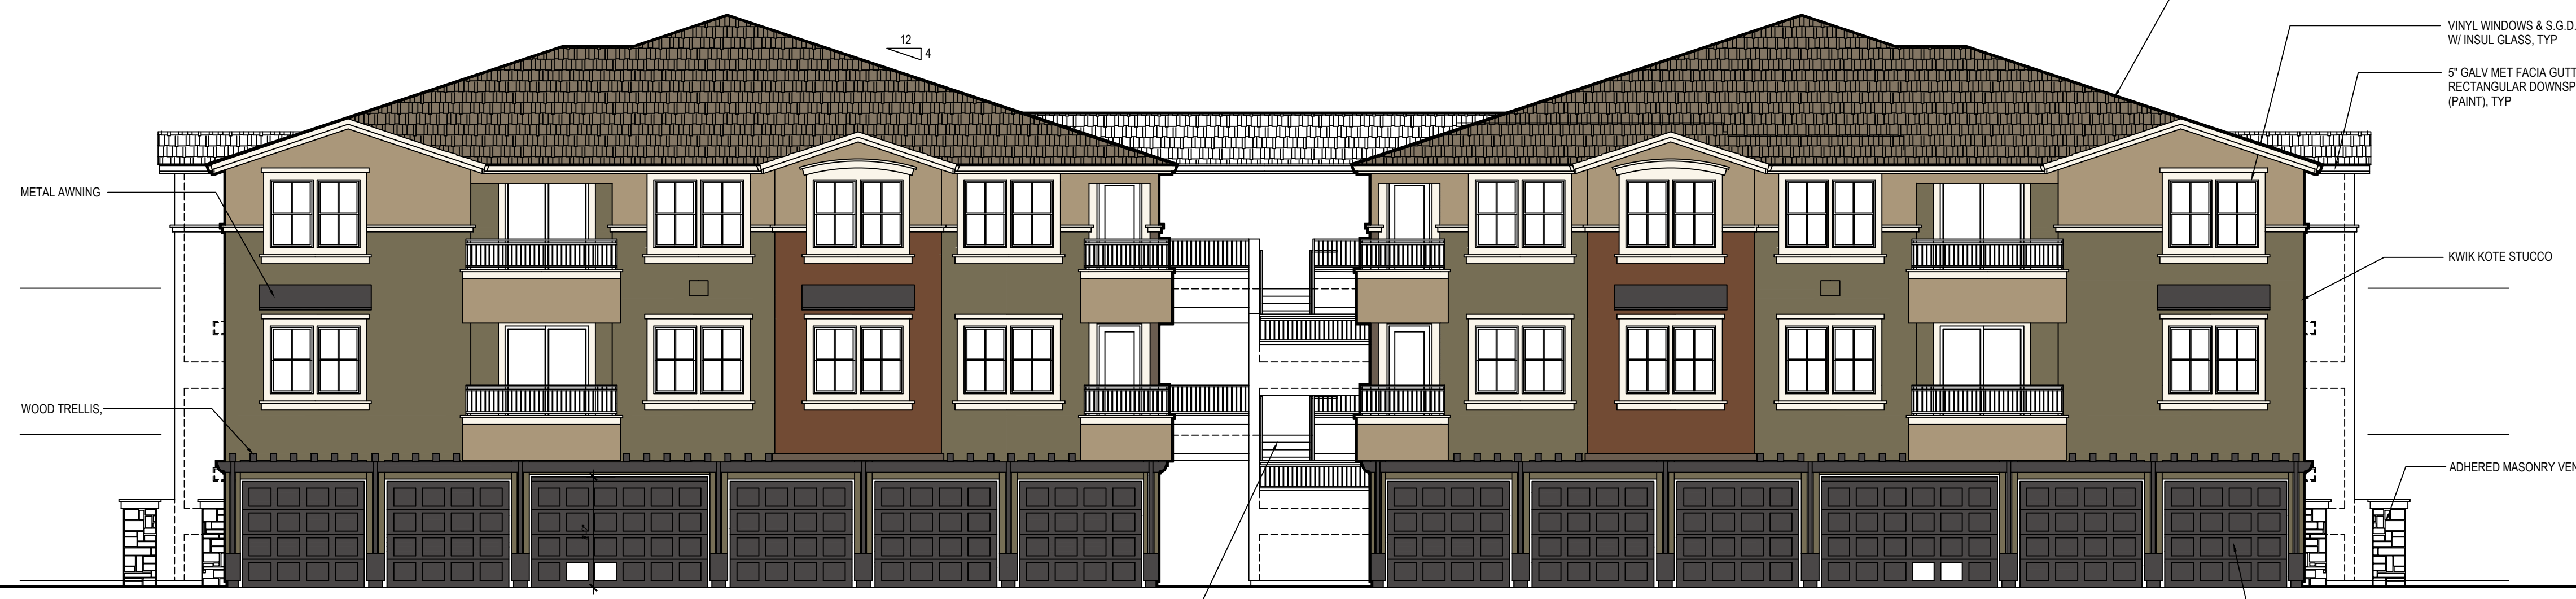
**REAR ELEVATION** A  
1/8" = 1'-0"

PREFABRICATED STAIR SYSTEM

CONCRETE ROOF TILES

5' GALV MET FACIA GUTTER WITH  
RECTANGULAR DOWNSPOUTS  
(PAINT), TYP.

PROFILE OF STAIR WALL IN  
FOREGROUND

VINYL WINDOWS & S.G.D.'S  
W/ INSUL. GLASS, TYP.

1-COAT STUCCO

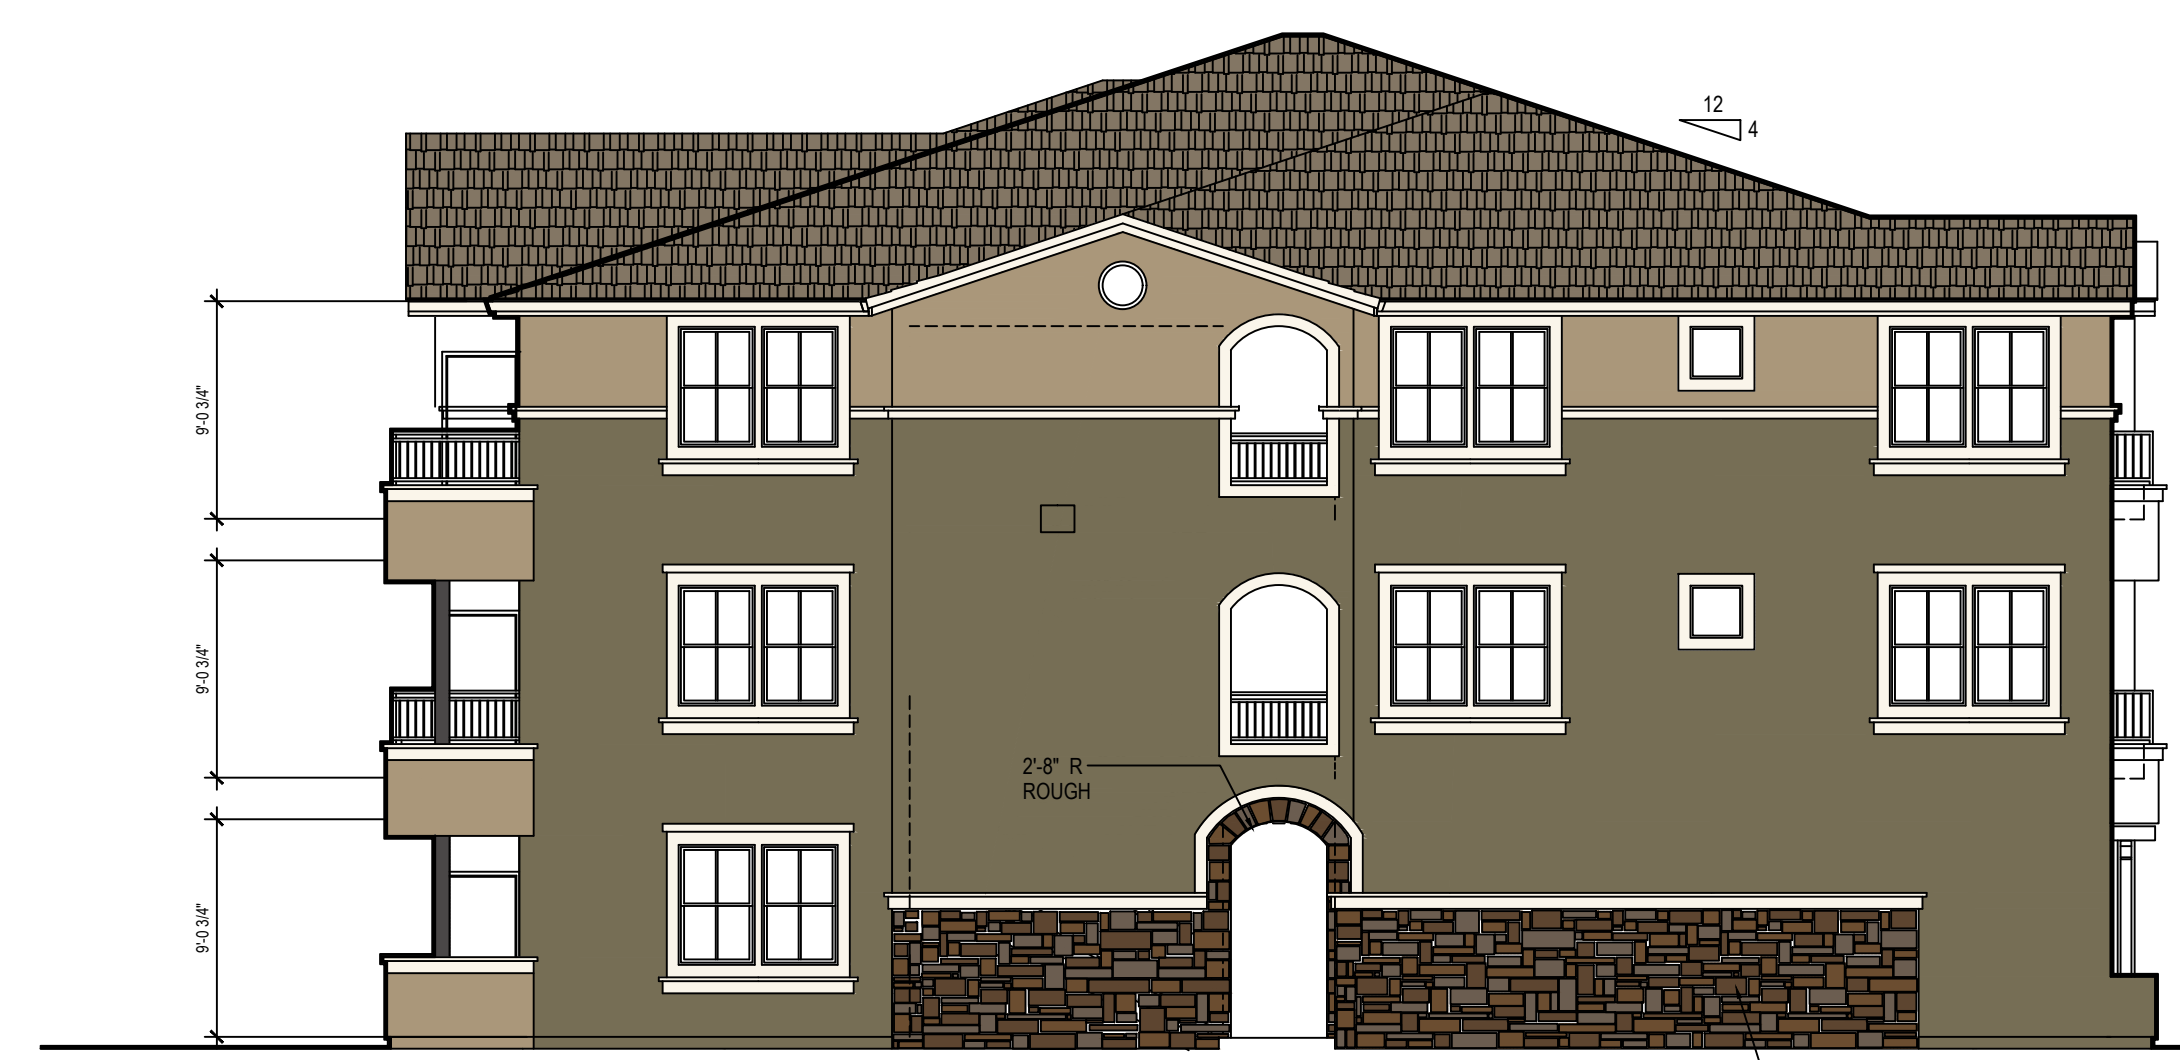
**SIDE ELEVATION** A  
1/8" = 1'-0"

ADHERED MASONRY VENEER

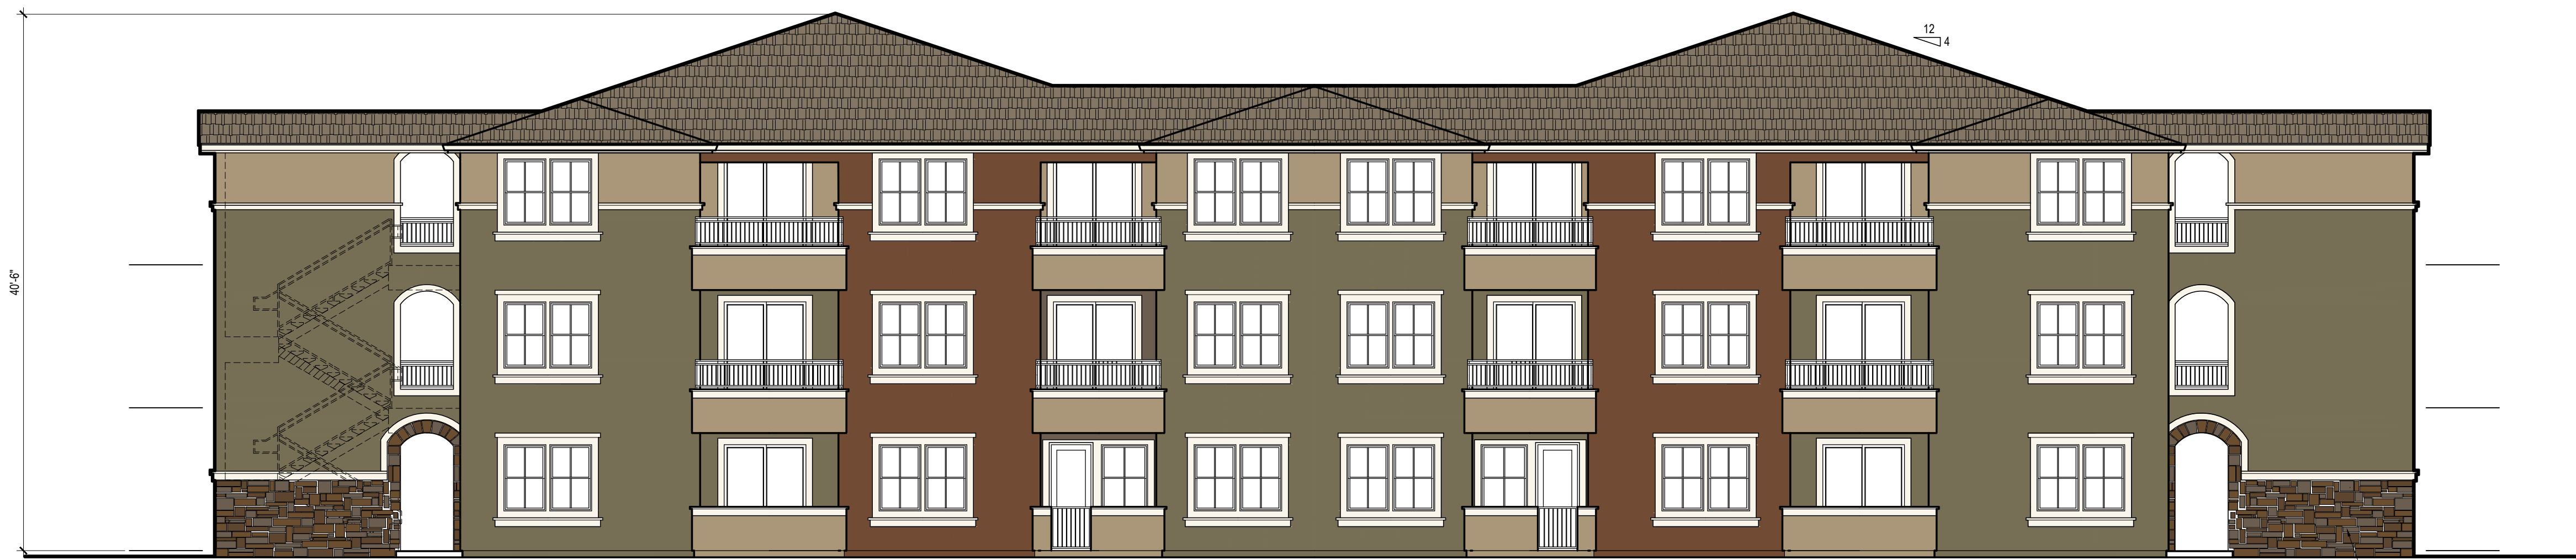
**FRONT ELEVATION** B2 COLOR SCHEME 2  
1/8" = 1'-0"

- ADHERED MASONRY VENEER
- CONCRETE ROOF TILES
- VINYL WINDOWS & S.G.D.'S W/ INSUL. GLASS, TYP
- 5' GALV MET FACIA GUTTER WITH RECTANGULAR DOWNSPOUTS (PAINT), TYP (B)
- KWIK KOTE STUCCO
- ADHERED MASONRY VENEER
- METAL OVERHEAD GARAGE DOOR

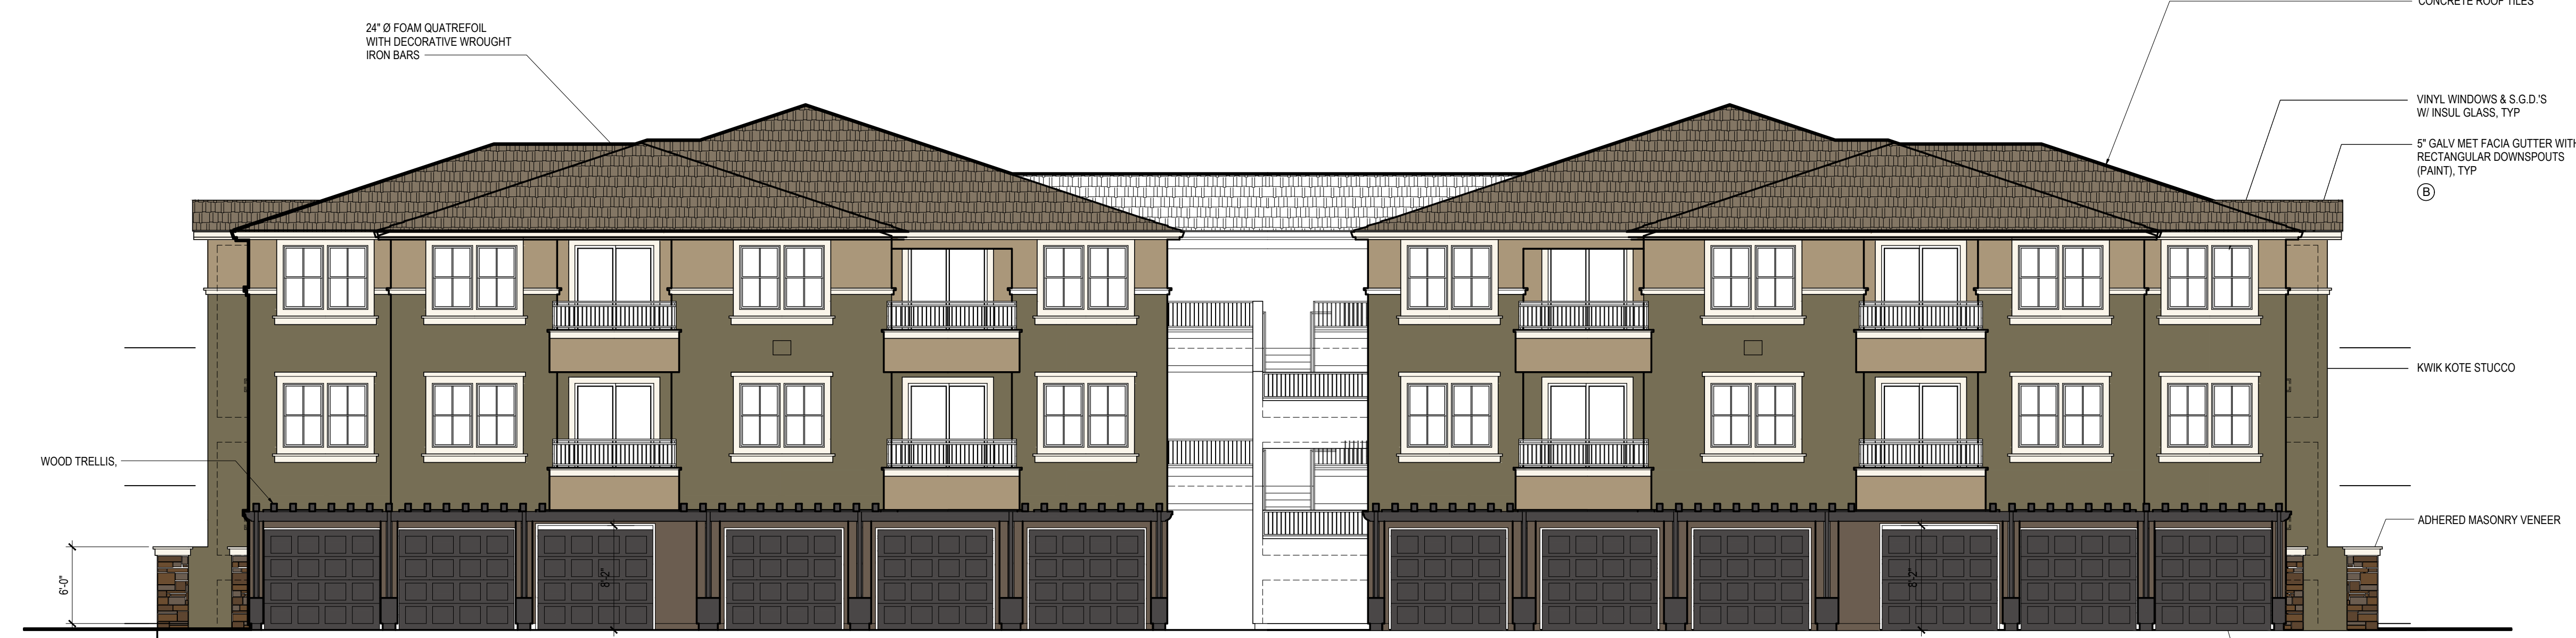
**REAR ELEVATION** B2  
1/8" = 1'-0"

- CONCRETE ROOF TILES
- 5' GALV MET FACIA GUTTER WITH RECTANGULAR DOWNSPOUTS (PAINT), TYP (B)
- PROFILE OF STAIR WALL IN FOREGROUND
- KWIK KOTE STUCCO
- PREFABRICATED STAIR SYSTEM

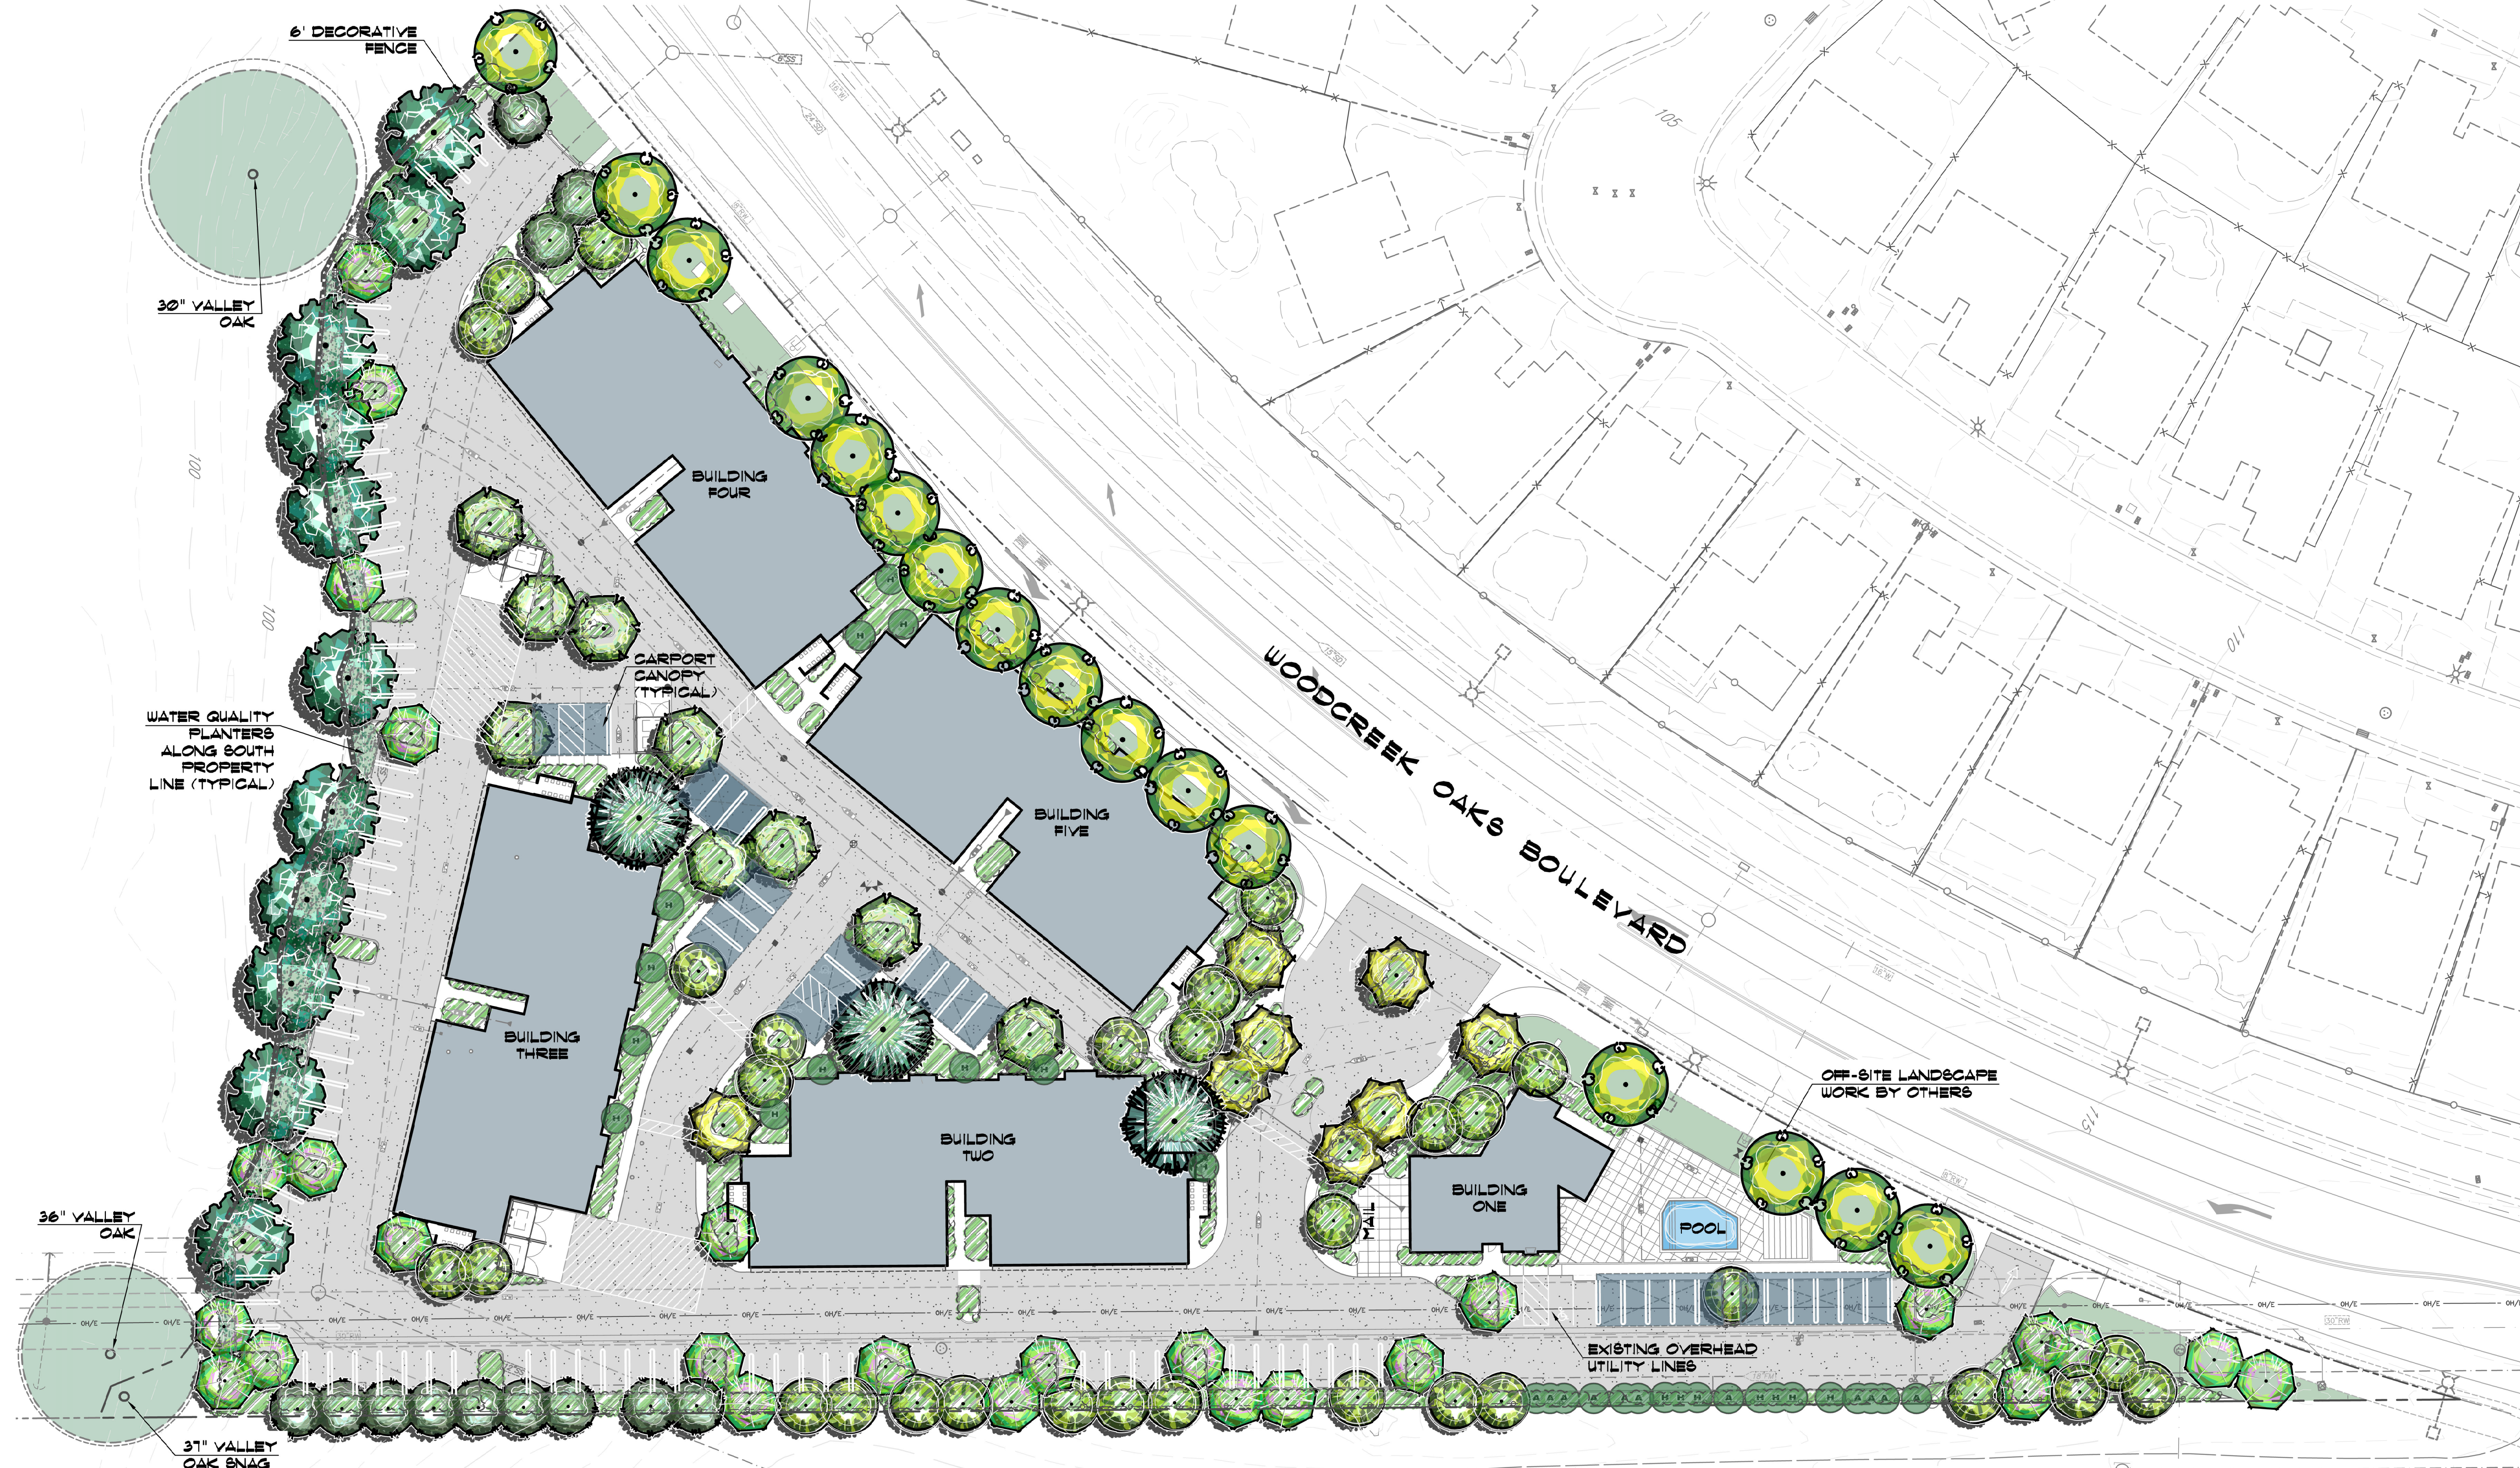
**PRELIMINARY LANDSCAPE PLAN**

MAXIMUM APPLIED WATER ALLOWANCE (MAWA) = 381992 GALLONS PER YEAR  
 MAWA = 52.2 ETO x 0.62 GAL/S.F. x 0.45 (ET ADJ. FACTOR) x 26222 S.F. LANDSCAPE AREA  
 ESTIMATED TOTAL WATER USE (ETUW) = 219376 GALLONS PER YEAR  
 HYDROZONE PLANT WATER PLANT AREA IRRIG. ESTIMATED  
 (STATION #) USE TYPE FACTOR (S.F.) EFF. CALCULATION WATER USE  
 PLANTERS LOW (FULL SUN) 0.20 2579 81% 52.2x42x .20x 2579 / 81% = 206003 GAL  
 POOL HIGH (FULL SUN) 0.70 443 75% 52.2x42x .70x 443 / 75% = 13373 GAL  
 TOTAL ANNUAL ESTIMATED WATER USE: 219376 GAL

TREE TYPE	AREA/FULL	QUANTITY	FULL	3/4	1/2	SUBTOTAL	TOTAL
<b>20" DIA. TREES</b>							
ACACIA ANEURA	314 S.F.	0	0	8	2	1413 S.F.	
CERCIS OCCIDENTALIS	314 S.F.	4	0	10	3	3062 S.F.	
OLEA EUROPEA	314 S.F.	0	0	5	1	864 S.F.	
							20" TOTAL: 5338 S.F.
<b>25" DIA. TREES</b>							
ULMUS PROPINQUA	490 S.F.	0	0	1	1	368 S.F.	
							25" TOTAL: 368 S.F.
<b>35" DIA. TREES</b>							
QUERCUS LOBATA	962 S.F.	0	0	11	0	5291 S.F.	
							35" TOTAL: 5291 S.F.
							COVERED PARKING: 4391 S.F.
							PARKING AREA: 28377 S.F.
							SHADE REQUIRED: 50% 14189 S.F.
							SHADE PROVIDED: 84.2% 15388 S.F.
