California Tree and Landscape Consulting, Inc.

359 Nevada Street, #201, Auburn, CA 95614

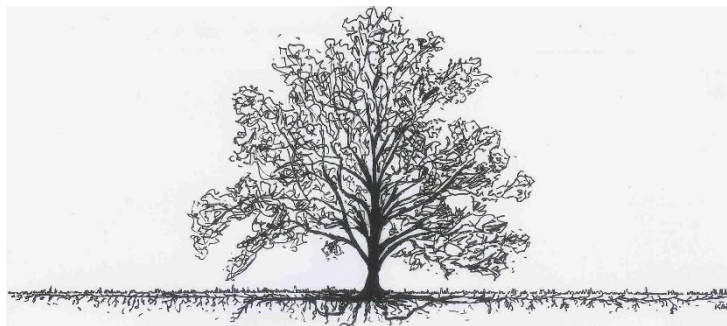
The reality of where roots are generally located

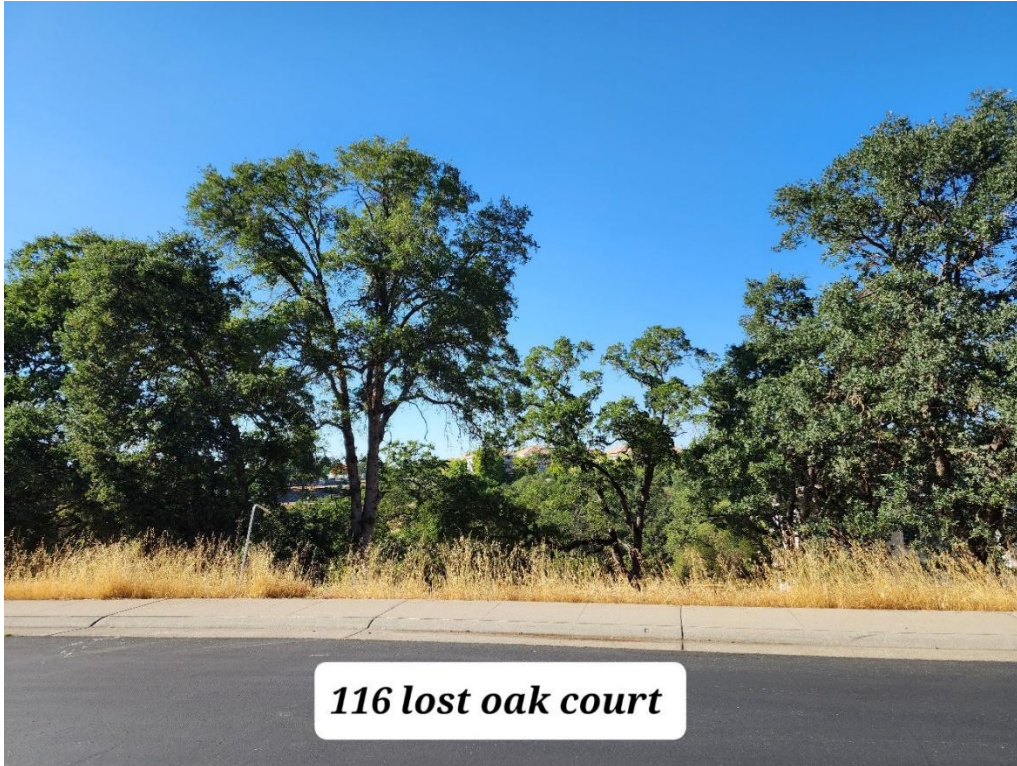
Photo #1, Shows a general overview of the site
