Environmental Consulting,  
Regulatory Compliance and  
Aerial Photographic Services

**Subject:** 6382 Phillip Rd., Roseville CA  
Bio/Wetland Resources Constraints Analysis

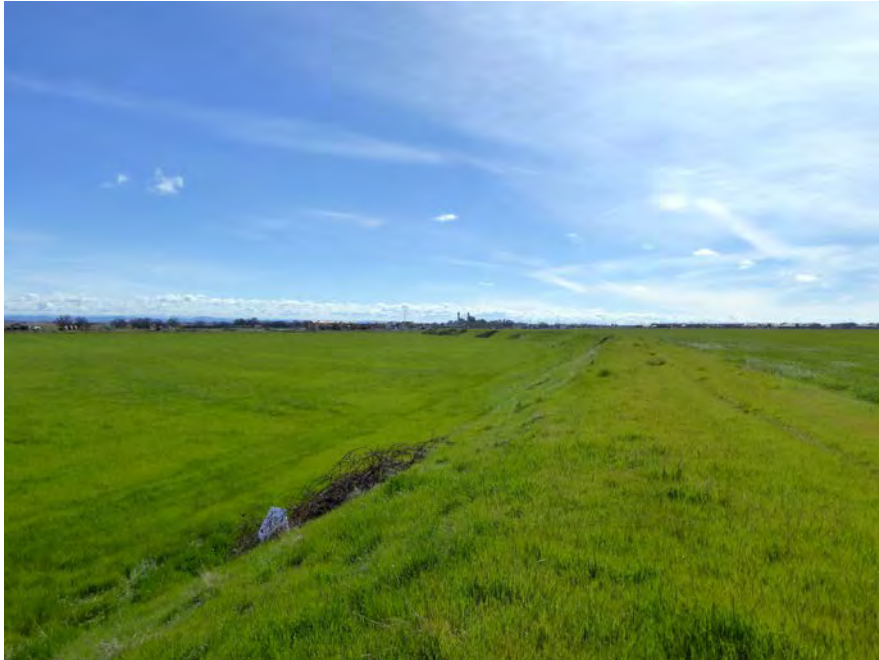
A 10'-15' escarpment runs in a southeasterly direction from the Phillip Road entrance of the property's southern "parcel" to its eastern boundary, clearly demarcating an elevation change between the southern and northern portions of this southern "parcel." Water outfalls into this "basin" via piped culverts from: (1) a large irrigation canal that runs in a S-N direction from Phillip Road (see photoplate); and (2) overflow water from the southern portion of the parcel.

**Escarpment looking East**

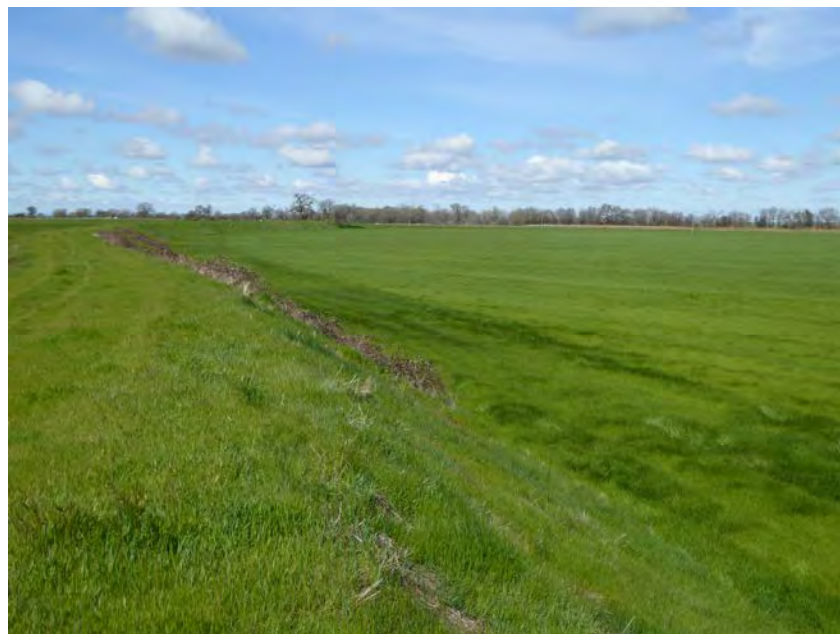
**Escarpment looking West**

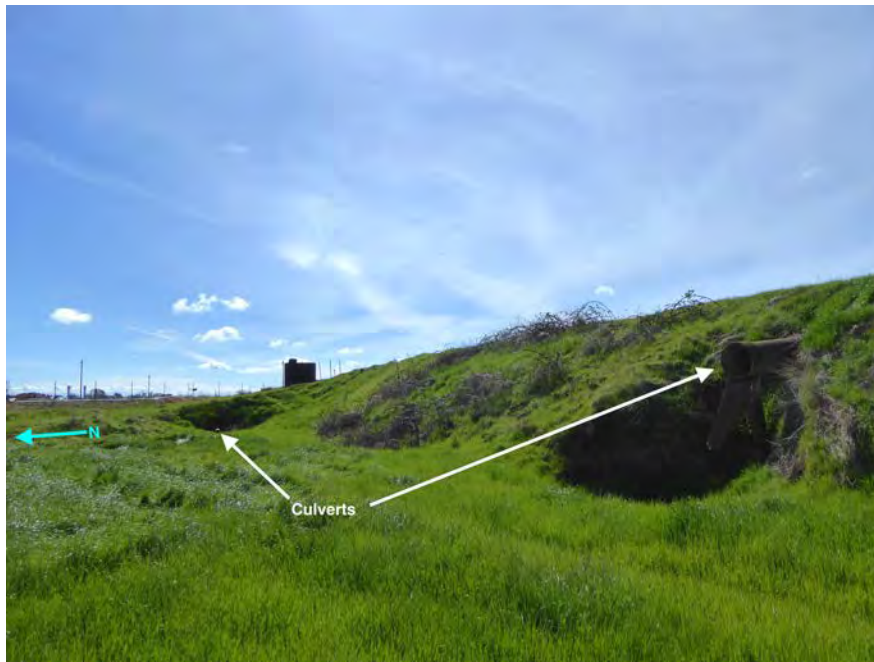
More recently, the northern half (55+ acres) of the southern portion of the property (i.e. 130+ acre southern "parcel") had been engineered to create a functioning, 10+-foot deep flood detention basin to direct floodwaters from the surrounding area to Pleasant Grove Creek as part of the City of Roseville's flood mitigation efforts. A new channel south of the creek was apparently excavated during the summer of 2019 to augment flood mitigation/control in this area. This was perhaps the impetus for the City to abandon the flood detention basin on this parcel, but that is merely speculation until/unless confirmed by the City or other jurisdictional flood agency.

**Water inputs to S parcel “detention basin”**

Resource issues related to development of the southern "parcel" therefore include: (1) resolution of water runoff from this parcel to Pleasant Grove Creek, and (2) discussion with the City regarding removal of oak trees (if necessary) from the NW corner of this "parcel". Issues related to development of the "northern" parcel involve the fate of the riparian habitat along the northern irrigation canal. As this feature demarcates the northern parcel boundary, it may be just as easy to leave the canal in its current condition to avoid any resource agency involvement.

I would recommend clarifying the resolution of flood/water issues with the City of Roseville in abandoning this property's use for flood mitigation to ensure that Panattoni would not be responsible for entitling a change of use of this existing flood detention basin through the respective resource agencies.

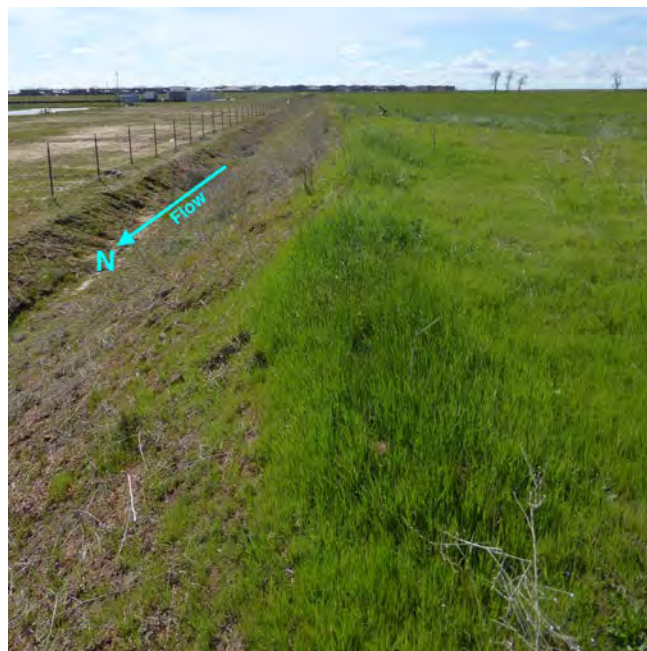
**S parcel eastern drainage ditch**

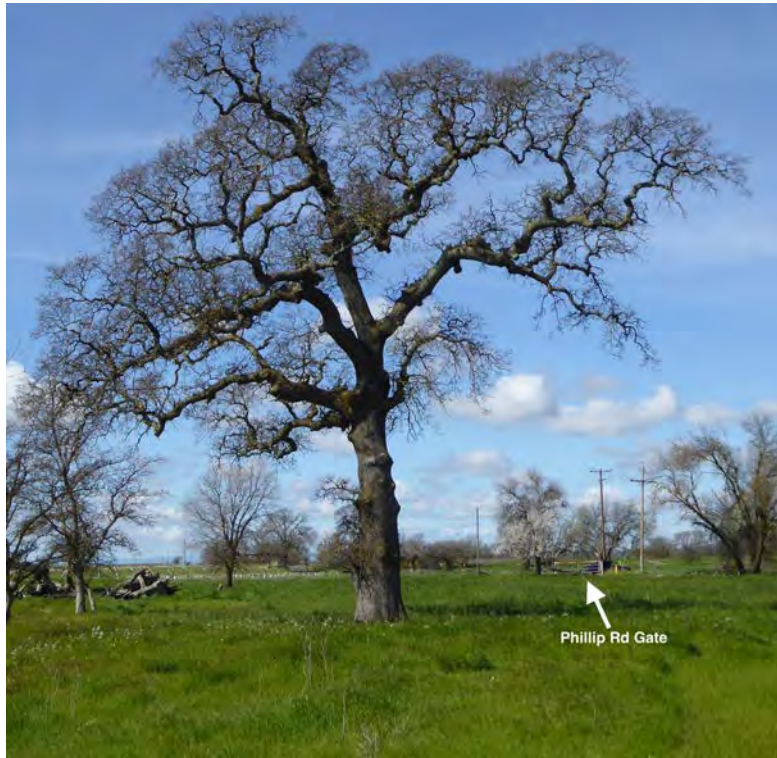
A small grove of oak trees grows in the vicinity of the property's entrance at the southern parcel's NW corner along Phillip Road. Several of these trees are quite large, including a interior live oak (*Quercus wislizeni*) with a ~36"+ DBH (see photoplate) and several valley oaks (*Q. lobata*) along the western end of the escarpment itself with DBHs > 20" (see photoplate).

**Interior live oak @ NW corner of S parcel**

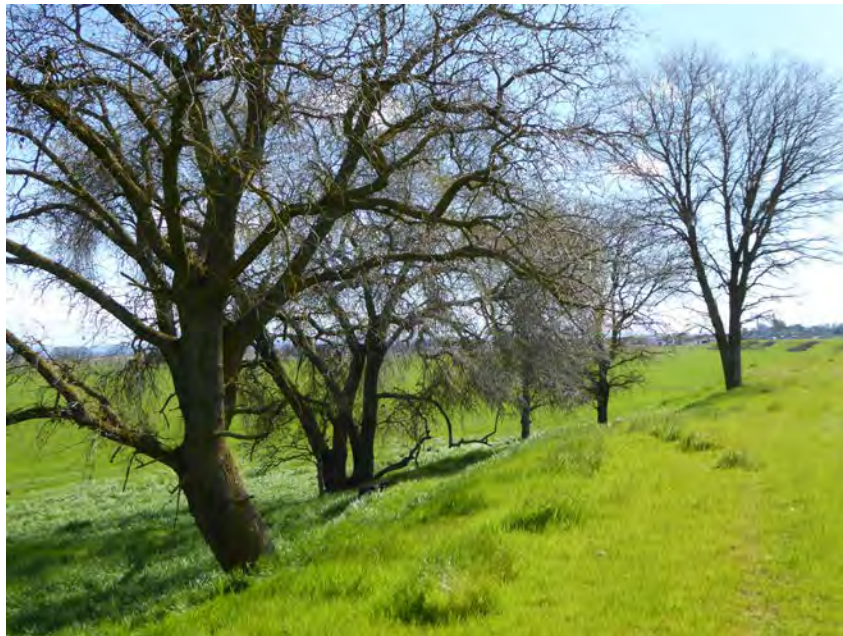
**Valley oaks @ NW corner along S parcel escarpment**

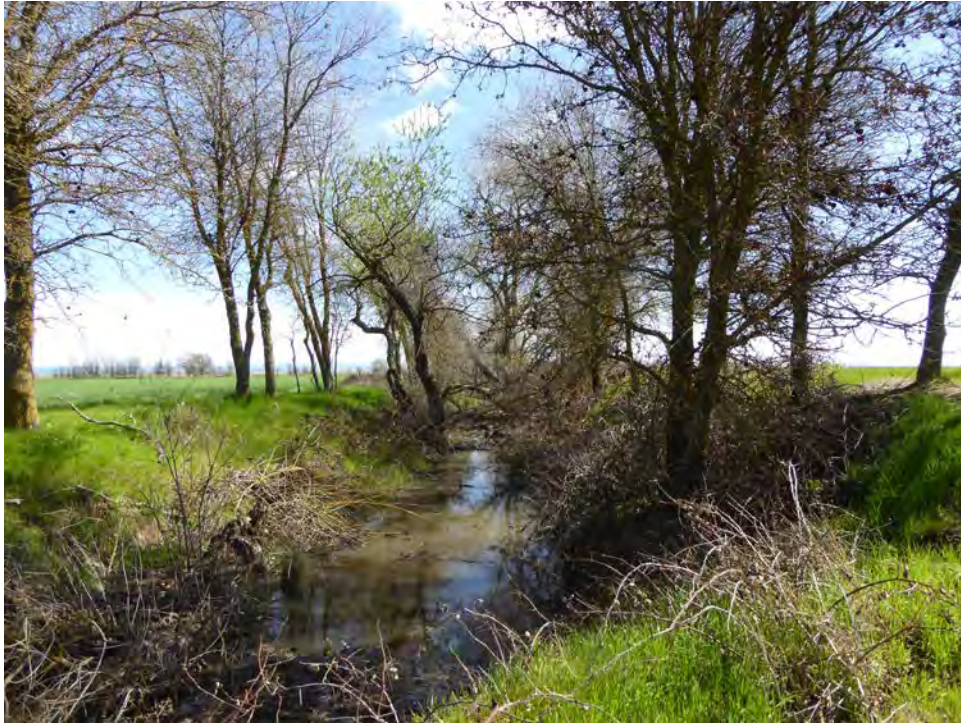
The portion of the property north of Pleasant Grove Creek (i.e. northern "parcel") is also currently in active cultivation and irrigated with water from a long-established irrigation canal along this northern parcel's entire northern boundary. Water drains from this canal southward, into several smaller irrigation ditches (see Figure 2). This irrigation canal has been functioning long enough to support a healthy riparian corridor – replete with oak, cottonwood (*Populus fremontii*), and willow (*Salix sp.*) trees – along its entire length bordering this parcel. A long-standing debris obstruction has effectively dammed water in the canal at the parcel's NW corner so that it backs up towards the east, helping to maintain the riparian habitat, but is blocked towards the west, where no trees occur.

**N parcel's northern irrigation canal (looking E)**

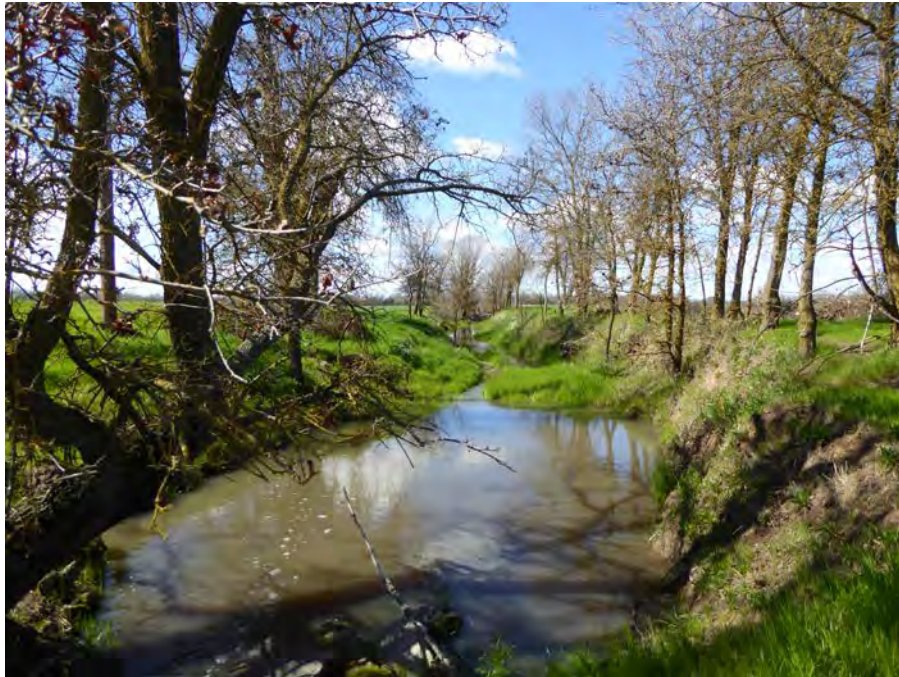
**N parcel northern irrigation channel @ NW corner  
(looking W)**

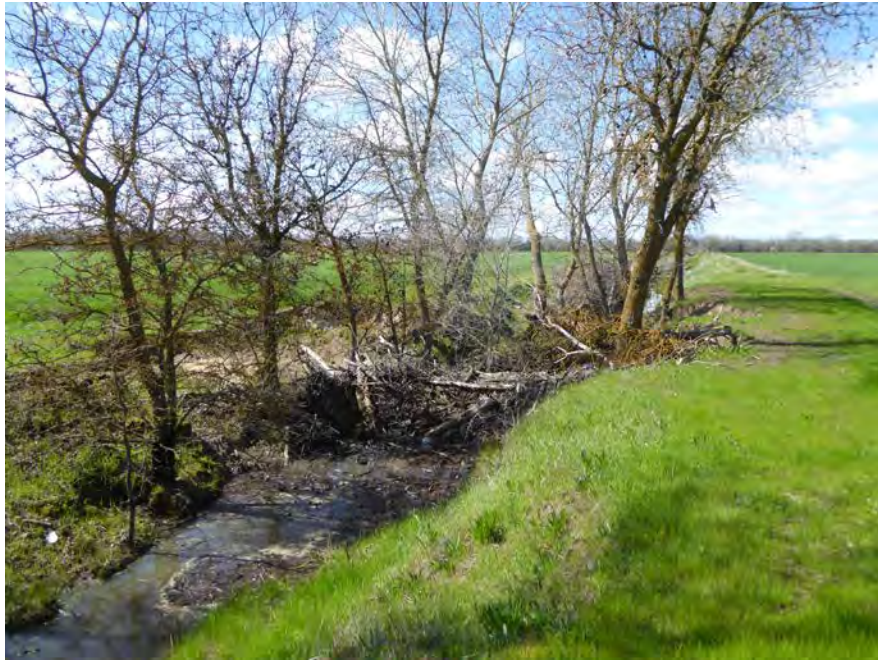
**Debris obstruction along northern irrigation canal**
