TENTATIVE MAP INFORMATION

CONCEPTUAL GRADING, DRAINAGE AND UTILITIES TENTATIVE SUBDIVISION MAP

SIERRA VIEW

Special-Status Plant Survey Report

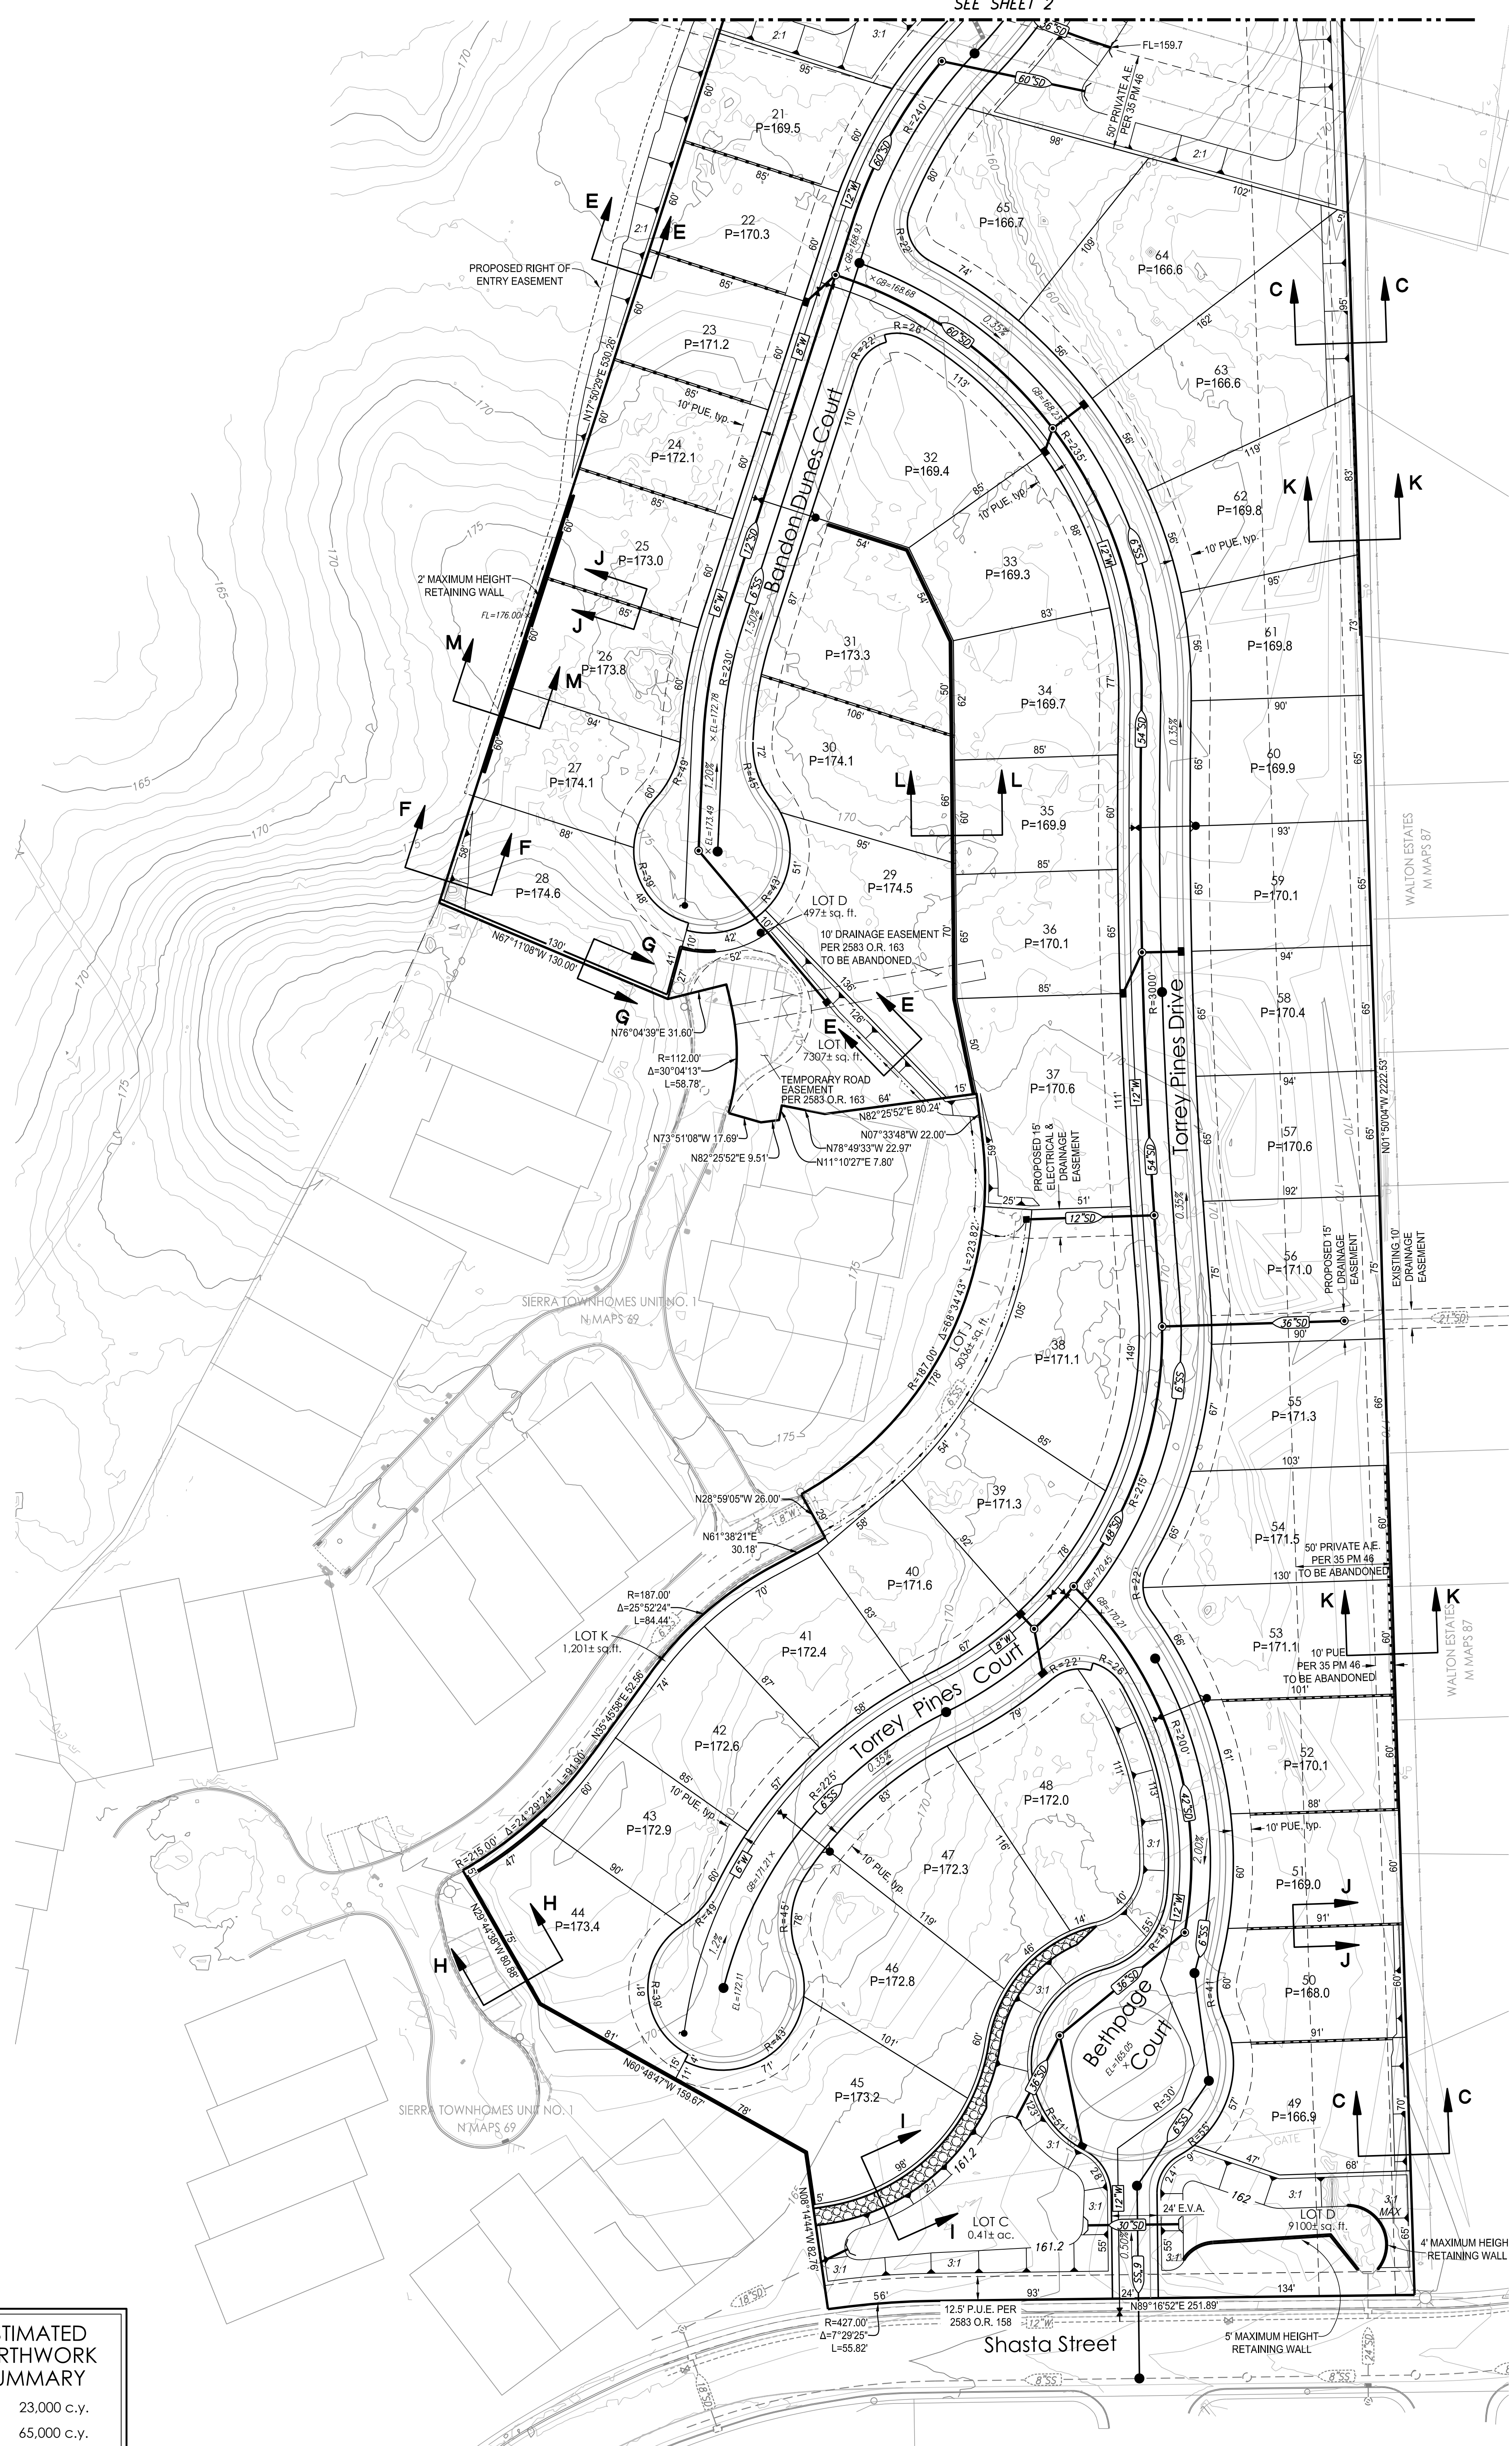
- UNLESS OTHERWISE NOTED, ALL LOTS ARE TO HAVE CLASS 1 LOT DRAINAGE AS SUCH, 2% SWALES, YARD DRAINS, AND UNDERGROUND PIPE SYSTEMS WITH BUBBLE UPS SHALL BE IMPLEMENTED IN LIEU OF 1% MINIMUM SWALES. AN OVERLAND RELEASE TO THE STREET RIGHT-OF-WAY SHALL BE INCLUDED AS PART OF THE FINISHED LOT GRADING DESIGN TO PRECLUDE ANY FLOODING AGAINST FUTURE BUILDING FOUNDATION. POSITIVE DRAINAGE AWAY FROM THE BUILDING AT A SLOPE OF 5% MINIMUM SHALL BE PROVIDED, CONSISTENT WITH SECTION 2304.11 OF THE CALIFORNIA BLDG CODE.

ESTIMATED EARTHWORK SUMMARY	
CUT:	23,000 c.y.
FILL:	65,000 c.y.
NET:	42,000 c.y.

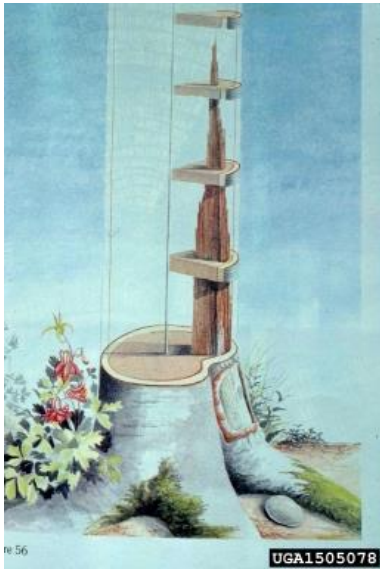
According to Evaluation of Hazard Trees in Urban Areas (Matheny, 1994) decay is a critical factor in the stability of the tree. As decay progresses in the trunk, the stem becomes a hollow tube or cylinder rather than a solid rod. This change is not readily apparent to the casual observer. Trees require only a small amount of bark and wood to transport water, minerals and sugars. Interior heartwood can be eliminated (or degraded) to a great degree without compromising the transport process. Therefore, trees can contain significant amounts of decay without showing decline symptoms in the crown.

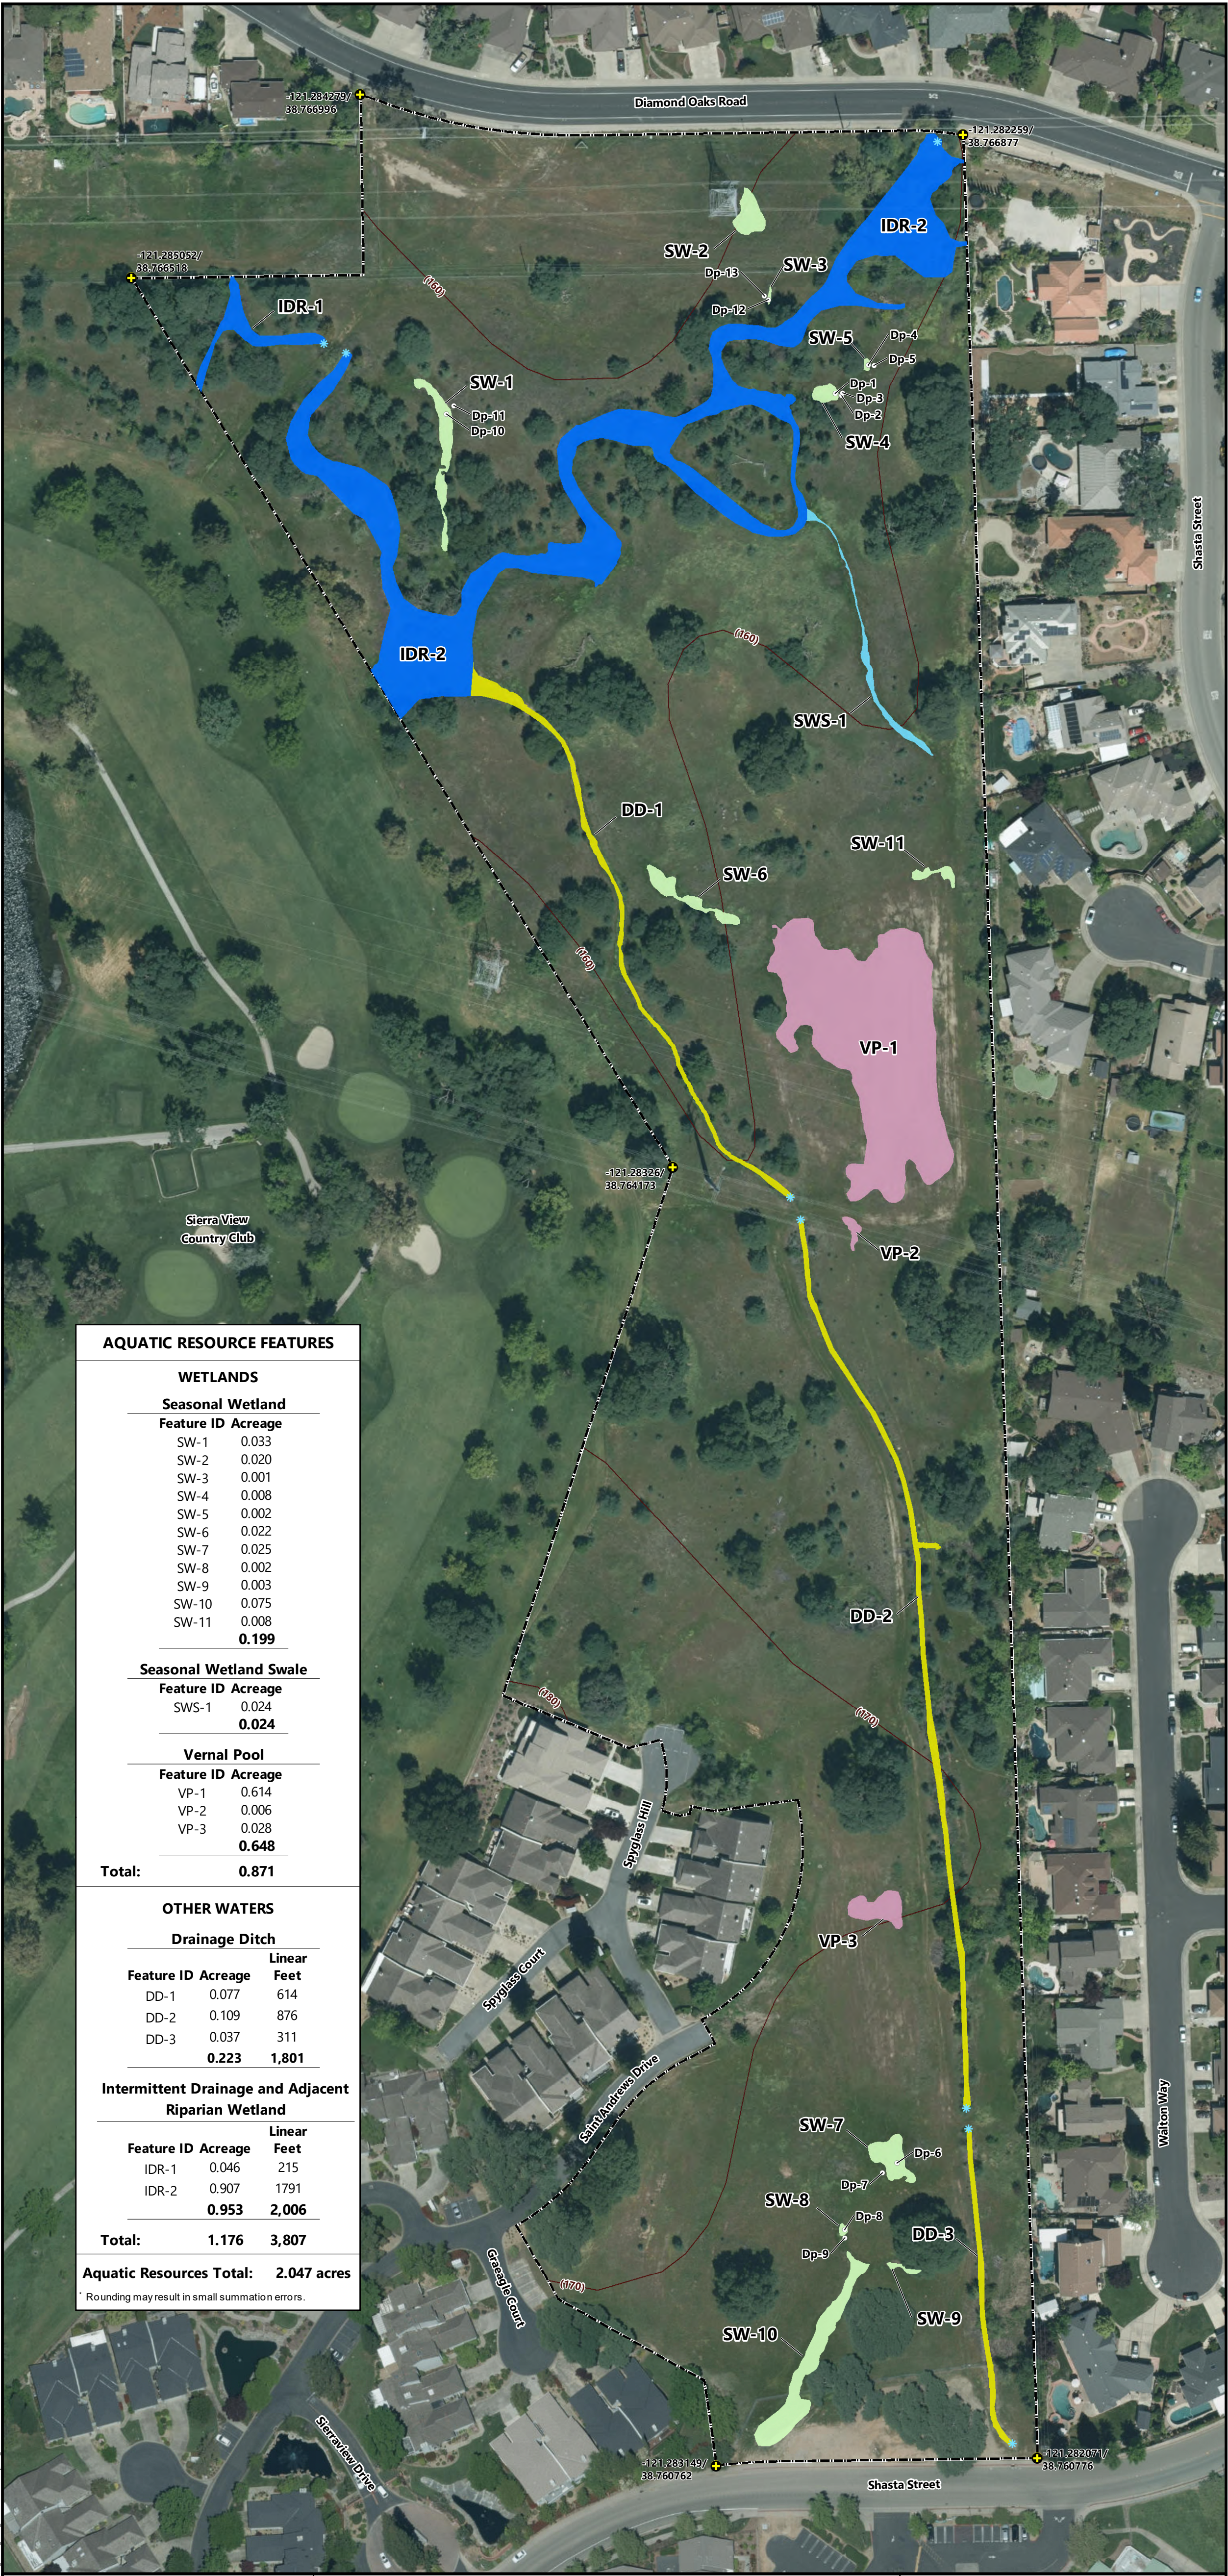
Aquatic Resources Delineation

AQUATIC RESOURCE FEATURES		
WETLANDS		
Seasonal Wetland		
Feature ID	Acres	
SW-1	0.033	
SW-2	0.020	
SW-3	0.001	
SW-4	0.008	
SW-5	0.002	
SW-6	0.022	
SW-7	0.025	
SW-8	0.002	
SW-9	0.003	
SW-10	0.075	
SW-11	0.008	
Total:	0.199	
Seasonal Wetland Swale		
Feature ID	Acres	
SWS-1	0.024	
Total:	0.024	
Vernal Pool		
Feature ID	Acres	
VP-1	0.614	
VP-2	0.006	
VP-3	0.028	
Total:	0.648	
Total:	0.871	
OTHER WATERS		
Drainage Ditch		
Feature ID	Acres	Linear Feet
DD-1	0.077	614
DD-2	0.109	876
DD-3	0.037	311
Total:	0.223	1,801
Intermittent Drainage and Adjacent Riparian Wetland		
Feature ID	Acres	Linear Feet
IDR-1	0.046	215
IDR-2	0.907	1791
Total:	0.953	2,006
Aquatic Resources Total:	2.047 acres

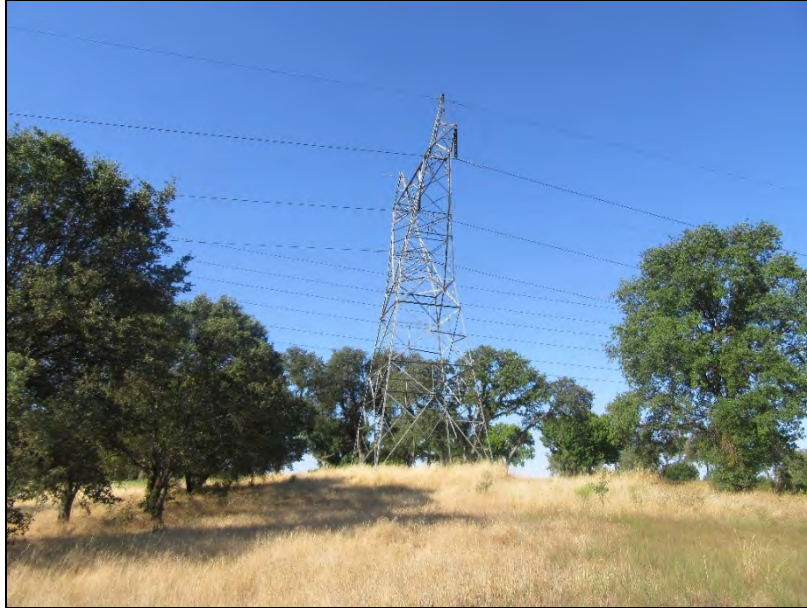
Figure 7. P-31-3280 transmission tower (view south; June 23, 2020).

During the 2020 survey, ECORP observed the line from the Project Area and the lattice-type steel towers are located outside of the Project Area but the line is situated above the Project Area land. It could not be determined if the towers or lines had been updated or altered since their original construction, but they appeared to be in overall good condition (Figure 7).

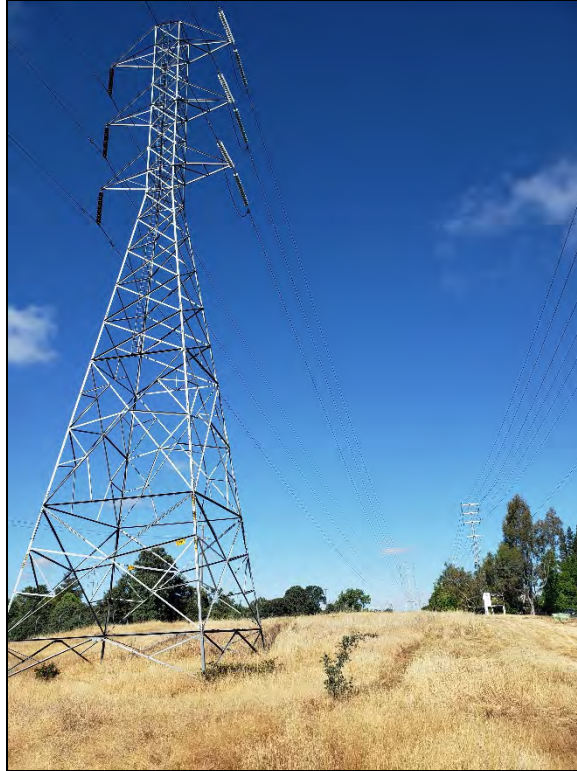
Figure 8. Overview: SV-001, SMUD 230kV transmission line; Diamond Oaks Road, right (view west, June 14, 2021).

During the current survey, ECORP observed the transmission line and one of its lattice-type steel tower within the Project Area.

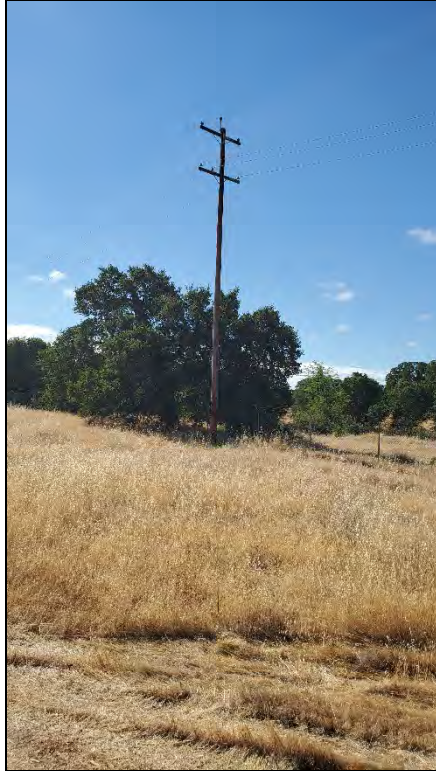
Figure 9. Overview: SV-002, SMUD 115kV distribution line (view southwest, June 14, 2021).

During the current survey, ECORP observed the distribution line and one of its wooden poles within the Project Area (Figure 9). Based on aerial photographs, this pole was relocated approximately 75 feet to the west sometime between 2007 and 2009.

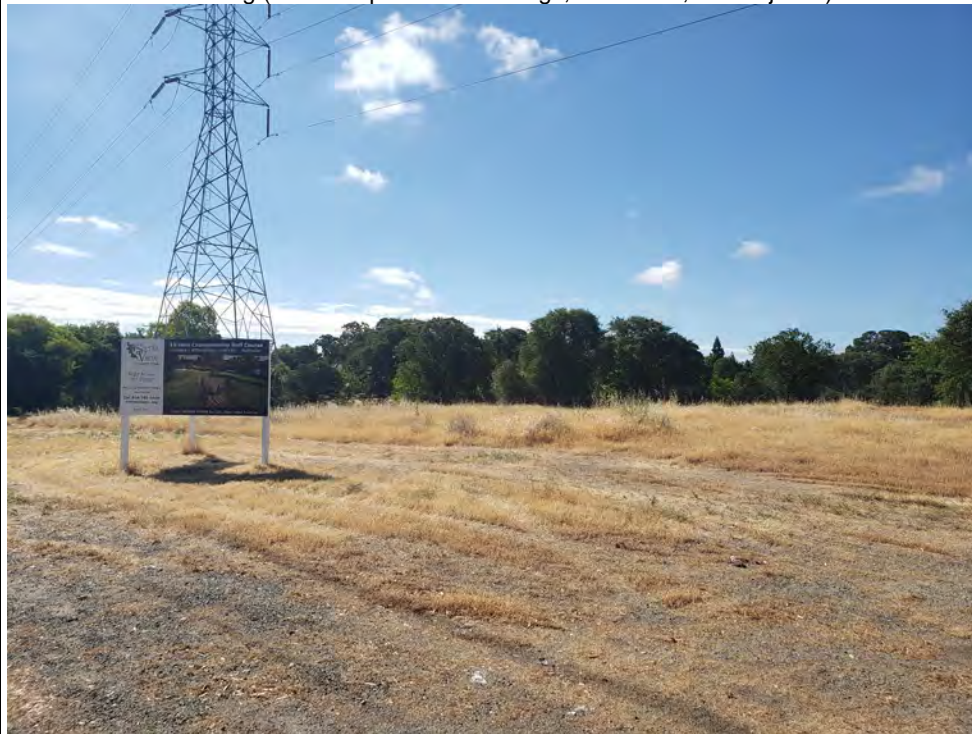
P5b. Description of Photo:
Overview of SV-001 (SMUD 230kV transmission line) from Diamond Oaks Road (view southeast, Acc# 004 (20210614_091421))
