# PROGRAMMATIC PHASE I ENVIRONMENTAL SITE ASSESSMENT FOR THE DOWNTOWN ROSEVILLE SPECIFIC PLAN

27 December 2007

**Natural  
Investigations  
Company**

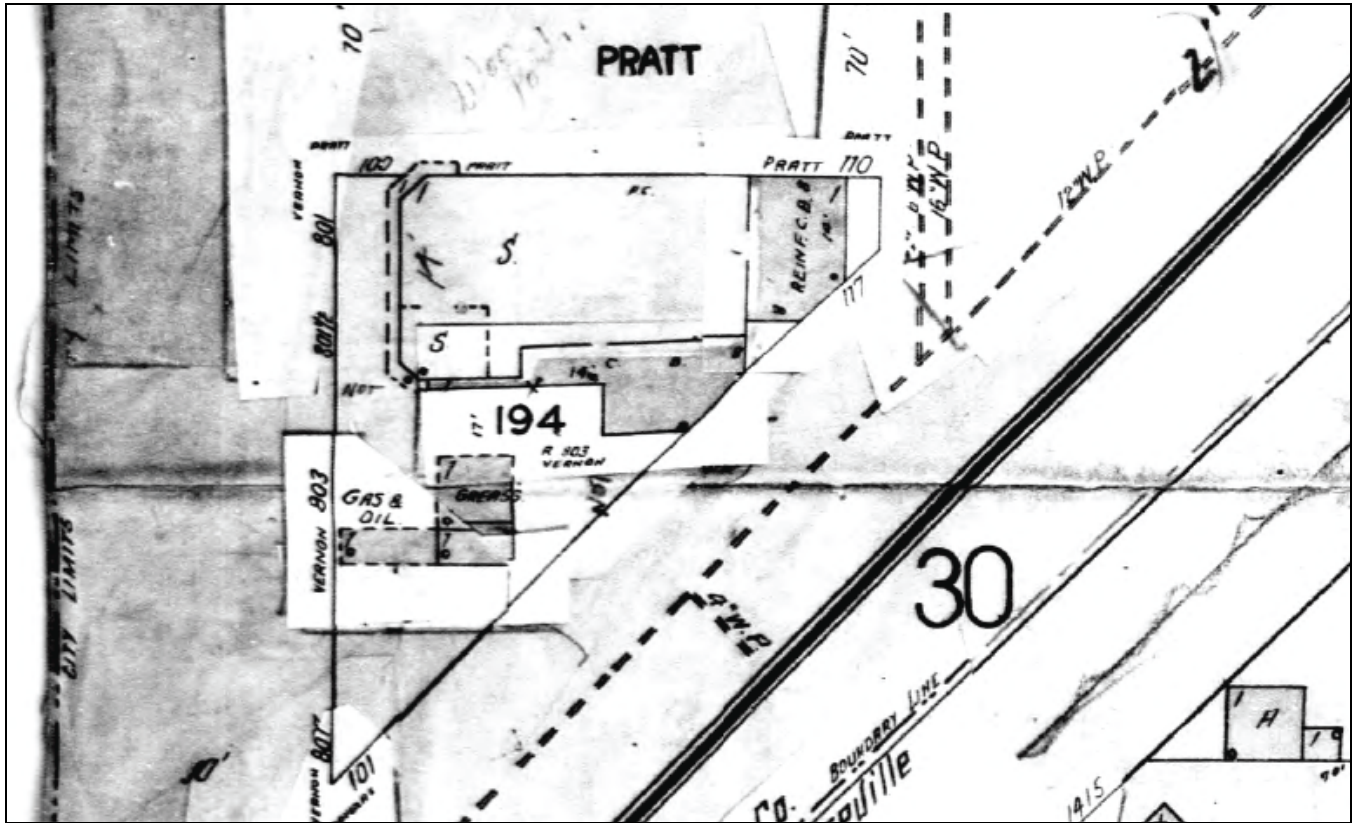
Figure 4.15. Detail of Sanborn Co. Map dated 1925 & revised 1960 (EDR Inc.)

The following commercial or industrial uses were indicated on the “Roseville” Series Sanborn Co. Fire Insurance Map dated 1925 and revised in 1960(see map detail in Figure 4.15).

- 803 Vernon St., 1 commercial building, “gas & oil” and “greasing”; this parcel is now Road Show Ltd.

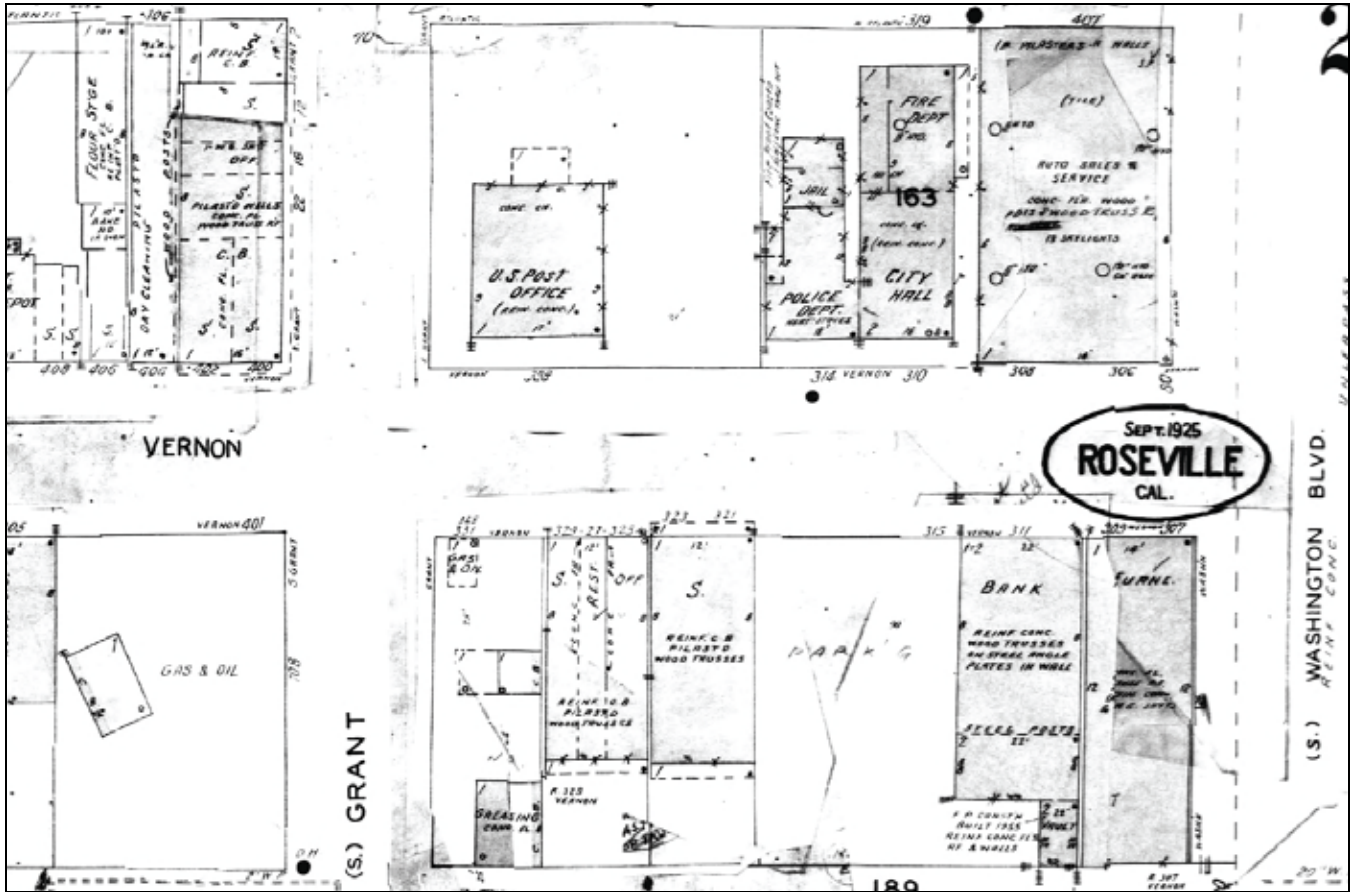
Figure 4.16. Detail of Sanborn Co. Map dated 1925 & revised 1960 (EDR Inc.)

The following commercial or industrial uses were indicated on the “Roseville” Series Sanborn Co. Fire Insurance Map dated 1925 and revised in 1960 (see map detail in Figure 4.16):

- 306-308 Vernon St., 1 commercial building, auto sales & service
- 325-331 Vernon St., 1 commercial building, “gas & oil” and “greasing”; this parcel is now the Roseville Civic Center
- 401 Vernon St., 1 commercial building, “gas & oil” (Catalyst Site)
- 404 Vernon St., dry cleaners; this parcel is now 404 Art Gallery

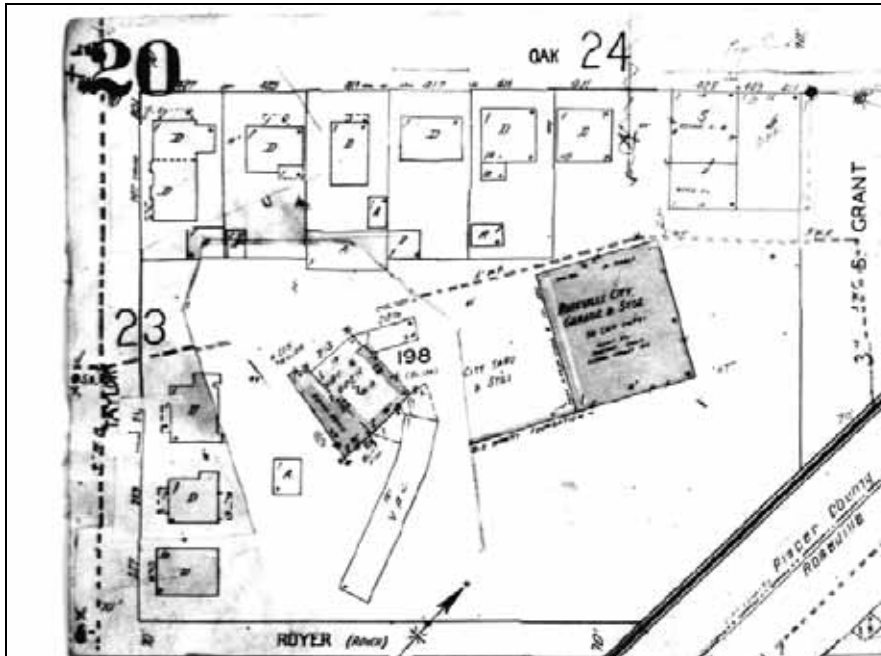
Figure 4.19. Detail of Sanborn Co. Map dated 1925 & revised 1960 (EDR Inc.)

The following commercial or industrial uses were indicated on the “Roseville” Series Sanborn Co. Fire Insurance Map dated 1925 and revised in 1960 (see map detail in Figure 4.19):

- bounded by Oak, Taylor, Royer Streets, Roseville City Garage & Storage, City Yard, (near Catalyst Site); this parcel is now the Roseville Public Library
