DRAFT INITIAL SITE ASSESSMENT/PRELIMINARY SITE INVESTIGATION

**Washington/Andora Widening Project
Roseville, California**

15 September 2017
Job No. 16-285.1

Subject: **DRAFT INITIAL SITE ASSESSMENT/PRELIMINARY SITE ASSESSMENT**
Washington/Andora Widening Project
Roseville, California
Existing Bridge No. 14C-0107

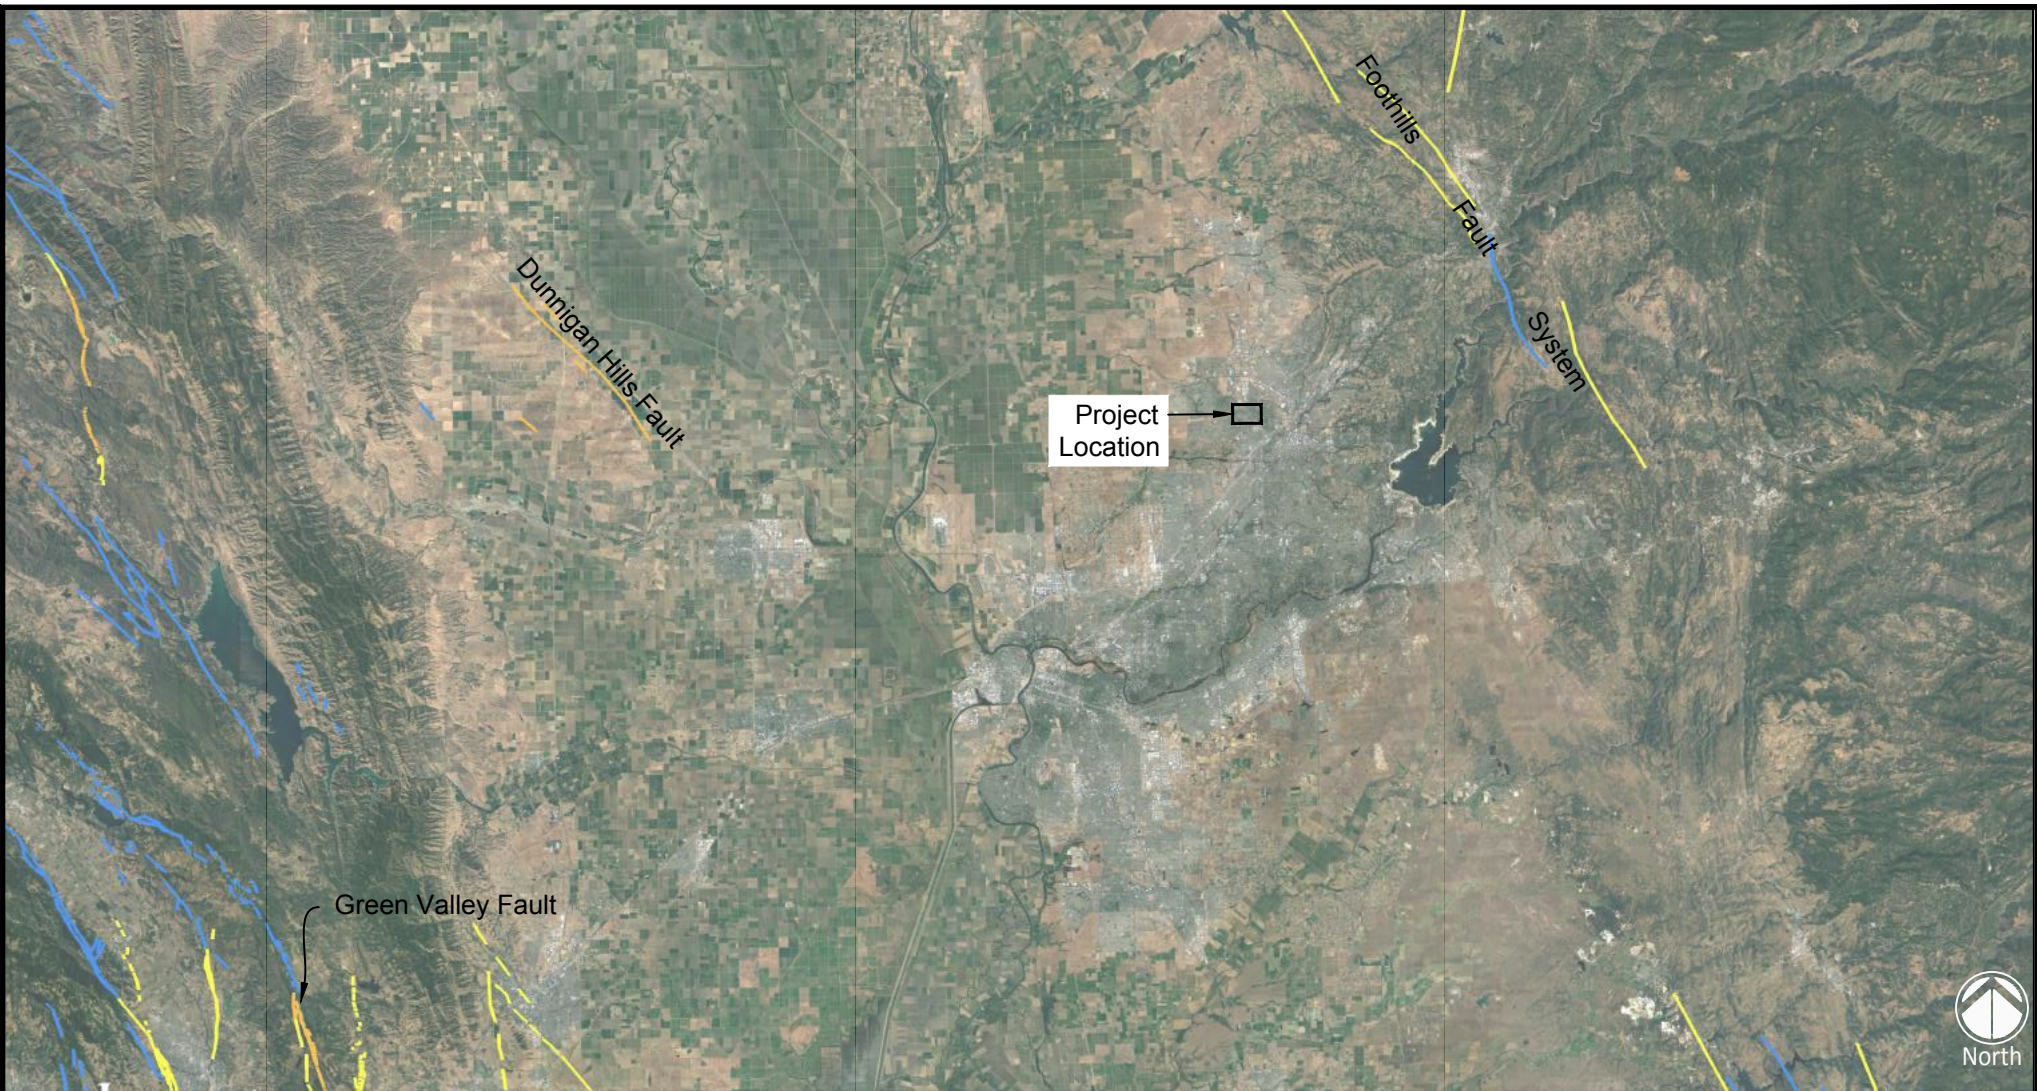
Figure 2
 Geology Map

Published geologic mapping¹ shows the site underlain by the Riverbank, Turlock Lake, and Mehrten Formations. The Middle to Late Pleistocene age Riverbank Formation is described as arkosic alluvium with sand and silt, forming alluvial terraces. The Riverbank formation overlies the Pleistocene age Turlock Lake Formation, which is described as arkosic alluvium, sand with some silt and minor gravel, deeply weathered and dissected. The Turlock Lake formation in turn overlies the Miocene age Mehrten Formation, described as andesitic conglomerate, sandstone and breccia. A geologic map of the area is provided as Figure 2 in Appendix A.

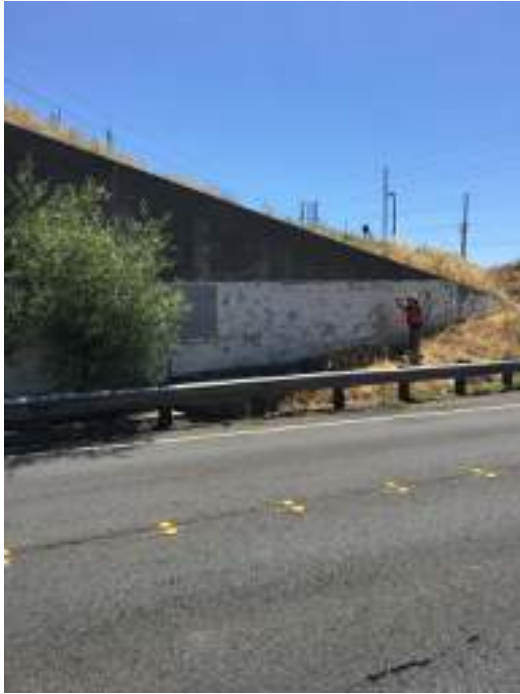
Photo 4 – Eastern abutment, southern face, viewed east.

CAInc observed white paint on vertical walls of the concrete underpass abutments. In several locations, the white paint was painted over with a gray paint. Paint was cracked and peeling, and flakes of paint were observed on the ground surface at the base of the abutment. Because lead-based paint (LBP) has historically been used on transportation structures, CAInc conducted a materials evaluation to determine if lead content in the paint requires special handling. Grime and detritus already on the bridge before the start of work may also contain lead, and is considered part of the existing paint system. Sample locations are plotted on Figure 1.

During the 14 July site reconnaissance, painted surfaces of the concrete railroad underpass abutments were observed to be flaking and peeling (Photo 4). Analytical data indicate the total lead concentration in this paint is above the 1,000 mg/kg threshold for hazardous waste. NAL's inspection on 5 July also indicated that orange paint on the metal underpass components contained lead above the Environmental Protection Agency (EPA) and California Public Health Department (CPHD) threshold of 1.0 mg/cm² (lead concentrations equal to or above this threshold require abatement or in-place management). Painted concrete and metal components removed for disposal, or other waste material from the painted portions of the bridge (e.g. sandblasting waste) must be handled and disposed of in accordance with the Caltrans 2015 Standard Specifications (SS) 14-11.13 and Standard Special Provision (SSP) 14-11.13. A Lead Compliance Plan will be required for this work (SS 7-1.02K(6)(j)(ii)).

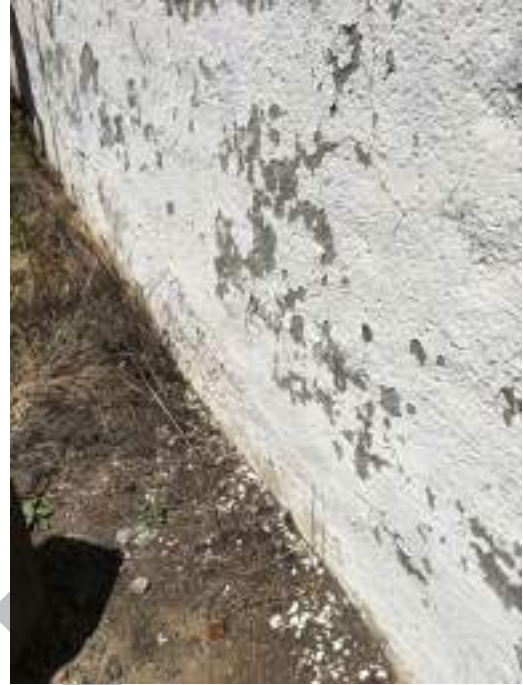
Photo 5 – Paint condition, southern face of western abutment.

Housing and Urban Development (HUD) guidelines are used to describe paint conditions. The condition of the paint on the abutment walls is peeling and flaking. Photographs of the bridge paint condition are included in Appendix B.

As indicated in the California Code of Regulations Title 22 §66261.24(a)(2), the lead concentration of the bridge paint samples is greater than 1,000 mg/kg lead, the regulatory threshold for wastes containing lead to be classified as hazardous. Wastes from the painted surfaces of the bridge generated during maintenance activities will need to be handled and disposed of as hazardous waste.
