## Kurt Stegen Consulting Arborist

Date: September 11, 2019

Location: 450 Diamond Oaks Road  
Roseville, CA. 95678  
APN 015-360-022

Customer: Tangent Design & Engineering Corp  
660 Auburn Folsom Road St 204  
Auburn, CA. 95603  
916-572-5955  
[www.tangentde.com](http://www.tangentde.com)

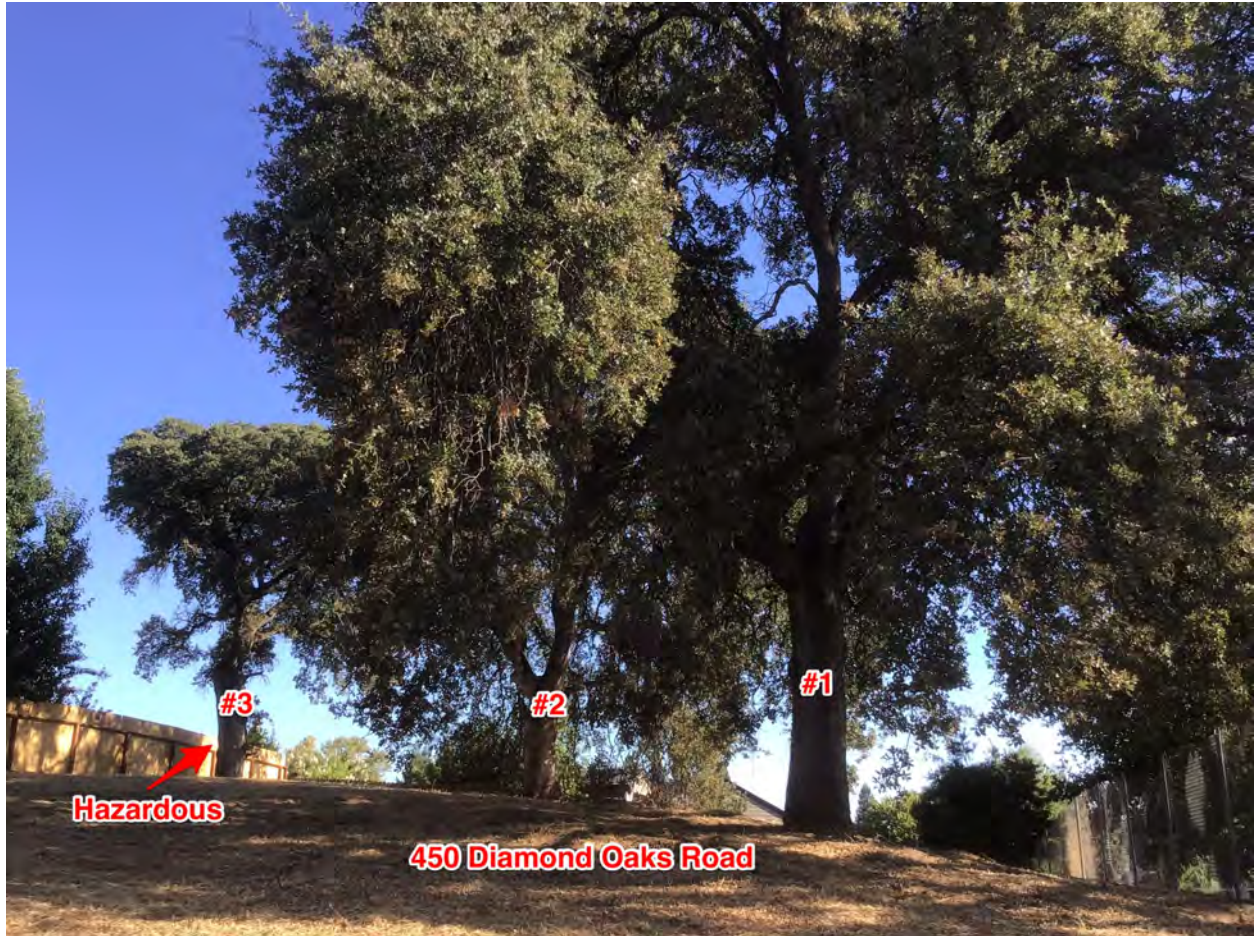
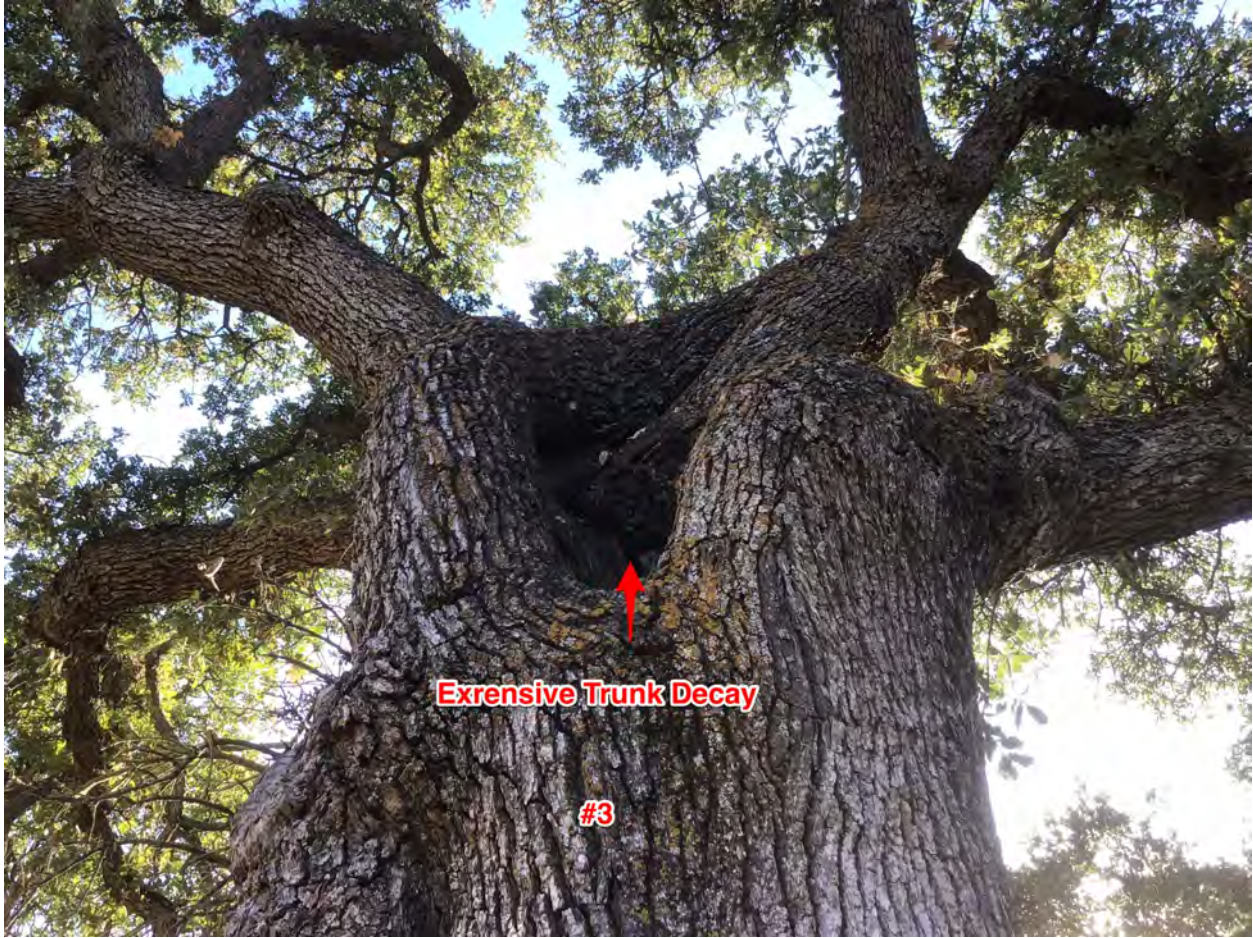
There are three Blue Oaks (*Quercus douglasii*) being evaluated. Oaks #1 and #2 are in fair condition. Oak #3 has extensive internal decay. Both the trunk and roots show decay. A mallet was used to strike the trunk, a drum or hollow sound was heard, indicating extensive internal decay. The tree is a single trunk tree that branches out at approximately fifteen to twenty feet above the ground. Decay in the area could cause the unions in the wood to be weak. Failure of the limbs could cause property damage and personal injury. People and property should be kept out of this area until the tree removed.
