This report has been prepared for Wesley Cambron and Allstate Renovations Inc., at the property 114 & 114A, Roseville Street, Roseville, CA. There is only one tree on the property and it will be designated as Tree # 1, as indicated on the attached aerial image of the property titled "Tree # 1 Location". This image also shows the two properties previously mentioned. This permit has been written to assess current conditions of Tree # 1 and future health impacts if said tree is retained, and proposed structures are built. This report has been written to conform with the guidelines established by Roseville Municipal Code 19.66.050

Minimum Information for Tree # 1

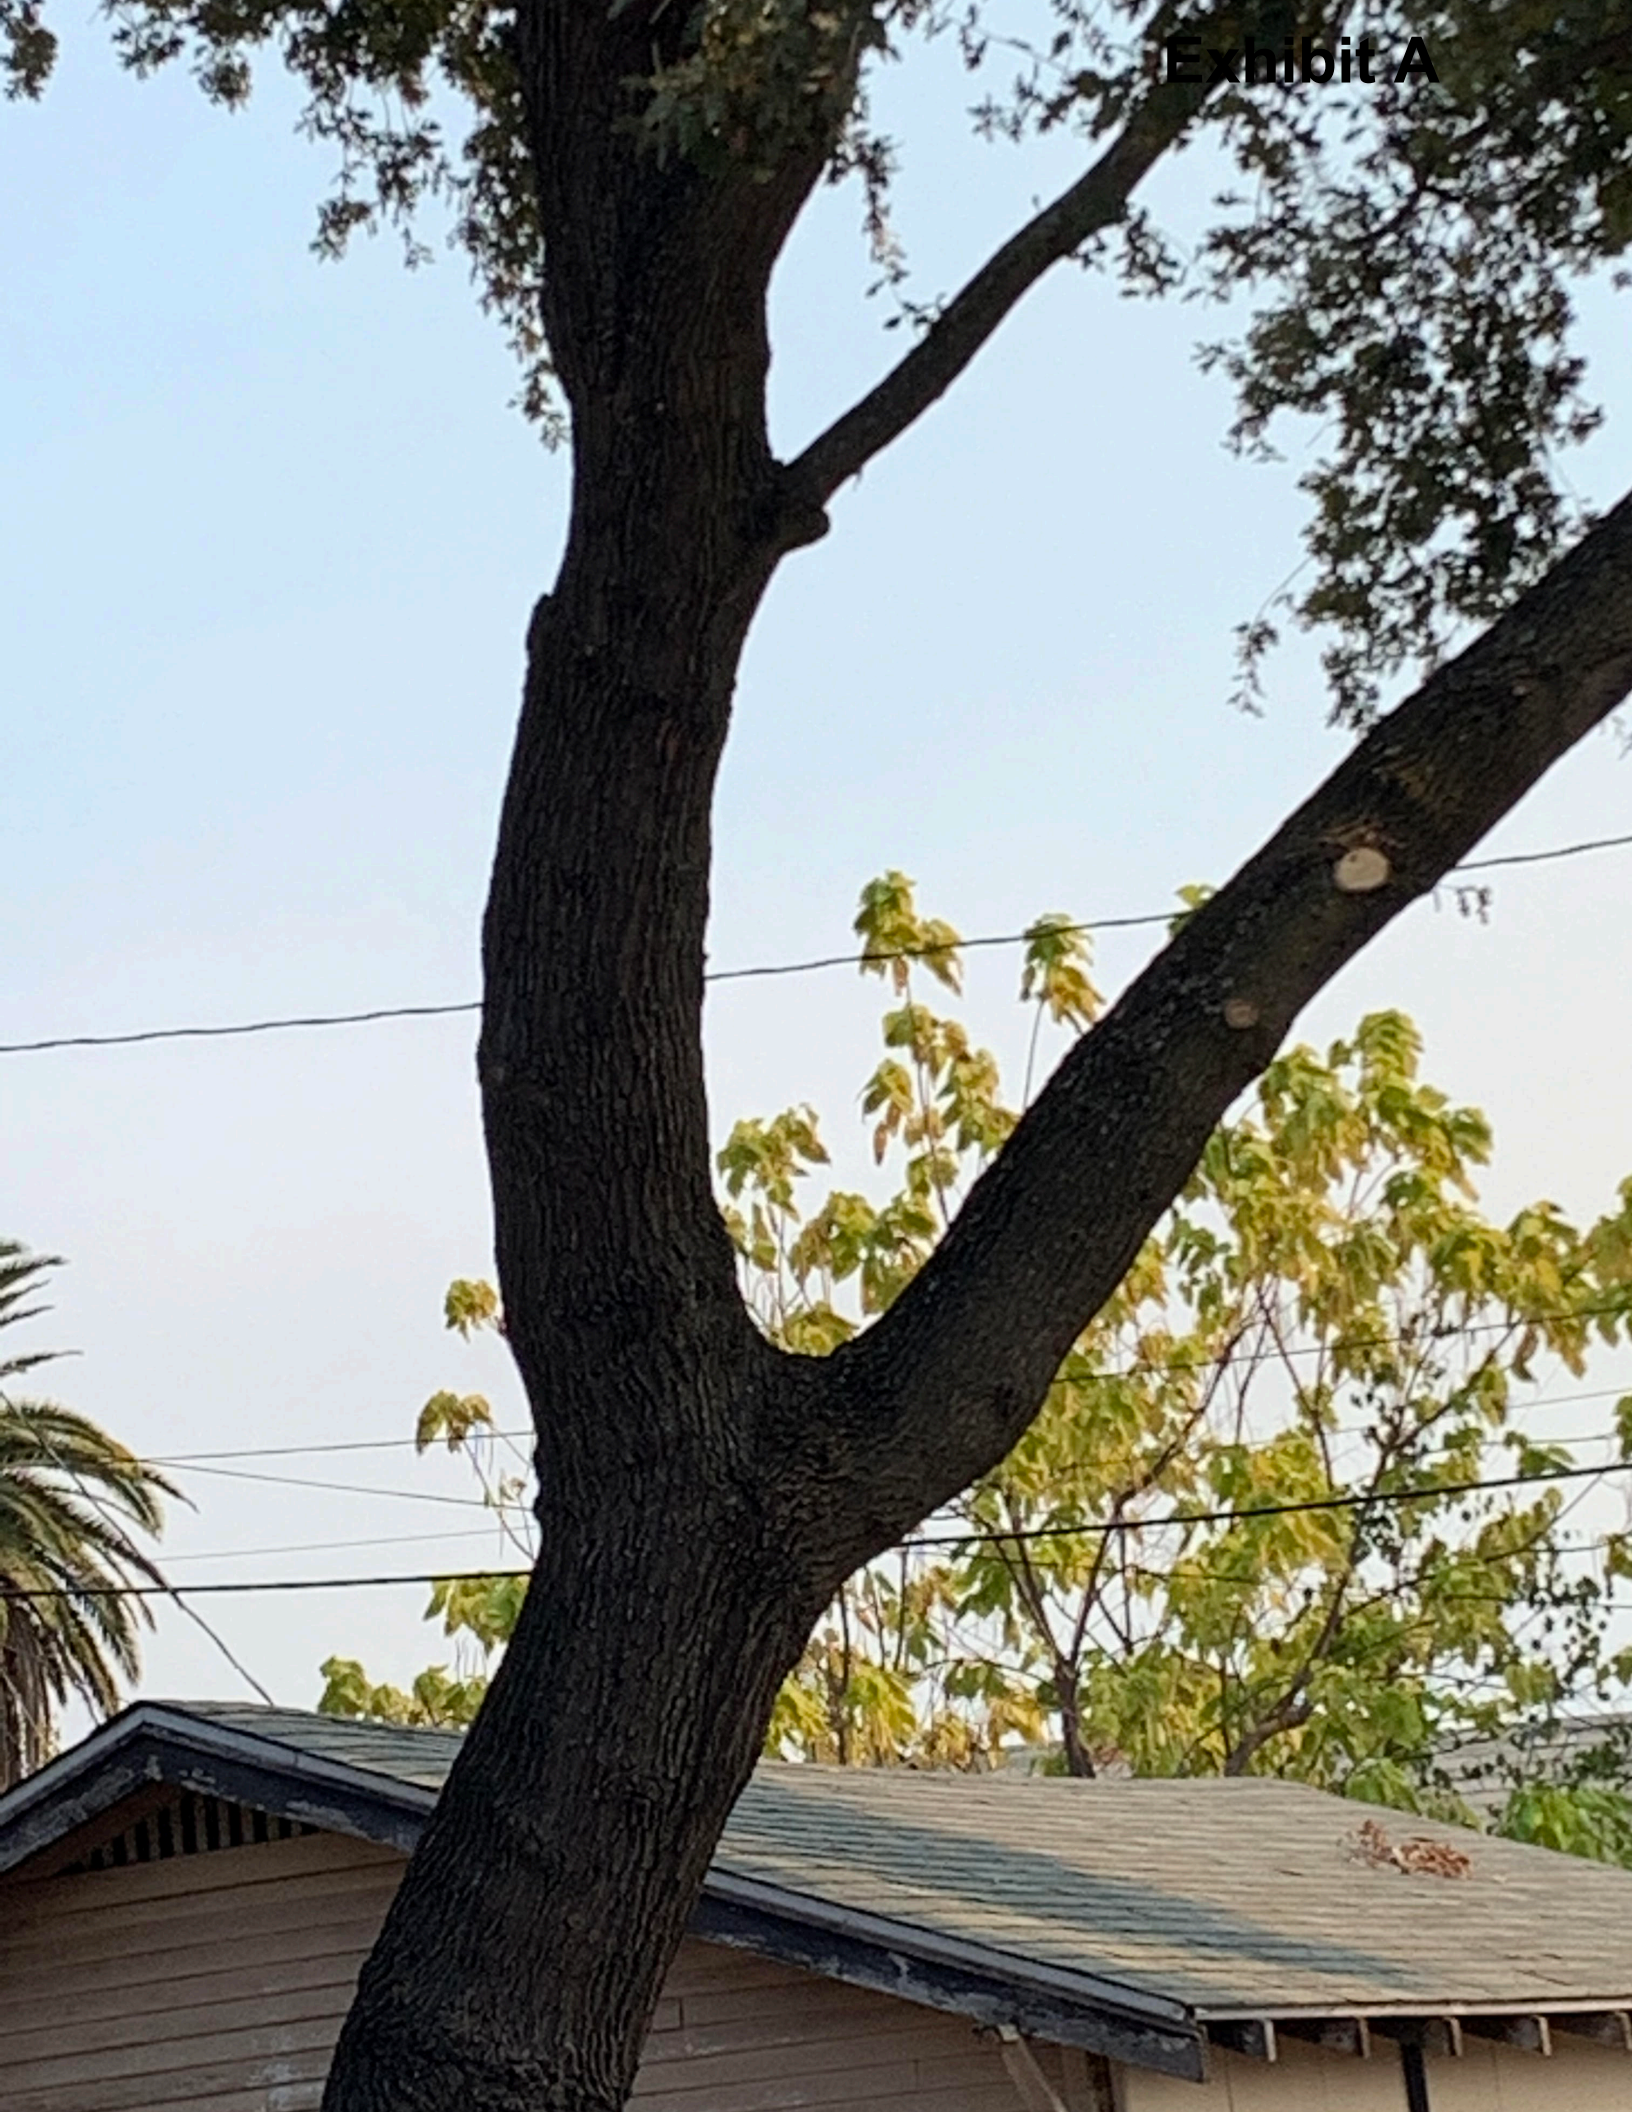
Exhibit A

measuring tape walked out from the base of the tree to its furthest spread, as well as using GoogleEarth to gauge an accurate spread of the canopy, as seen in attached image titled, "Tree # 1 Dripline".
