Dry Creek Greenway Trail Fluvial Audit

Prepared for:
City of Roseville
and Psomas

Prepared by:
cbec, inc.

December 2014
Project Number: 13-1041

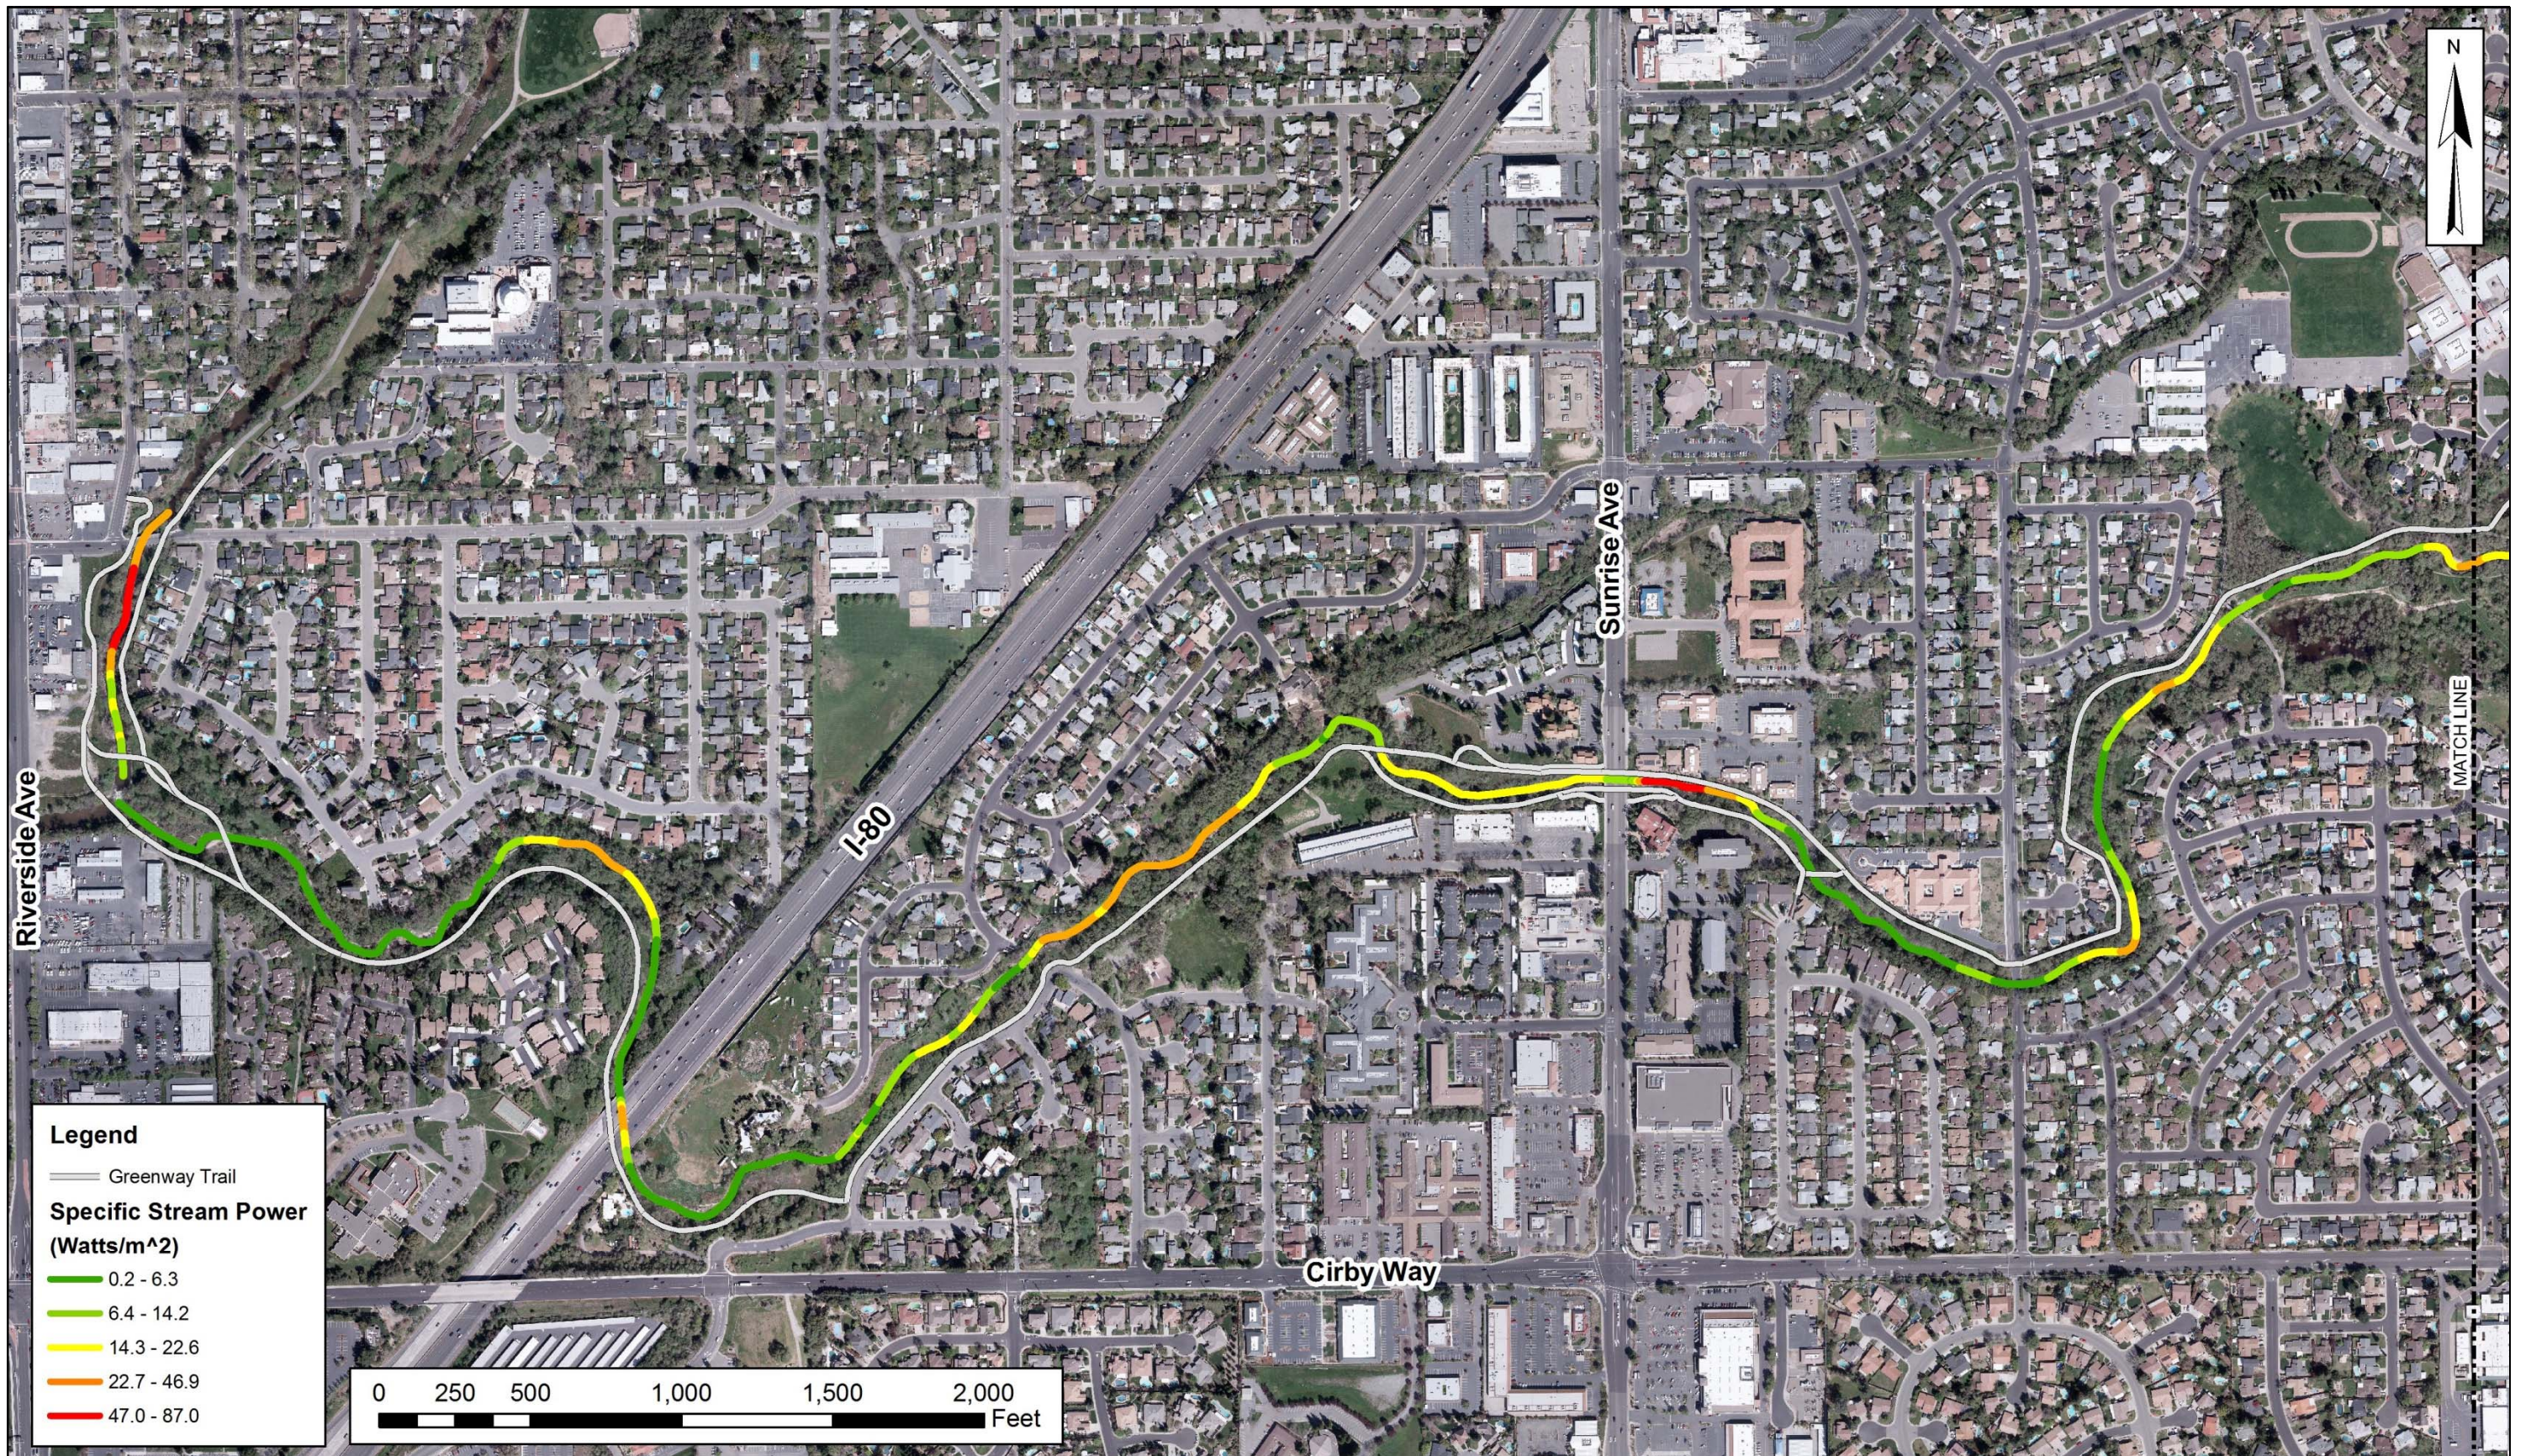
Figure 3

3. Between Rocky Ridge Drive and Champion Oaks Drive, a high-flow flood bypass channel is present in the Linda Creek floodplain (see Figure 3). This flood bypass channel interacts with the main channel in a number of locations and likely influences in-channel hydraulics and bank erosion. The proposed trail's proximity to the flood bypass channel may increase erosion risk to the path at several locations.

The proximity of the proposed trail to the flood bypass channel (or excavated terrace), particularly between Rocky Ridge Dr and Old Auburn Rd, poses an increased erosion risk to the trail in several locations as demonstrated in Figures 3 and 18.

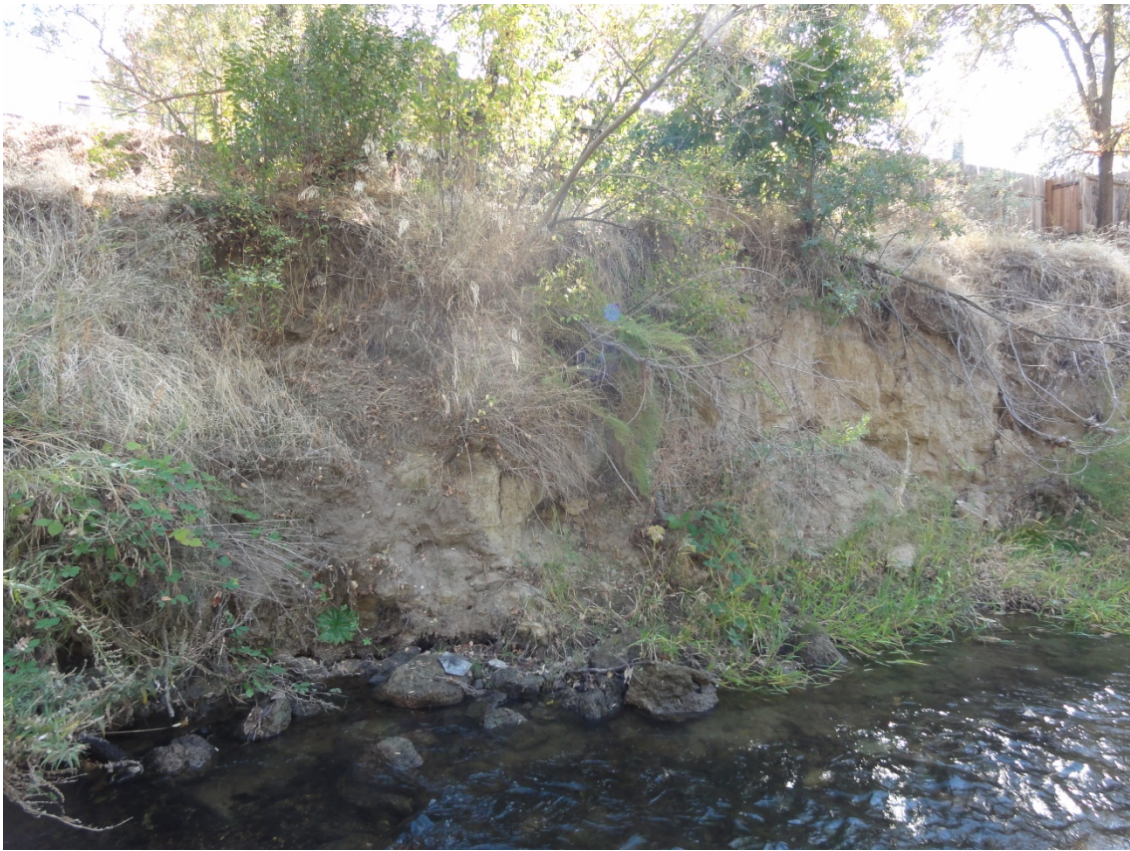
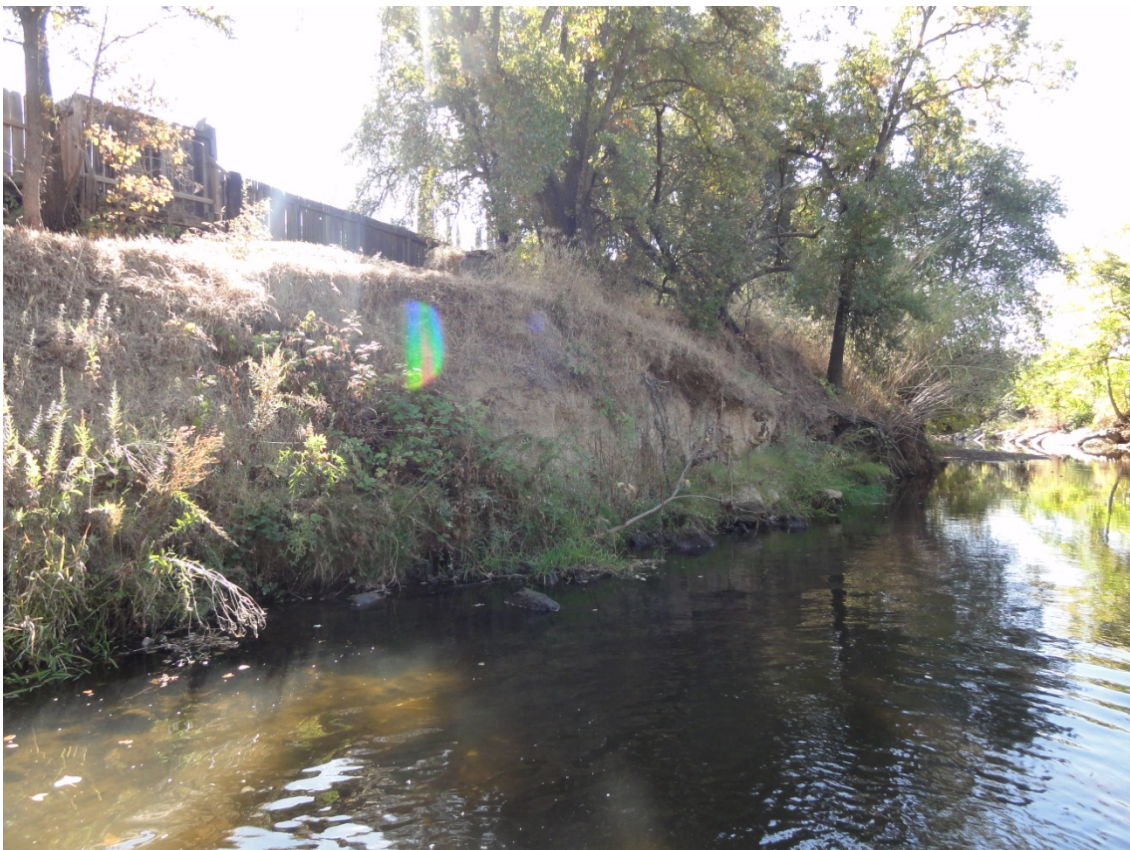
This section of trail along the left-bank of Dry Creek downstream of the Darling Way bridge runs parallel to a section of moderate severity bank erosion (see Figure 20 and 27). The proposed trail is less than 10 feet from the approximate location of the top of the eroding bank. The sections of trail immediately upstream and downstream of this area were assessed with moderate risk, despite their not being adjacent to an eroding bank. However, their proximity to the channel, the nearby bank erosion and the bank protection measures in the reach that were already implemented along the opposite bank informed a moderate risk assessment. Given the relatively narrow space available between the top of bank and the private property fence line, the following actions are suggested in order of priority:

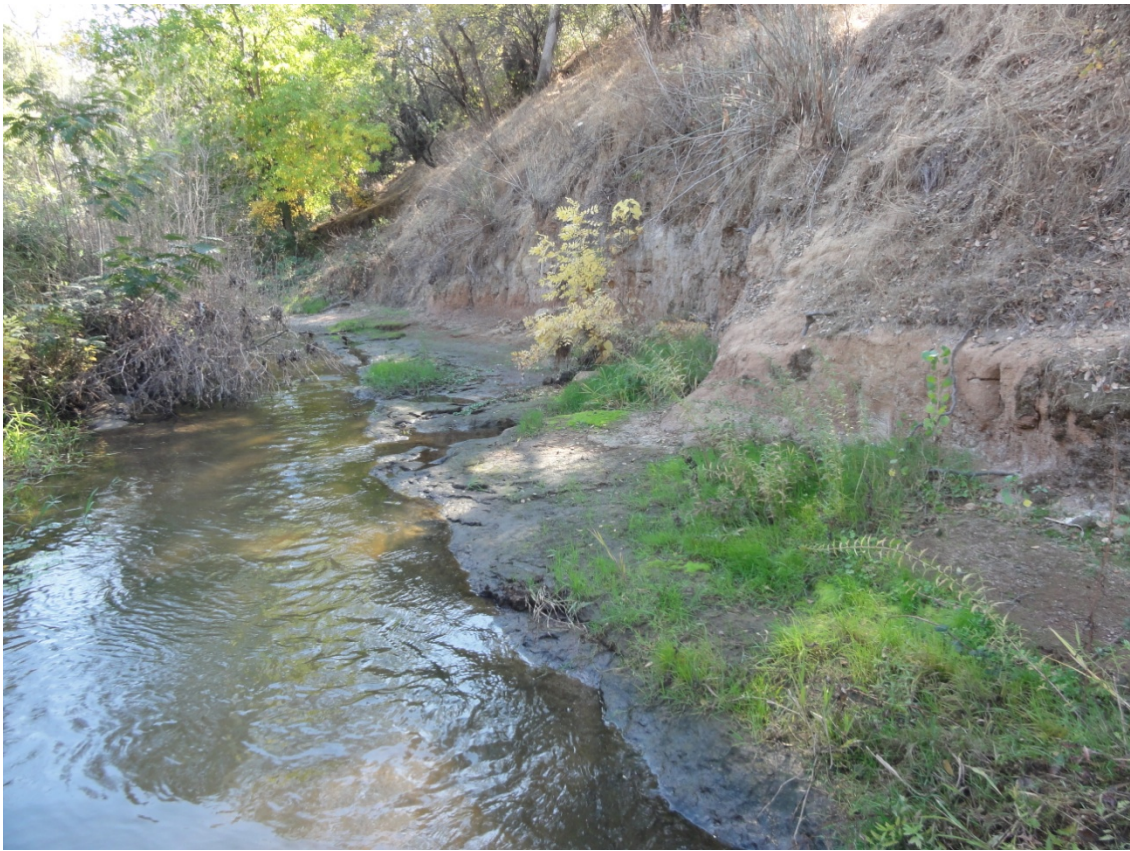
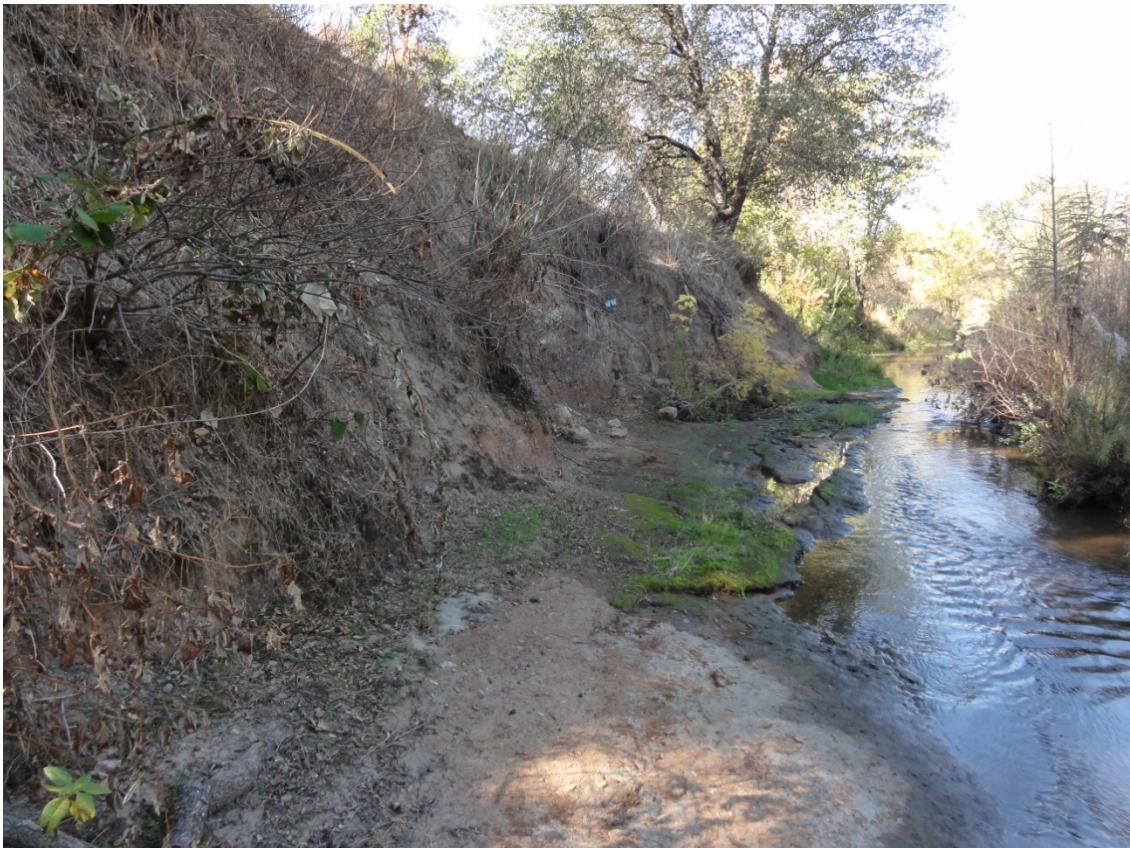
Figure 21

Notes: Top - looking upstream; bottom - looking downstream

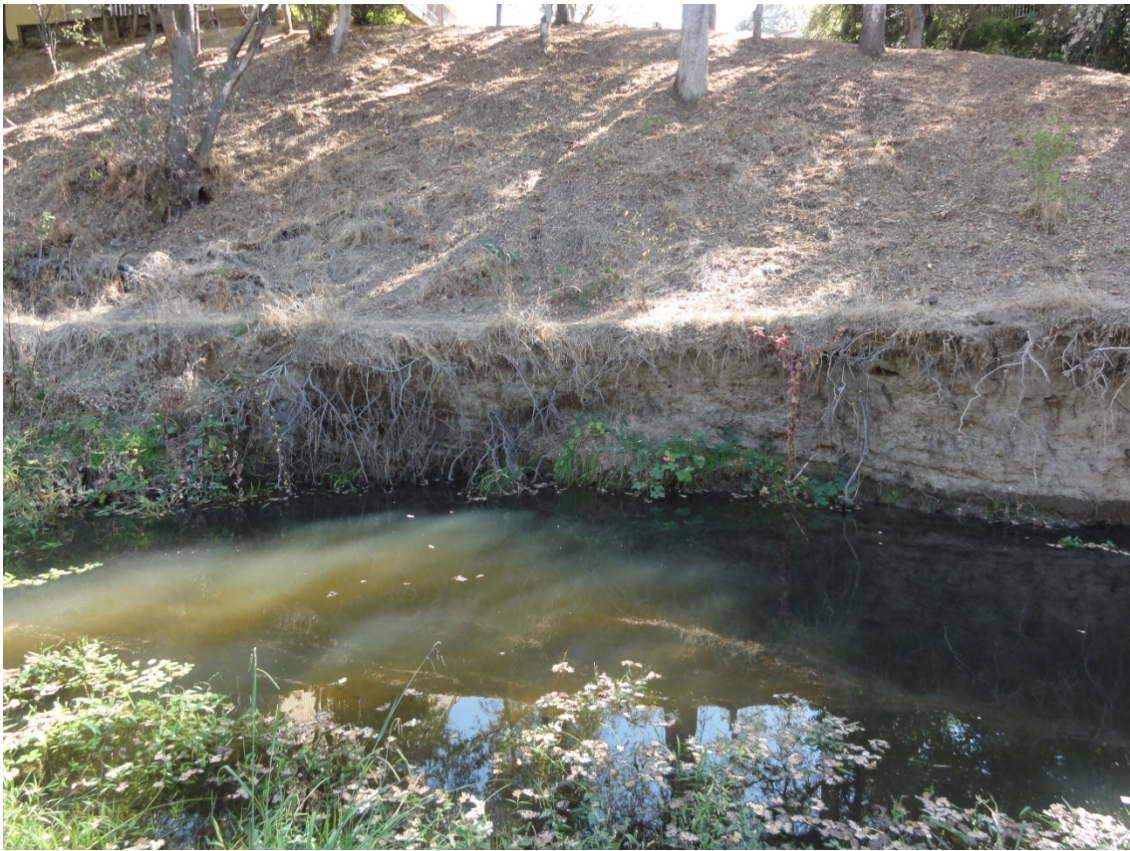
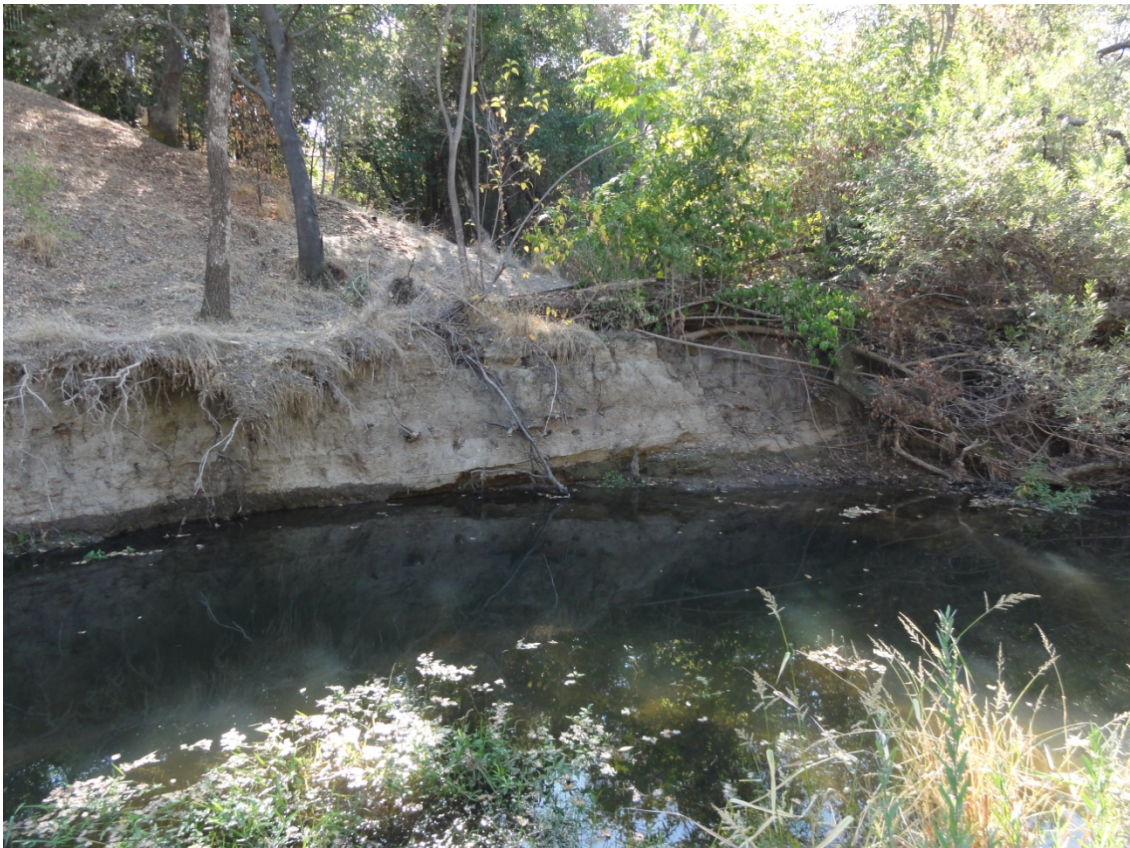
Figure 22

The proposed trail between I-80 and the confluence of Dry and Cirby Creeks has a segment of extreme and high erosion risk near Cirby Hills Drive and Machado Lane (see Figures 22 and 28). This section of trail along the southern side of the channel is the most concerning section of the proposed path along the entire length of the fluvial audit. The ongoing severe erosion and the limited space between the top of bank and the toe of the hill slope will likely jeopardize the integrity of the trail. The following actions are suggested in order of priority:

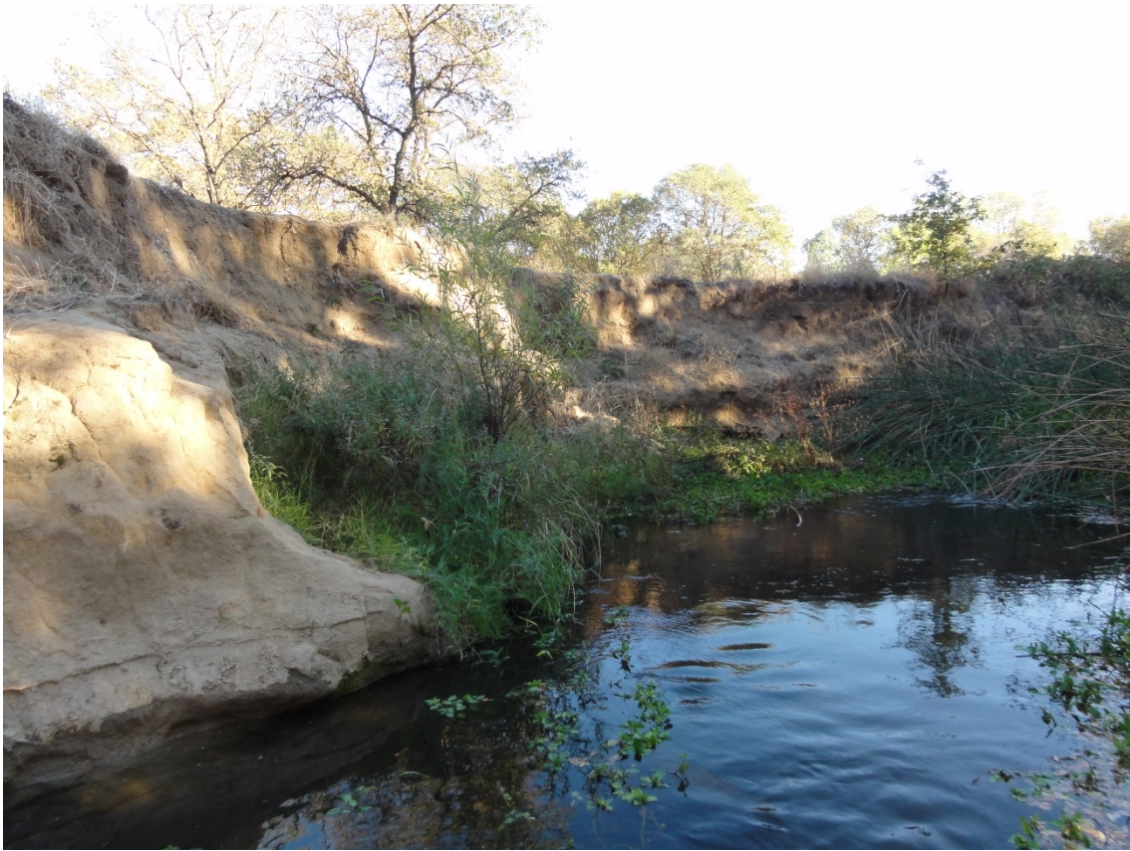
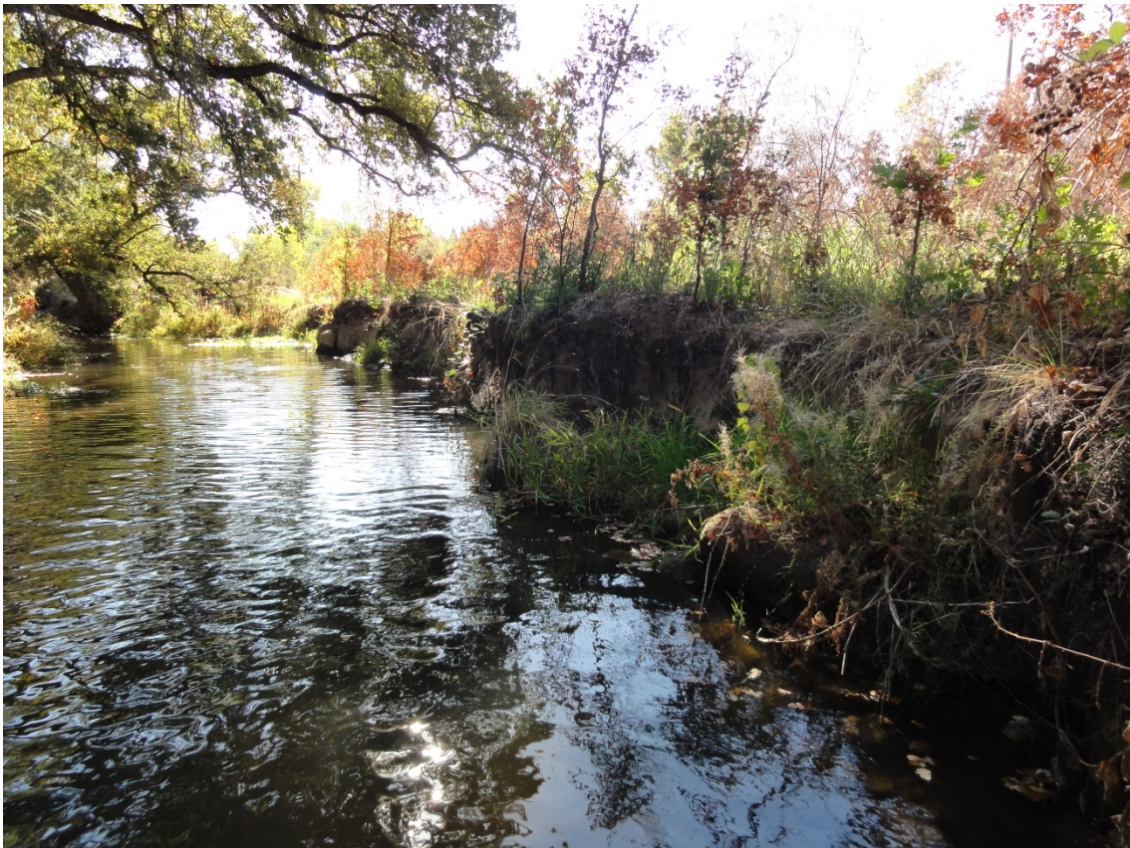
Figure 23

LINDA-H1 is the furthest downstream segment of trail along Linda Creek with a high risk classification. The trail is located adjacent to a lengthy section of bank erosion (see Figures 23 and 30) and is positioned on the outside of a relatively large radius meander bend. The extent of bank erosion may be enhanced somewhat by a pipe crossing the channel with an angled alignment rather than one that is perpendicular to flow. The angled alignment may be directing erosive energy towards this outside bank, contributing to bank erosion at the site. Given the close proximity of the proposed trail alignment to the top of bank, the following actions are suggested in order of priority:

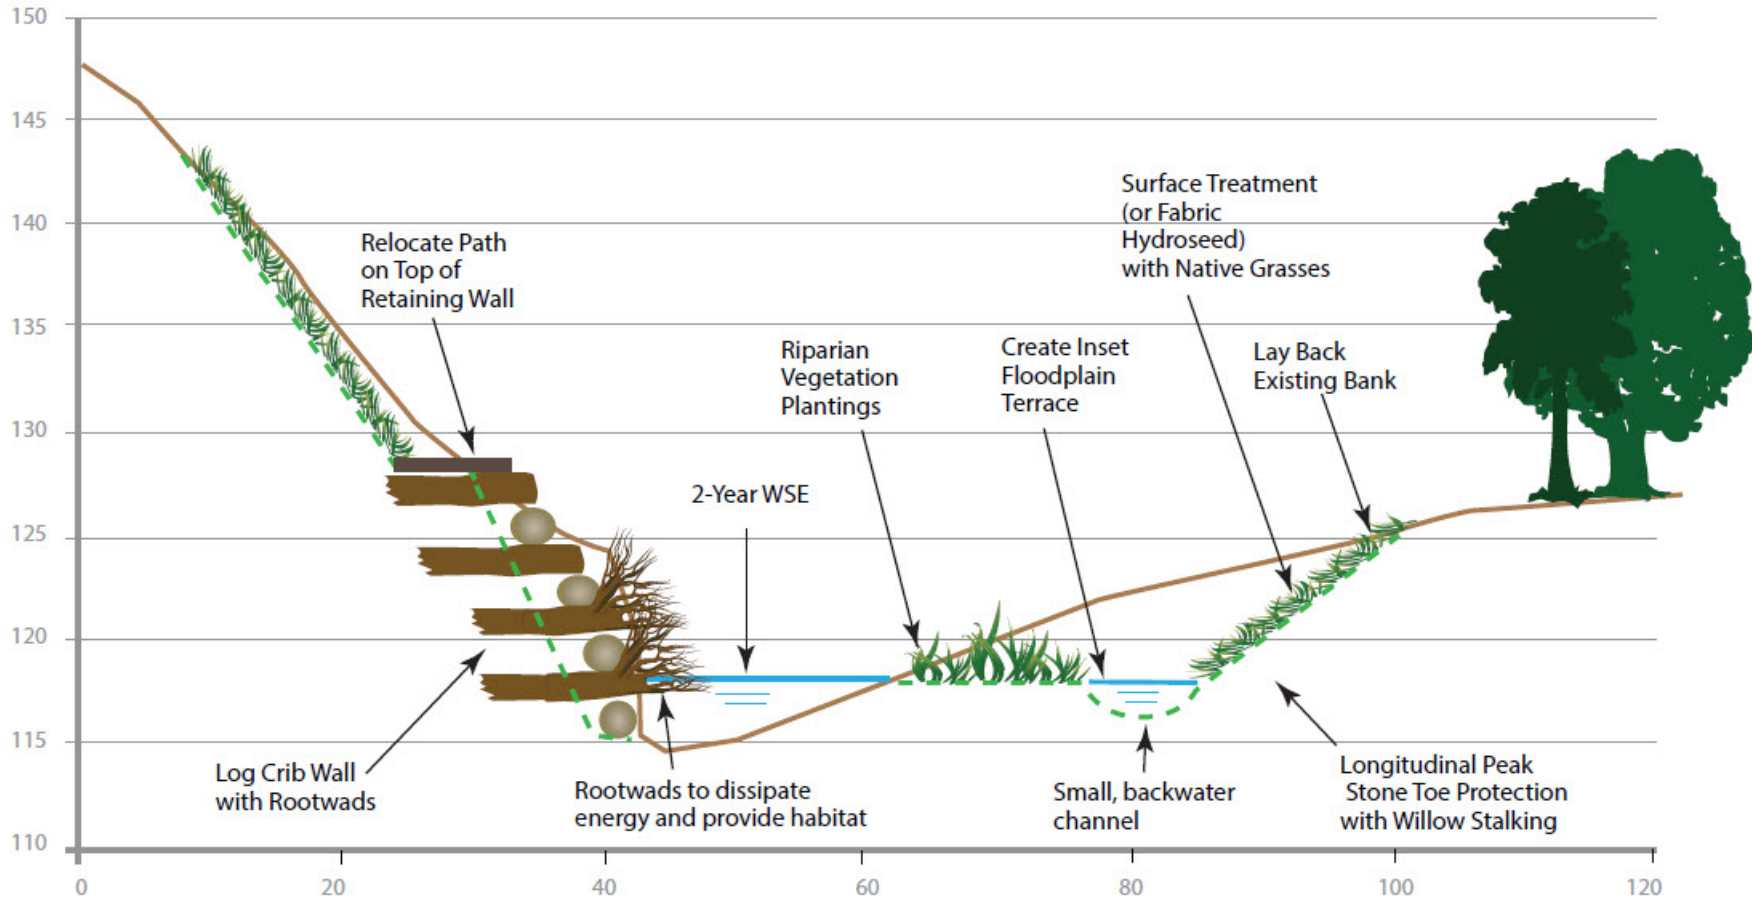
Severe bank erosion must be addressed if trail alignment is left as-is. Site will require extensive bank protection/stabilization measures such as a log crib wall. These actions could potentially be complemented with floodplain terracing on opposite side of channel. See Figure 29 for a cross section with potential concept design.

Notes: Apartment buildings located on top of left hill slope

3. If the trail is to be constructed as proposed, implement a suite of measures as indicated in Figure 29:
 - a. Construct a log crib wall (or similar structural measures) along the southern bank and locate the trail on top of the wall. The crib wall could be outfitted with root wads that would further protect the bank from erosion while also generating a habitat feature.
